REVITALIZATION OF A DYING GARAGE

Answers to the Whats, Hows, and Whys

Sunil Puri, P.E.

ICRI: Modern Trends in the Repair Industry

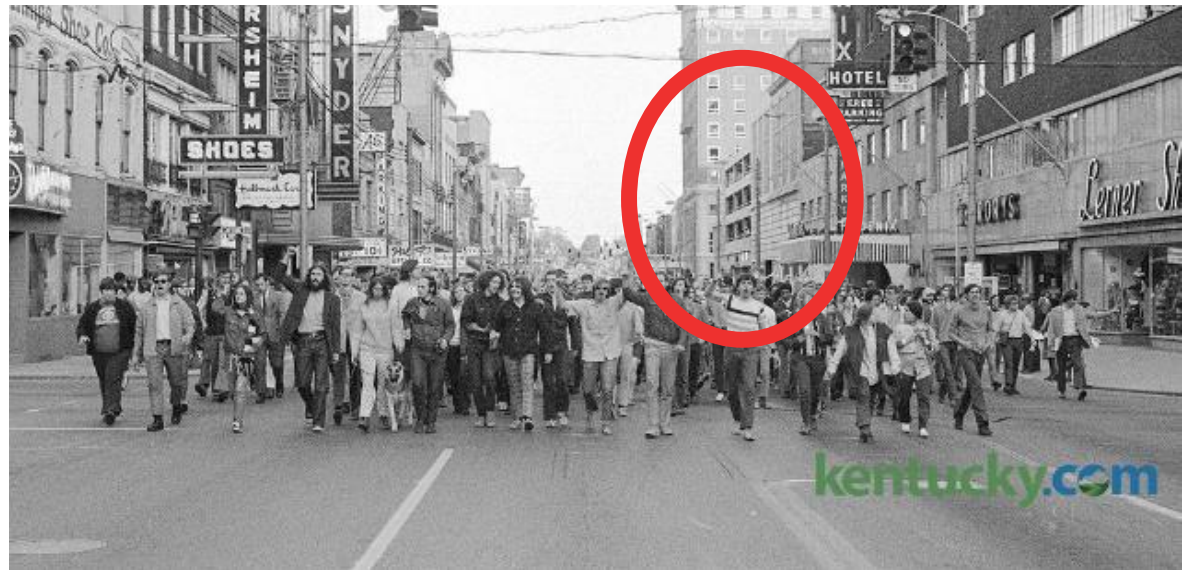
Helix Garage
was built

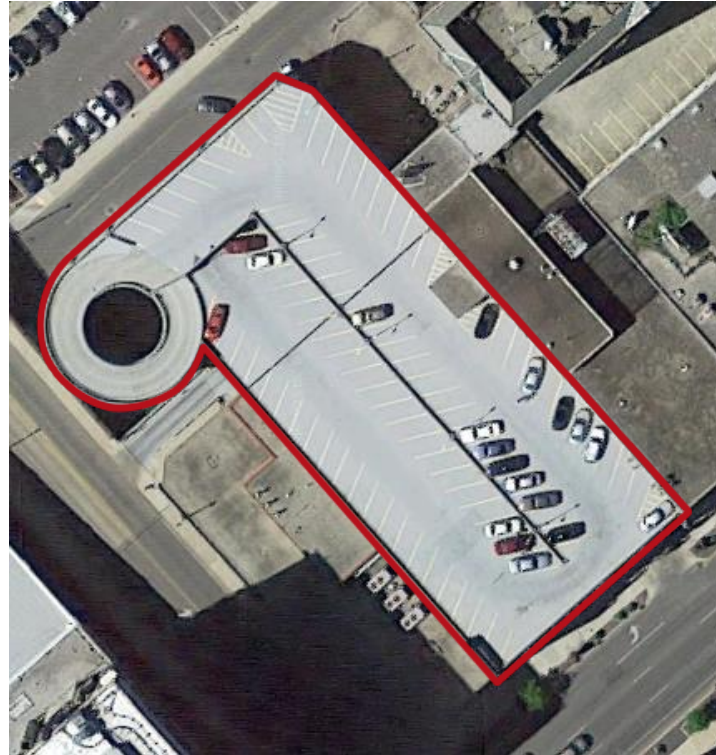
Half-century
OLD

28,600
sq. ft. / level

6
levels

Cast in place,
Conventionally reinforced
CONCRETE

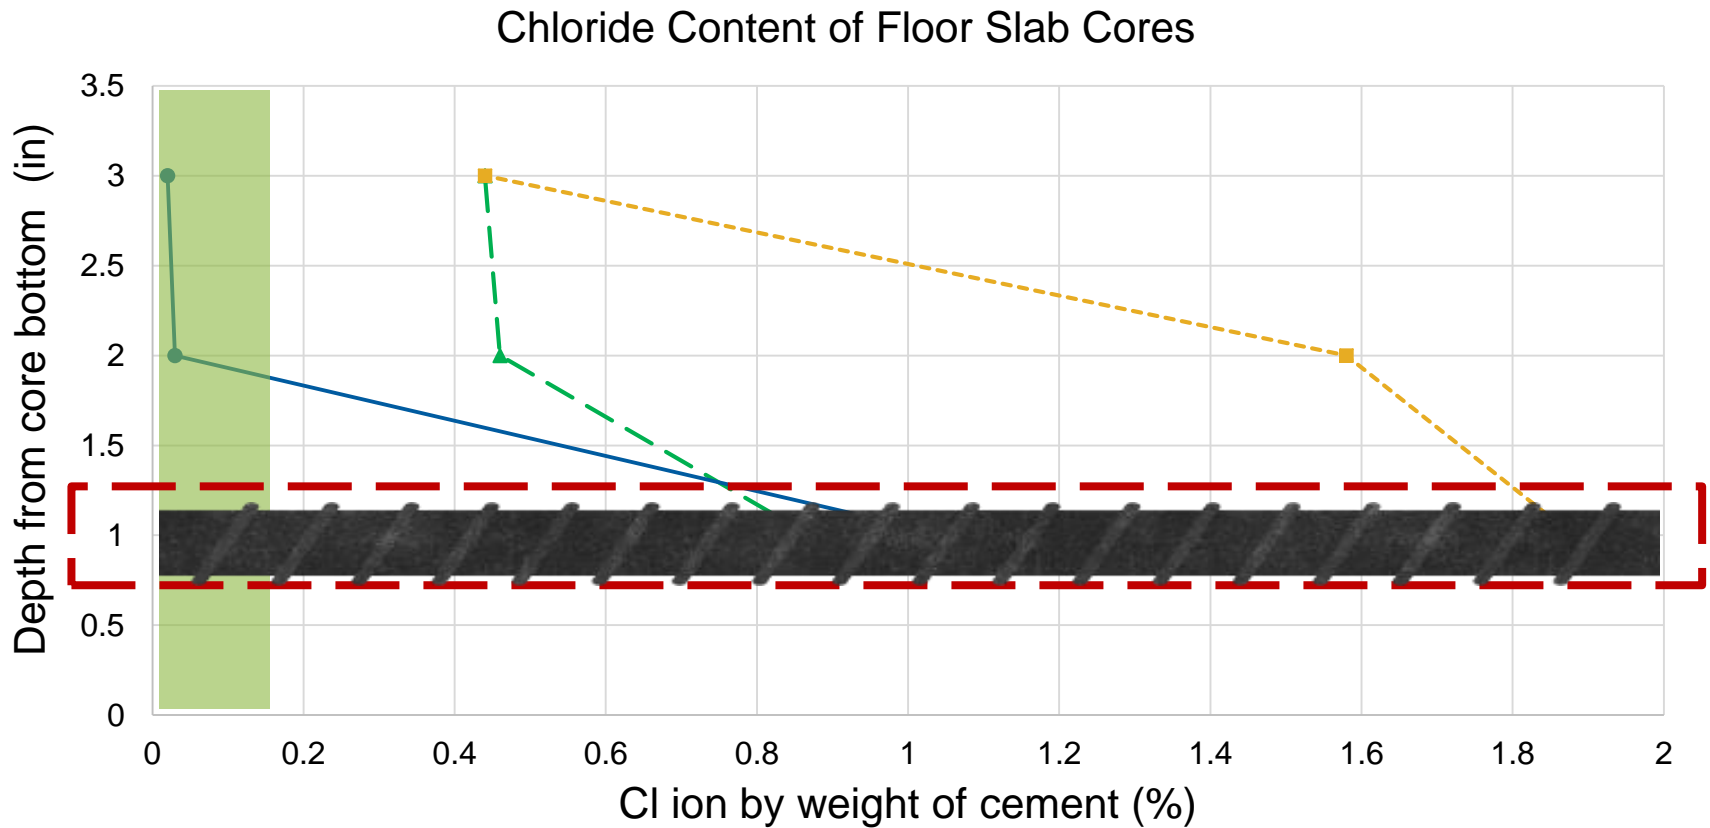
2 Partially Destructive Testing → Chloride Content

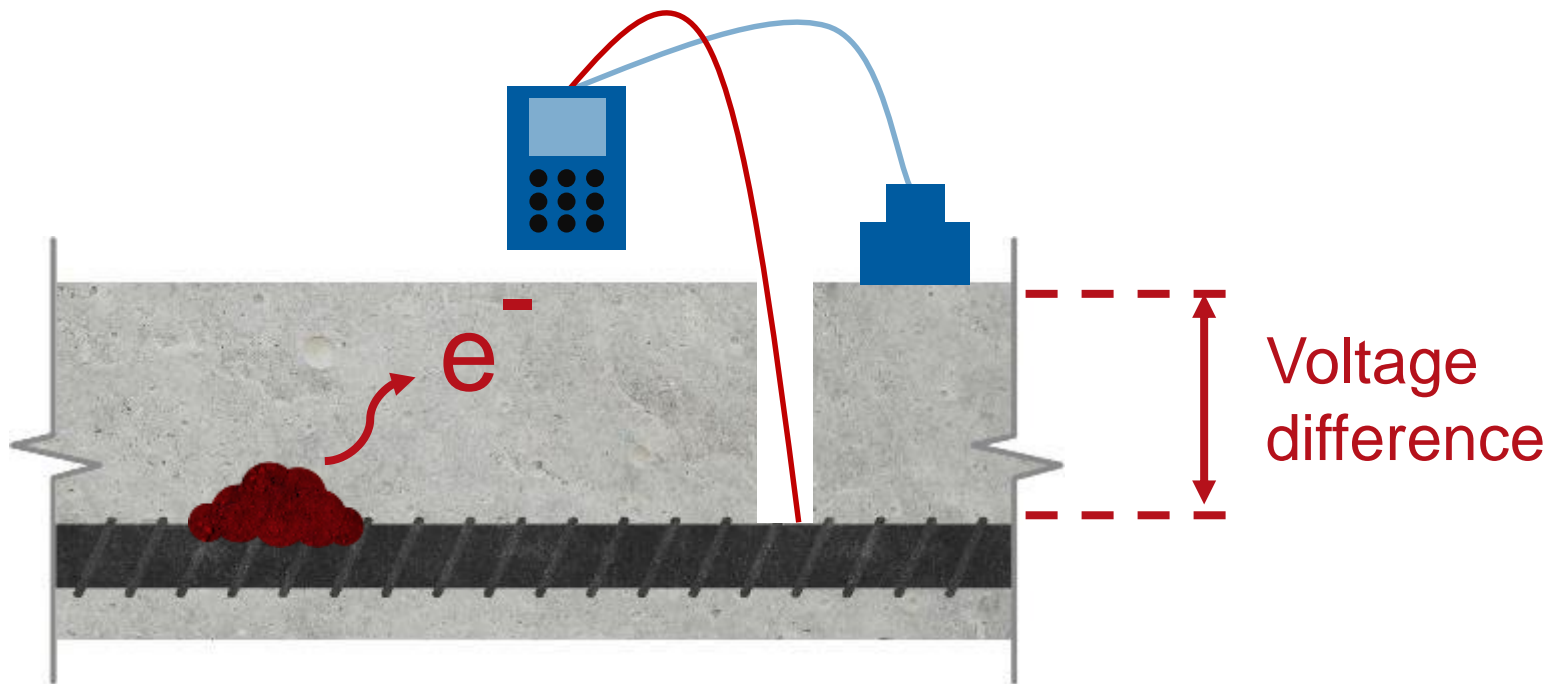
3 Nondestructive Testing → Half-cell Corrosion Potential

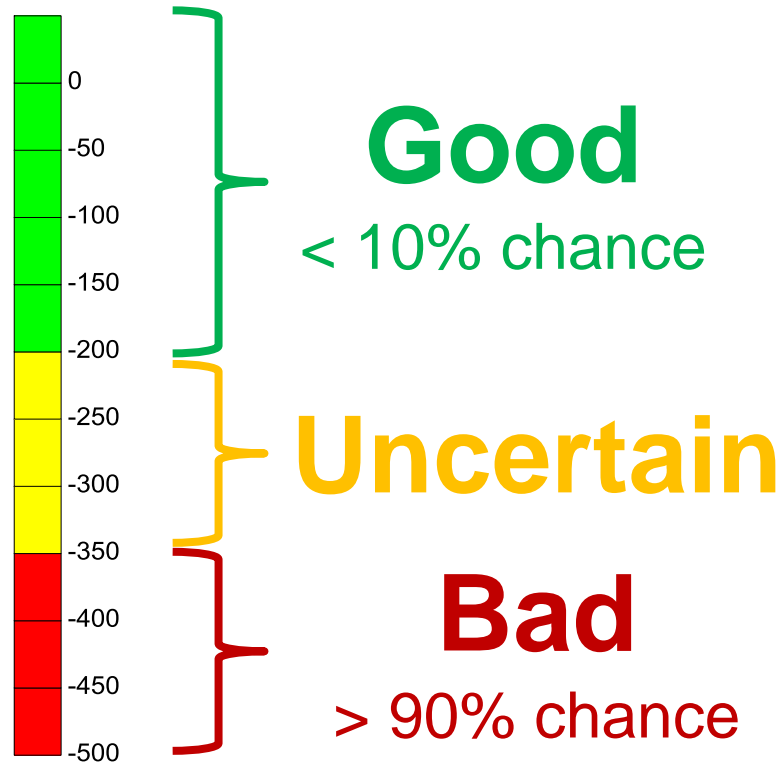
3 Nondestructive Testing → Half-cell Corrosion Potential

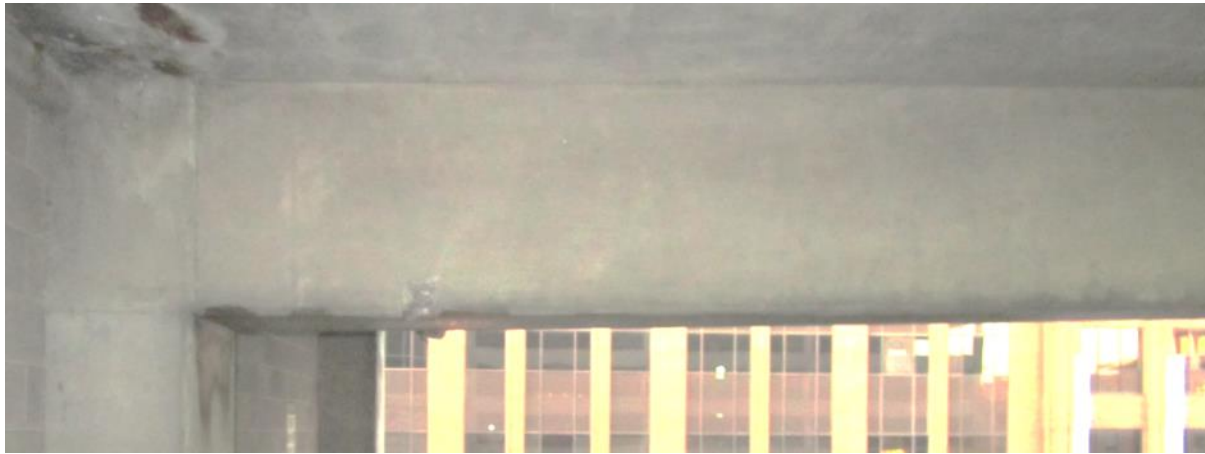
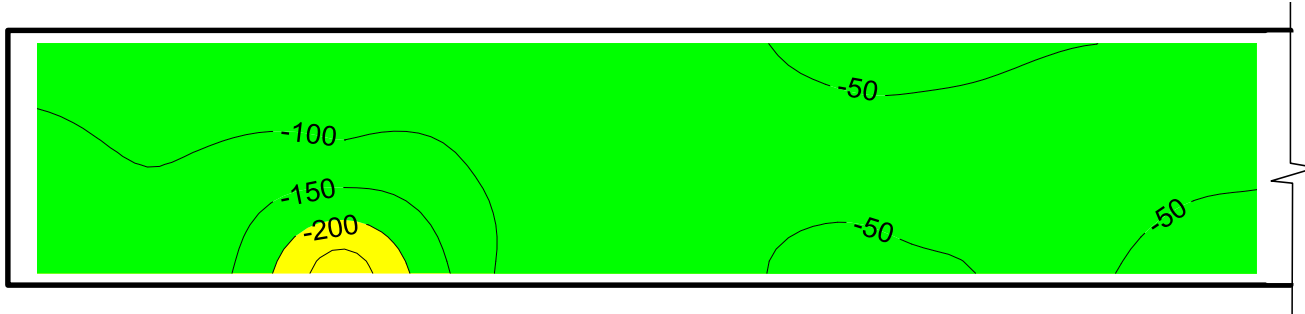
3 Half-cell Corrosion Potential

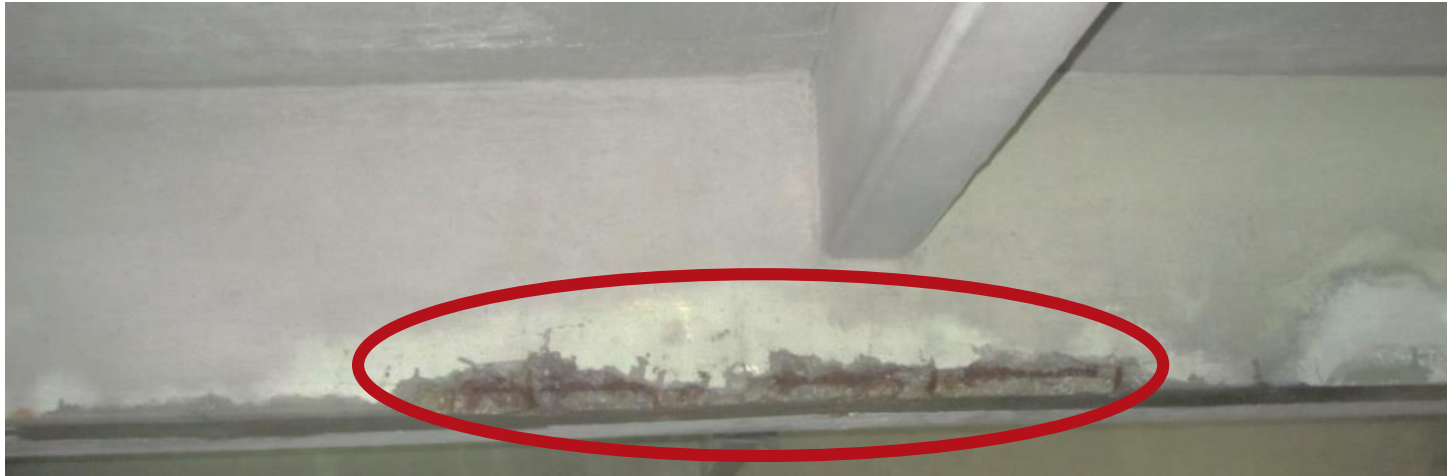
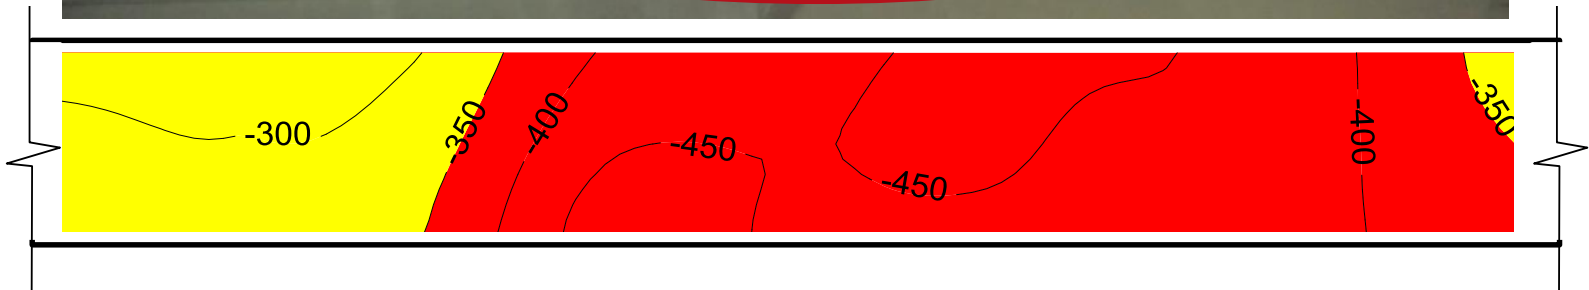
3 Half-cell Corrosion Potential

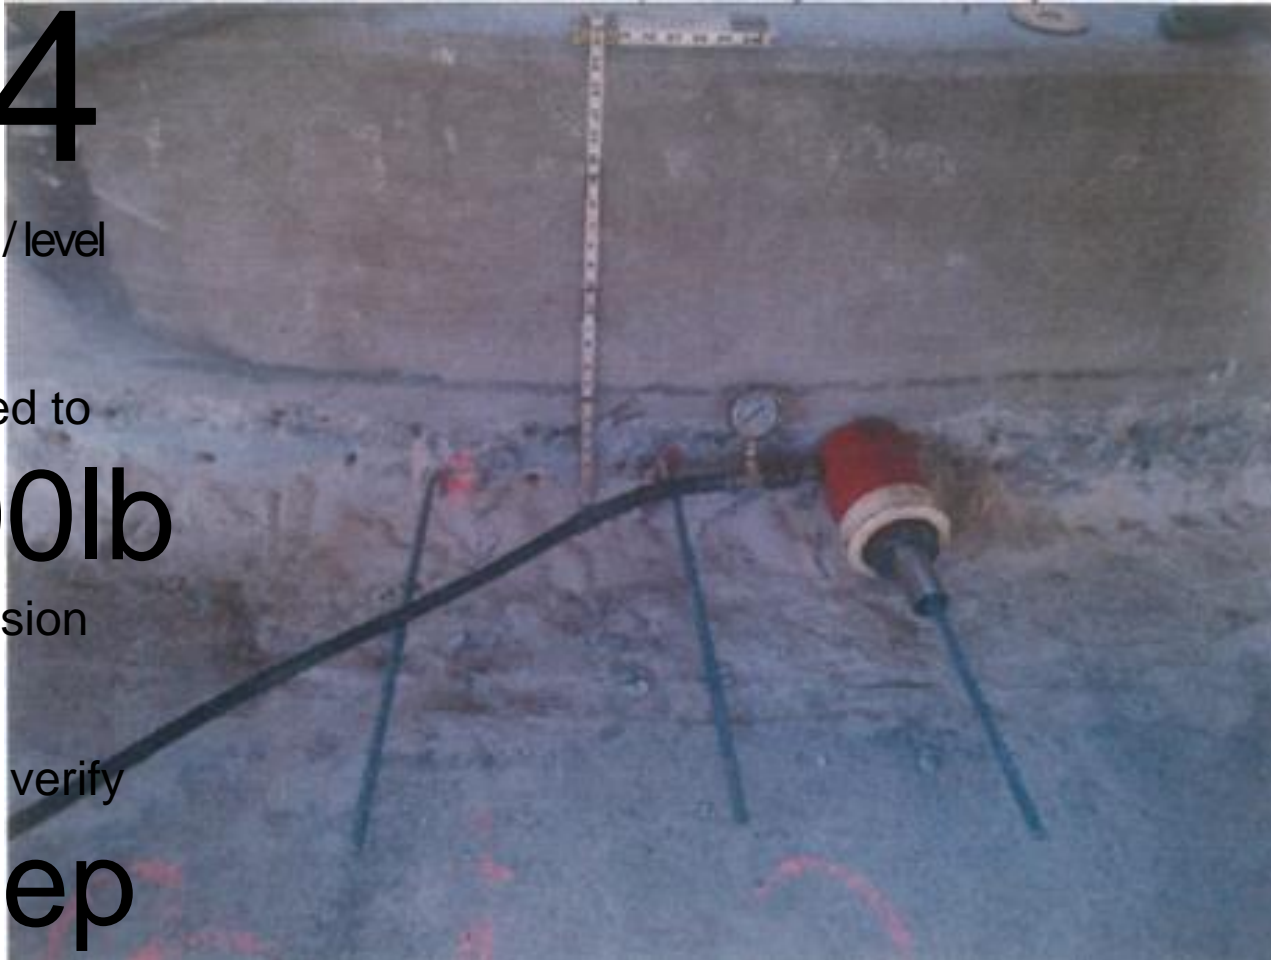
Quality Assurance – Dowel Pull-Out Test

24

dowels / level

Loaded to

4500lb

In tension

Held to verify

creep

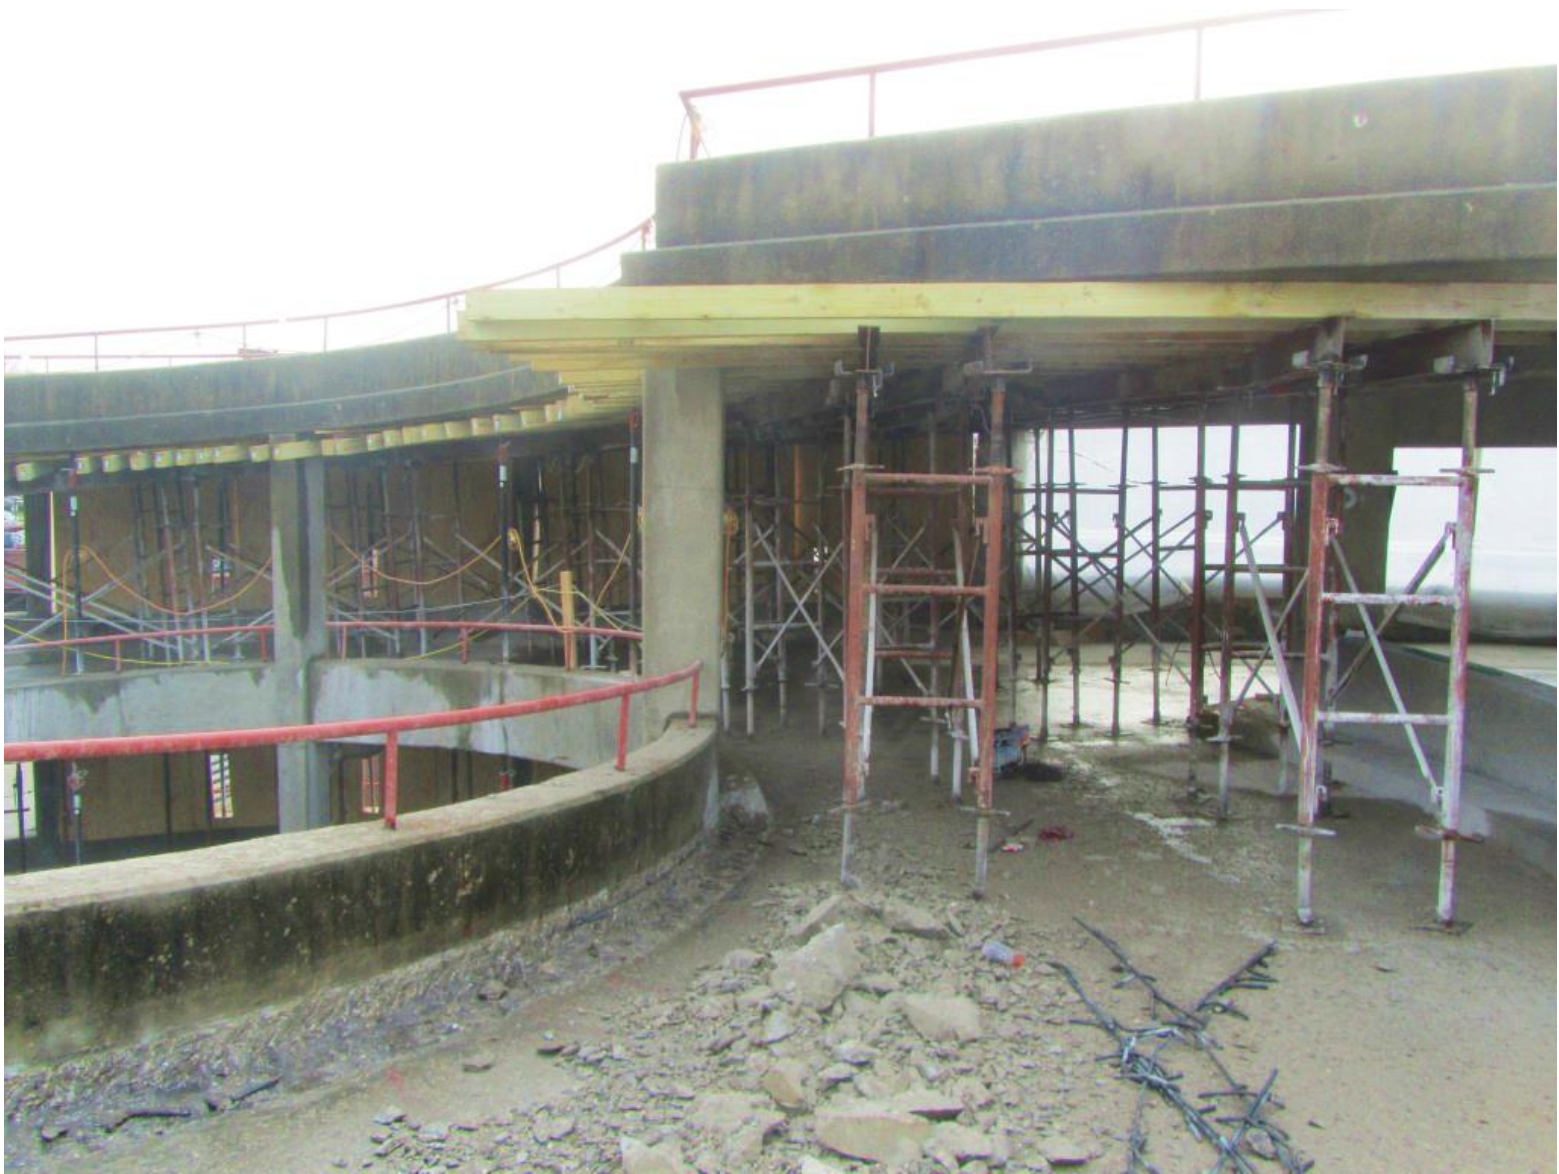
Helix Ramp - Shoring
