# DETERIORATION, DEFECTS AND REPAIR OF ABOVE THE GROUND SWIMMING POOLS AND SUPPORTED DECKS

Dunja Vla, Predrag Popovic  
*Wiss, Janney, Elstner Associates, Inc., Northbrook, IL, USA*

## REPAIR OF THE OLYMPIC SIZE POOL

## REPAIR OF THE POOL AT SENIOR INDEPENDENT LIVING HIGHRISE

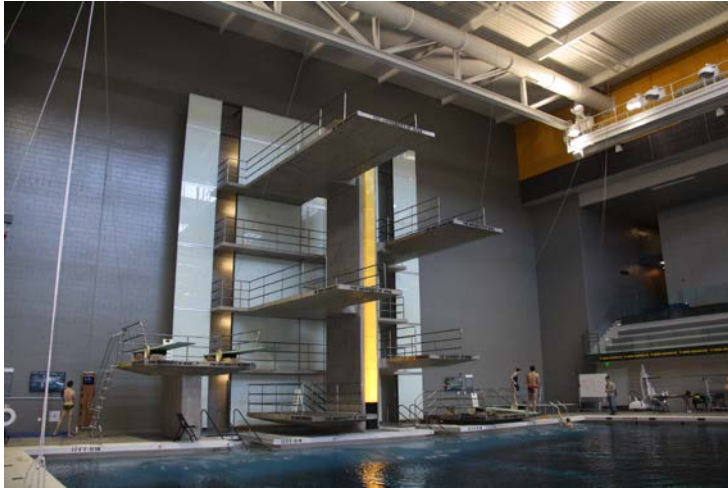
# DIVING PLATFORMS

- Concrete deterioration at platform edges
- Corrosion of metal
- Peeling off rubber mats

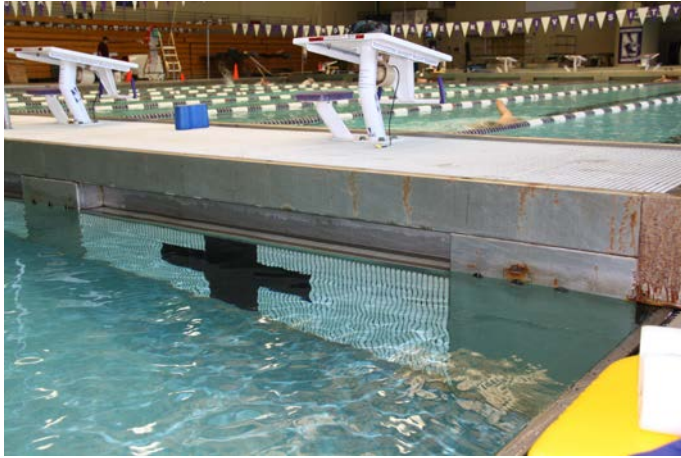
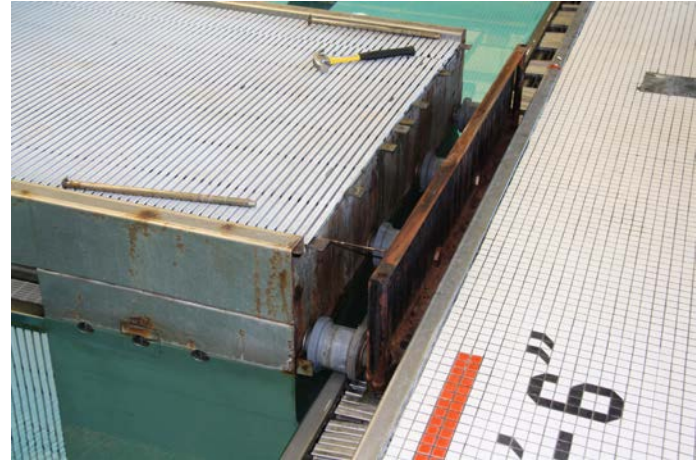
- **BULKHEADS – WORN OUT BEARINGS AND CORROSION**

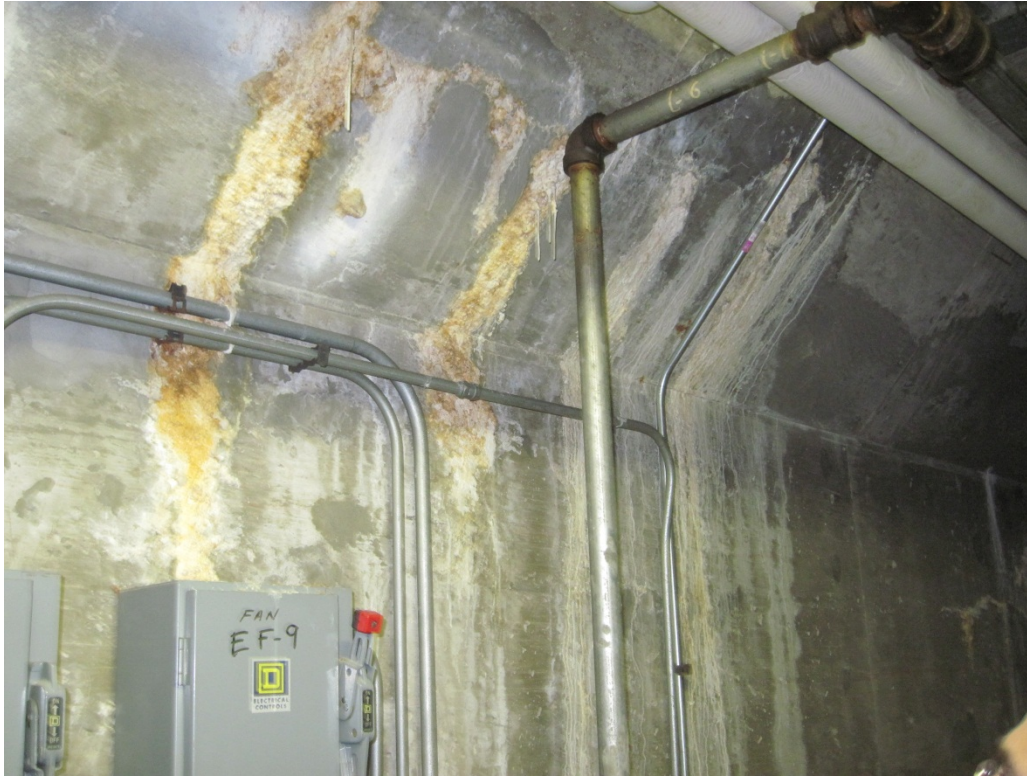
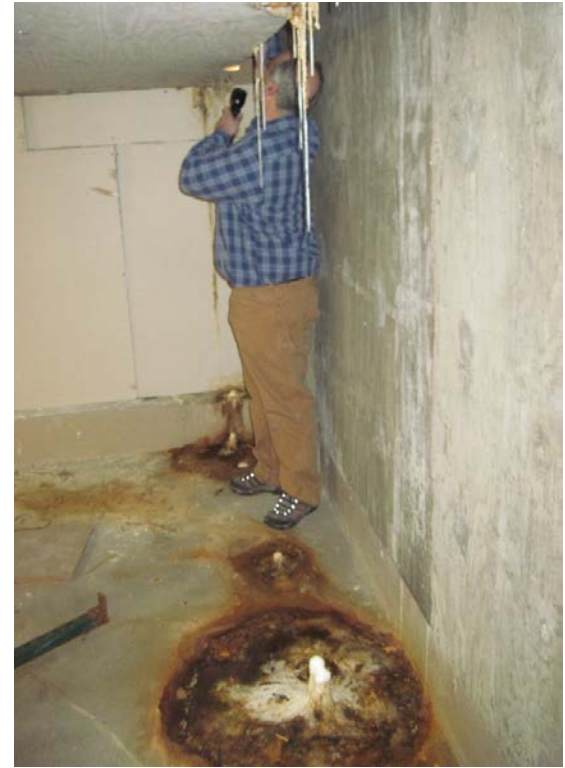
- **UNDERSIDE OF THE POOL**
