Case Study: Software Application for a Bridge Rehabilitation Project

Dennis Burns

October 22, 2010

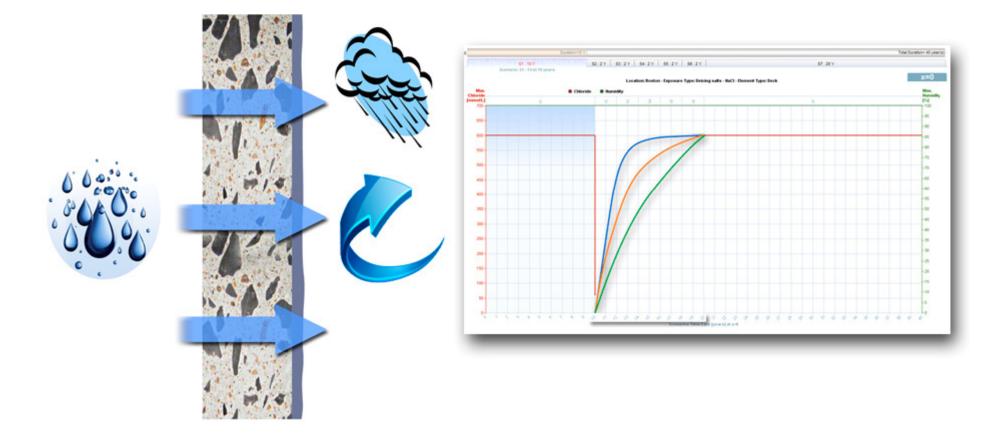
Topical sealer application

STADIUM[®] 3.0 Maintenance Options

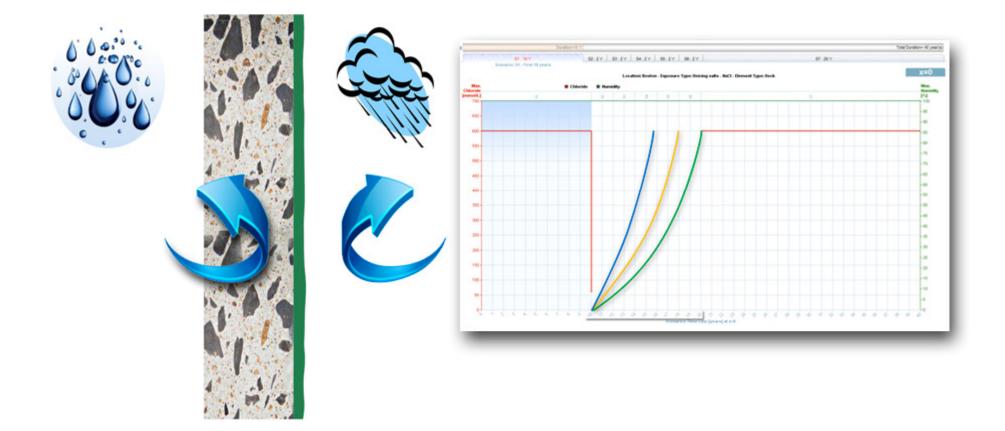
Membrane application

STADIUM[®] 3.0 Maintenance Options

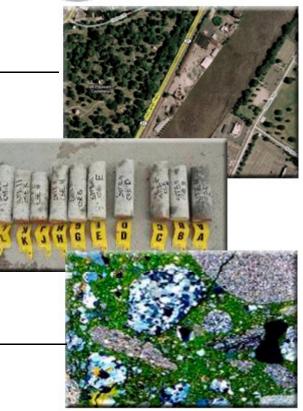
STADIUM[®] Methodology

Visual Inspection Walk through/damage survey

Concrete Core Extraction

Core sampling

Laboratory Investigation Concrete characterization

Service Life Predictions

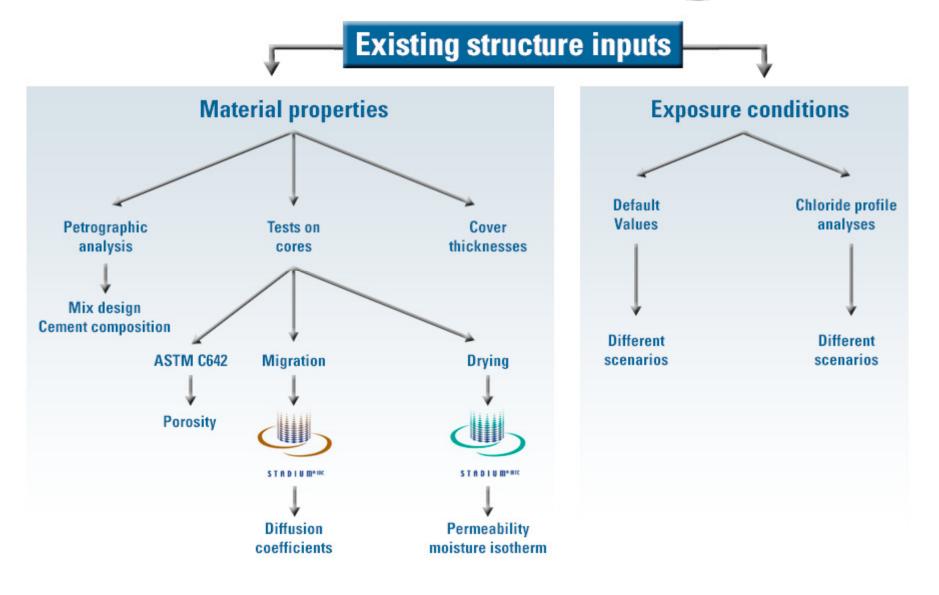
Know Your Concrete – Coring

- Total number of cores: 56
- 31 cores from the northbound structure:
 - 15 in the box beams
 - 16 in the prestressed piles
- 26 cores from the southbound structure:
 - 12 in the I-beams
 - 13 in the pile caps
