RIO-ANTIRIO BRIDGE CONCRETE MAINTENANCE CONCEPT

MARCH 2016, M. DONADIO, A. STATHOPOULOS-VLAMIS, P. CORBETT ,
I. PAPANTONIOU AND N. ANAGNOSTOPOULOS
SIKA SERVICES AG, GEFYRA S.A., SIKA HELLAS SA

CASE STUDY

LOCATION, FINDINGS & ANALYSIS

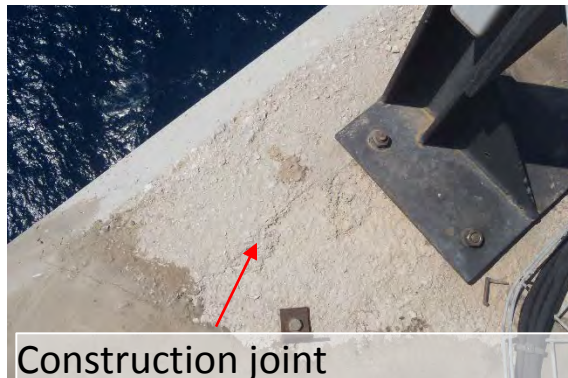
- The Pylon Base acts as a restraining hoop for the base of Pylon Legs and ensures the transition of forces from the Pylon to the Pier.
- The restraining action is achieved by prestressing (P/T).
- The tendons are anchored in the corners of Pylon Base.
- The anchors are covered with “second phase” reinforced concrete /strength class C 60/75 (8 faces of P/T anchors per pier - 32 faces in total).
- Minor cracks (<0.200 mm) were found in a routine inspection in 2009. Also the exposed construction joint was highlighted by the inspectors.
- **Protection against water & chloride ingress was proposed after the analysis of findings.**

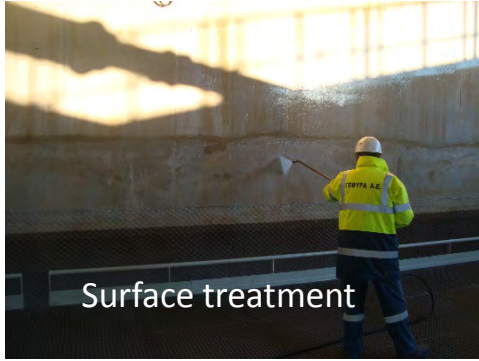
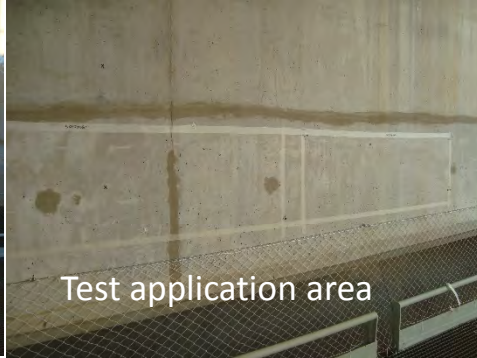
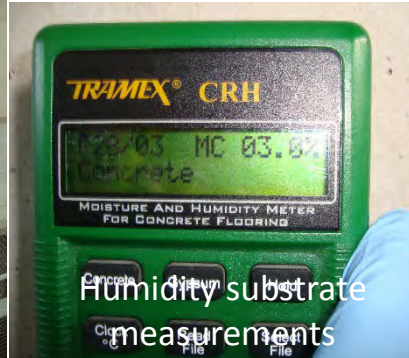
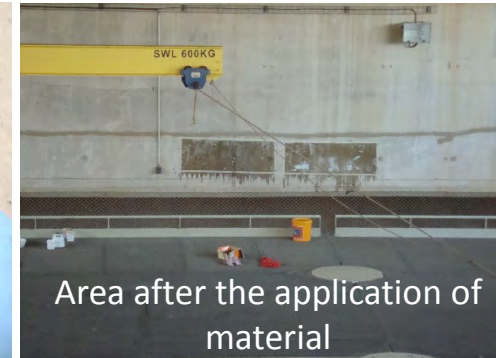
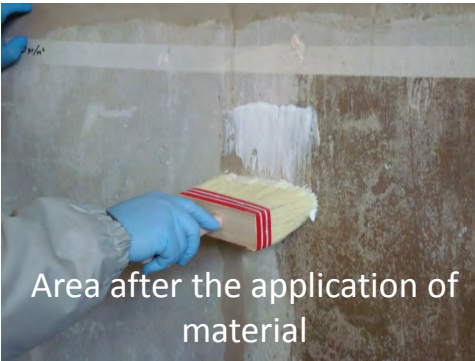
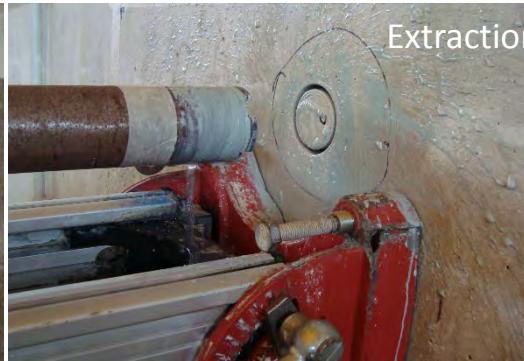
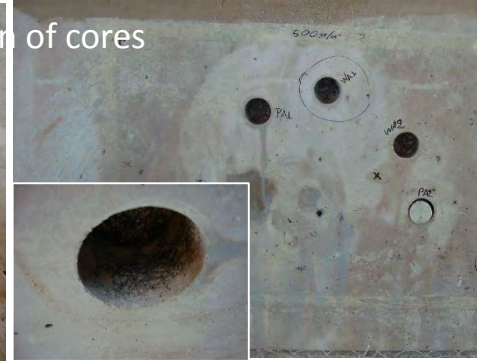
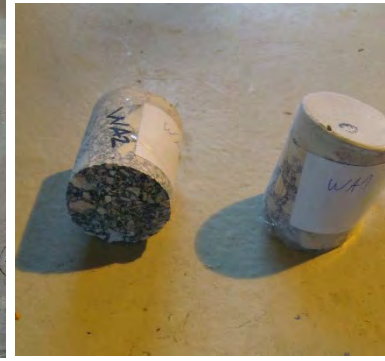
2 rates of application: 500 & 700 g/m²

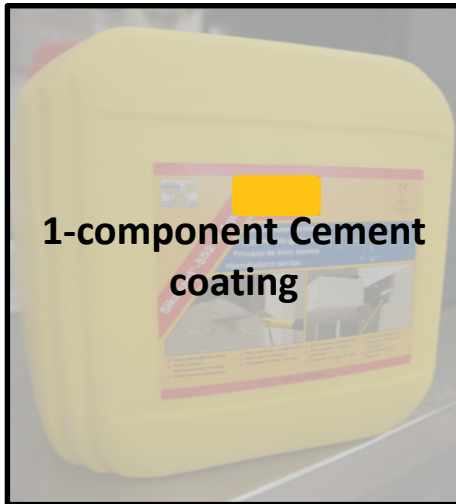
System	Delay between application
Hydrophobic – cement coating	7-days
Hydrophobic – acrylic primer	7-days
Acrylic primer – cement coating	2-hours

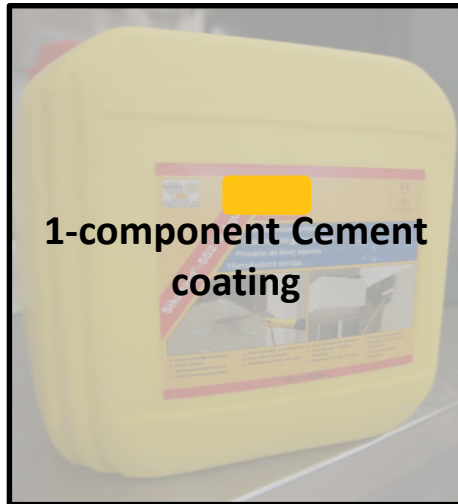
1.905 N/mm²
Break in cement coating

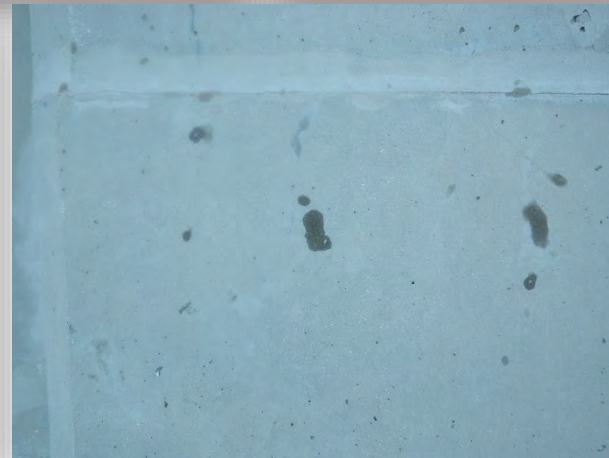
View after the application
