**INTERNATIONAL  
CONCRETE REPAIR  
INSTITUTE**

**Guide to ACI 562-16 – Design Example No. 3  
Adaptive Reuse of Historic Depot**

Kip Gatto, *Wiss, Janney, Elstner Associates, Inc.*  
Tony Gueorguiev, *Freyssinet, Inc.*  
November 11, 2016

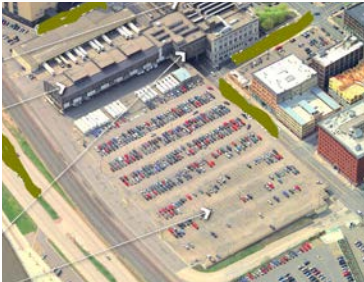
**Description of Structure**

- 300,000 sf
- Constructed in 1920s
- Designed for trains
- Converted to Postal Distribution in 1970s
- Columns on 21 ft. grid
- Portion is on grade

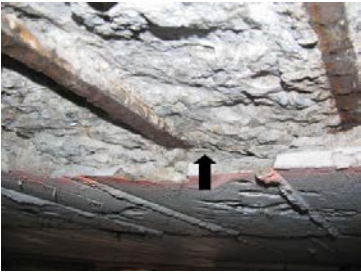
### Concrete Conditions, Findings

- Minimal corrosion activity at top surface of deck
- Deterioration of columns without jackets extended 1 to 2 feet above pavement
- Localized areas of corrosion above steel jackets
- Some jackets split along seams (underlying corrosion)
- Reinforcement layout consistent with design drawings

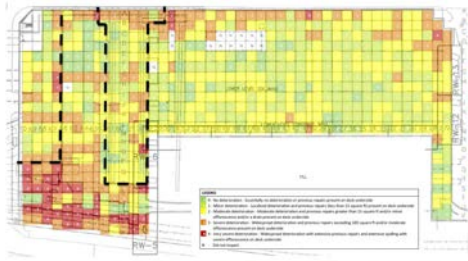
### Concrete Conditions, Findings

- Localized freeze-thaw deterioration on top surface of deck
- Corrosion related soffit spalls/delaminations prevalent at joints, drains, and openings
- Sounding revealed far more delaminations than visual examination
- Corrosion testing indicated moderate corrosion was occurring at deck soffit at joints, drains, and openings

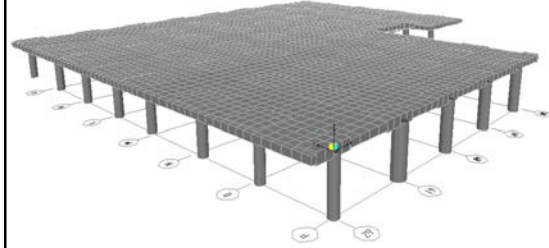
## Structural Assessment, Model

- **Loads (1.3.8, 5.1.4, 5.2.3, 6.5.1)**
  - In accordance with design basis code (IBC, AREMA)
  - Gravity, wind, and seismic
- **Analysis (6.5.2, 6.5.3)**
  - Portion of deck modeled using finite element methods
  - Repairs to be included in repurposing so modeling did not include concrete deterioration
  - Construction period loads considered members undergoing repair (6.7.1)
  - Capacities calculated in accordance with AREMA, which took precedence over Section 5.4 (5.1.3, 5.2.2)
