### Victoria Street Garage Rehabilitation

Presented By:  
 JAMES G. HAGUE, P.E. – STRUCTURETEC  
 JOHN SCHNEIDER, P.E. – SCHNEIDER ENGINEERING  
 ROBERT G. MASON, JR., P.E. – STRUCTURETEC

INTERNATIONAL CONCRETE REPAIR INSTITUTE

2016 Fall Convention | November 9-11 | Cleveland, Ohio

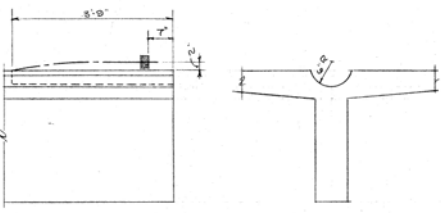
**TYPICAL THRU POST TENSIONED TEE END DETAIL**

- Precast concrete single tees are both pre-stressed and post-tensioned

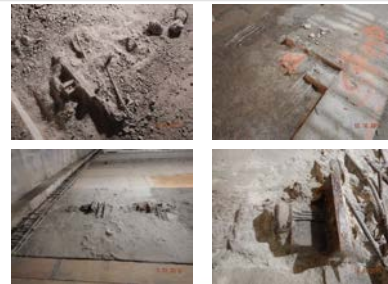
### Single Precast Tee Anchor Points Not Where Shown on Drawings

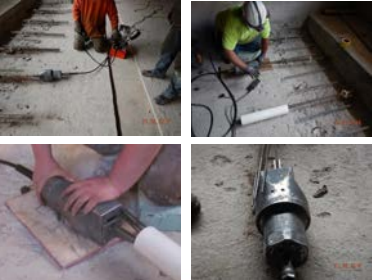
### Existing Buttonhead to New Monostrand PT Tendon Splice

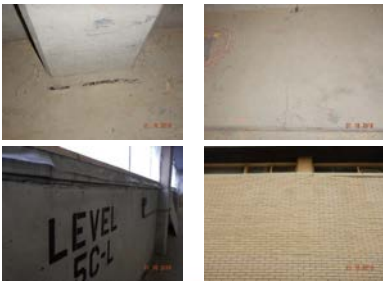
### Façade Wall Deformation

- Maintaining existing post-tensioned members to remain
  - Avoiding demolition of post-tensioned tendons or anchors to remain
  - Avoiding damage to the exterior façade repairs completed in 2013
- Design forces discussion
  - What happens to the design force of the Level 5 composite H-beams when the top slab is removed?

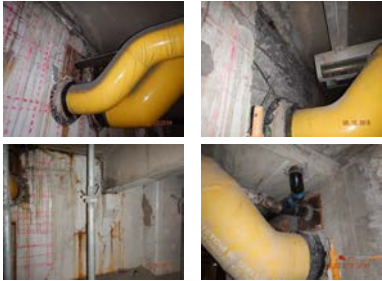
### Concrete Repairs at Steam Piping
