Unbonded Post-Tensioned Structures Exposed to Flooding

Ryan Coles, BSc, P.Eng.
Read Jones Christoffersen Ltd.
Building Science and Restoration

INTERNATIONAL CONCRETE REPAIR INSTITUTE | 2016 Fall Convention | November 9-11 | Cleveland, Ohio

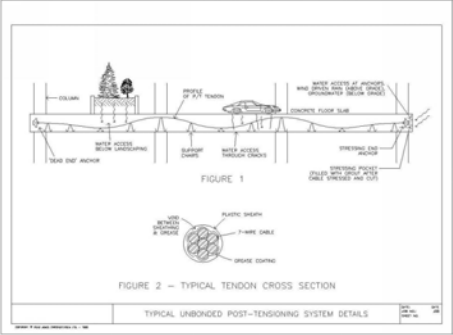
FIGURE 1

FIGURE 2 – TYPICAL TENDON CROSS SECTION

TYPICAL UNBONDED POST-TENSIONING SYSTEM DETAILS

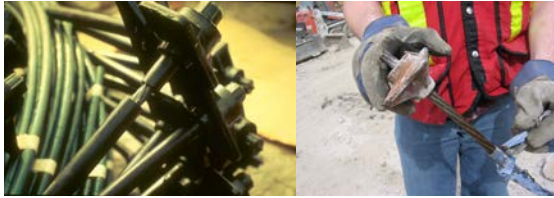
Discontinuities In Strand Sheathing

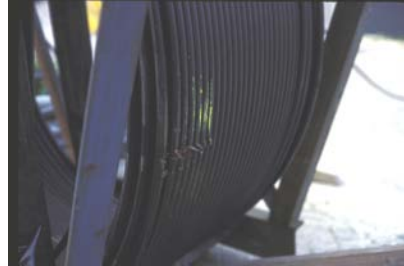
Damage To Sheathing During Construction

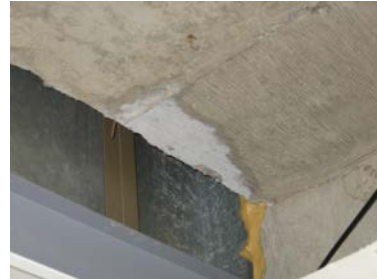
Construction Moisture Precipitation on Slab Before Exterior Cladding Installed

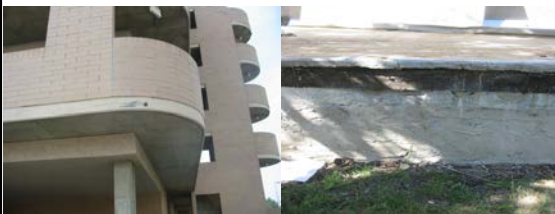
Exposed Anchor Pockets

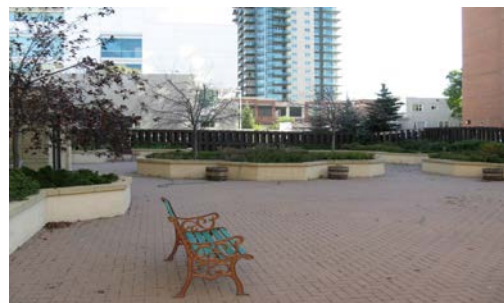
Plaza Levels

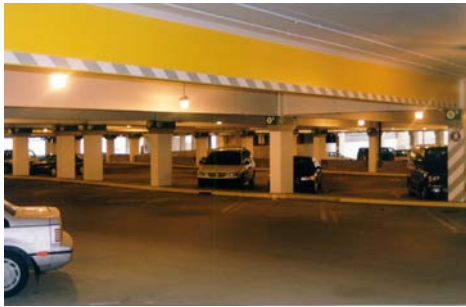
Parking Structure Slabs

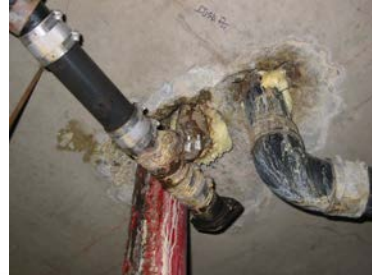
Moisture From Plumbing Leaks & Floods

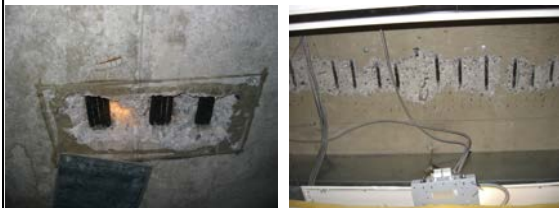
Inspection Recesses

Standard Inspection Recesses

- 250 – 300 mm length
- Visual Observations
- Grease / Moisture Sampling
- Tension Testing with Screwdriver

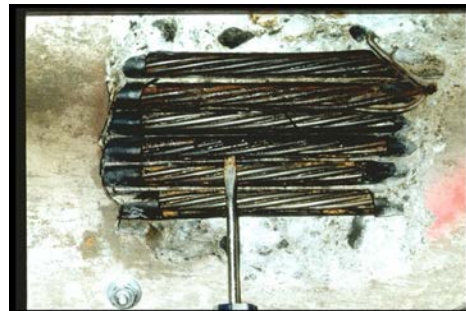
Penetration Testing

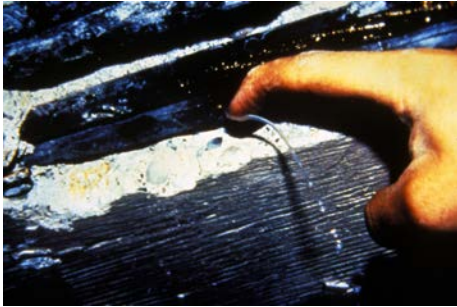
Moisture In Strand Sheathing

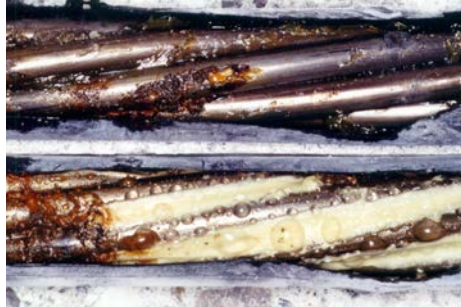
Moisture In Grease (Emulsified)

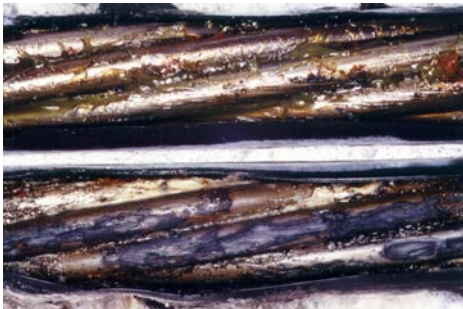
Corrosion of Wires
