Date of Presentation
ICRI 2022 Spring Convention

Multiyear Restoration & Protection of 1969 CIP Post-Tensioned Parking Garage

Kevin Carrigan, PE, SE
Principal/Vice President
THA Consulting, Inc.

Eric Williams
National Sales Manager – US
Vector Corrosion Technologies Inc.

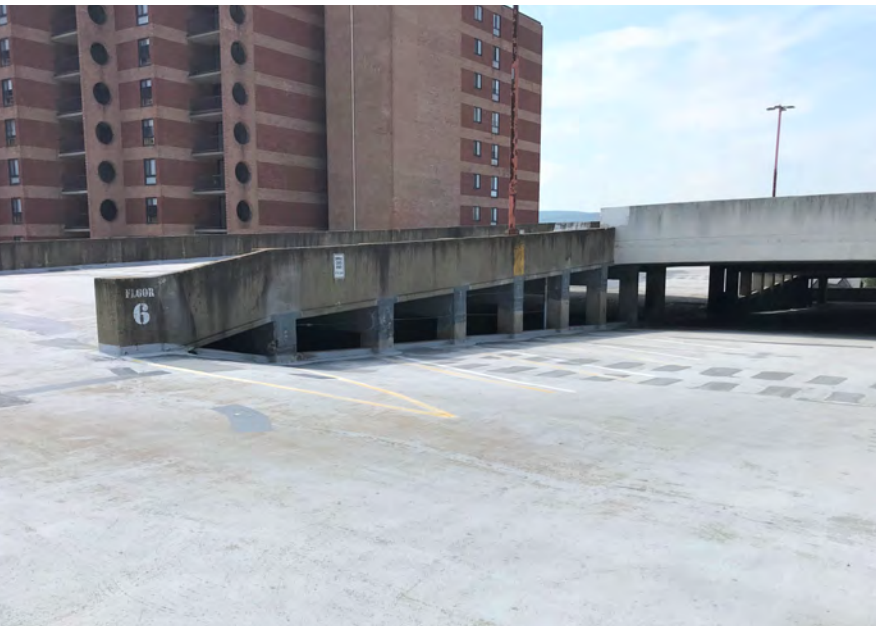
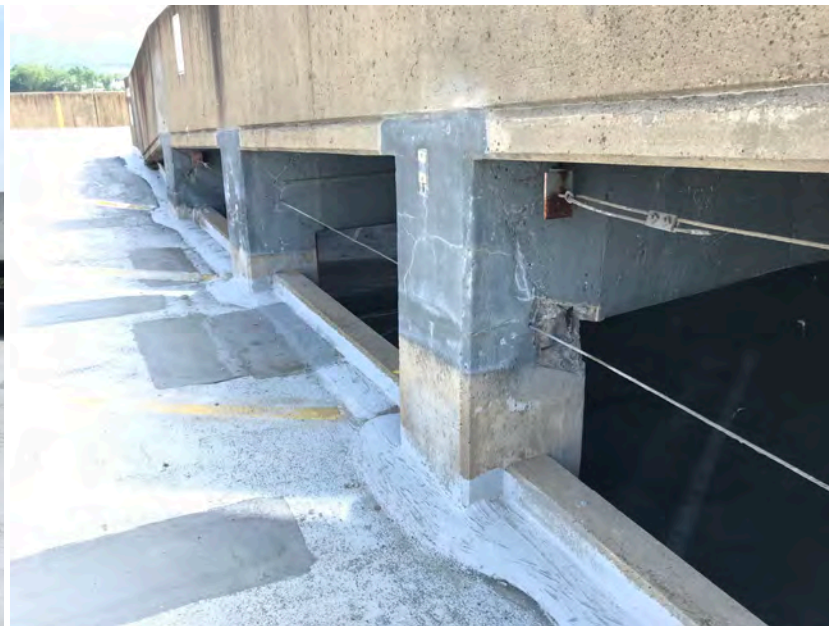
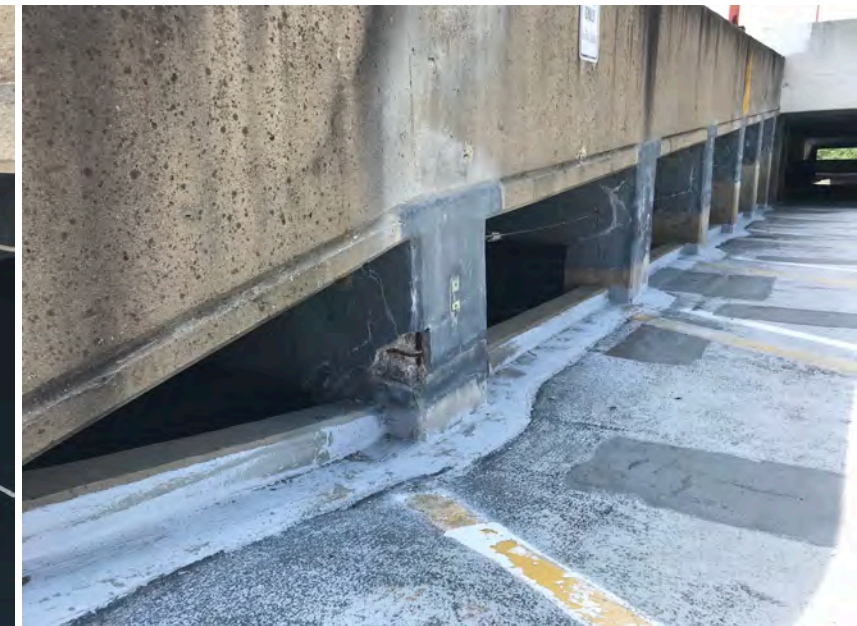
- 2018 Critical Repair Program
 - PT Induced Shear Failure – Top Tier Ramp Columns

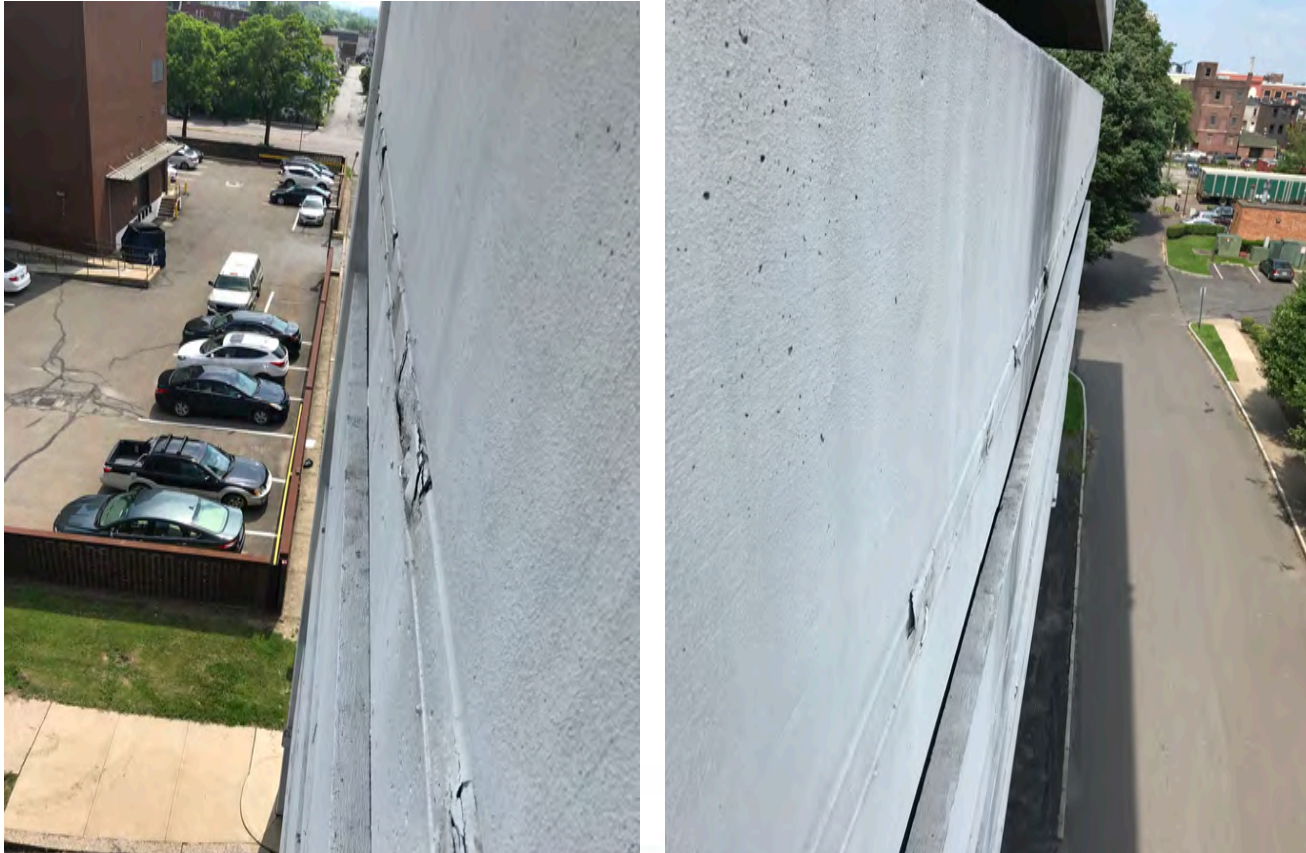
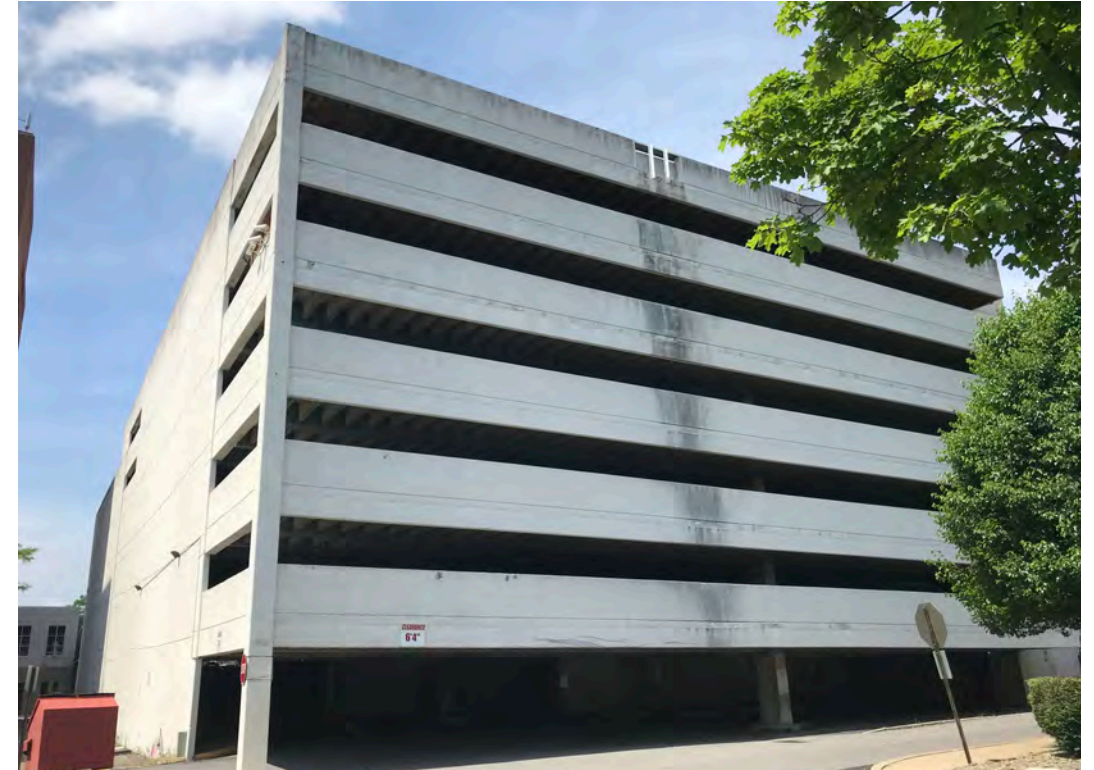
- Structural Repairs
 - PT Slab Failures at Façade
 - Primary Tendons
 - Broken Strand and/or Anchorage Zone Failure

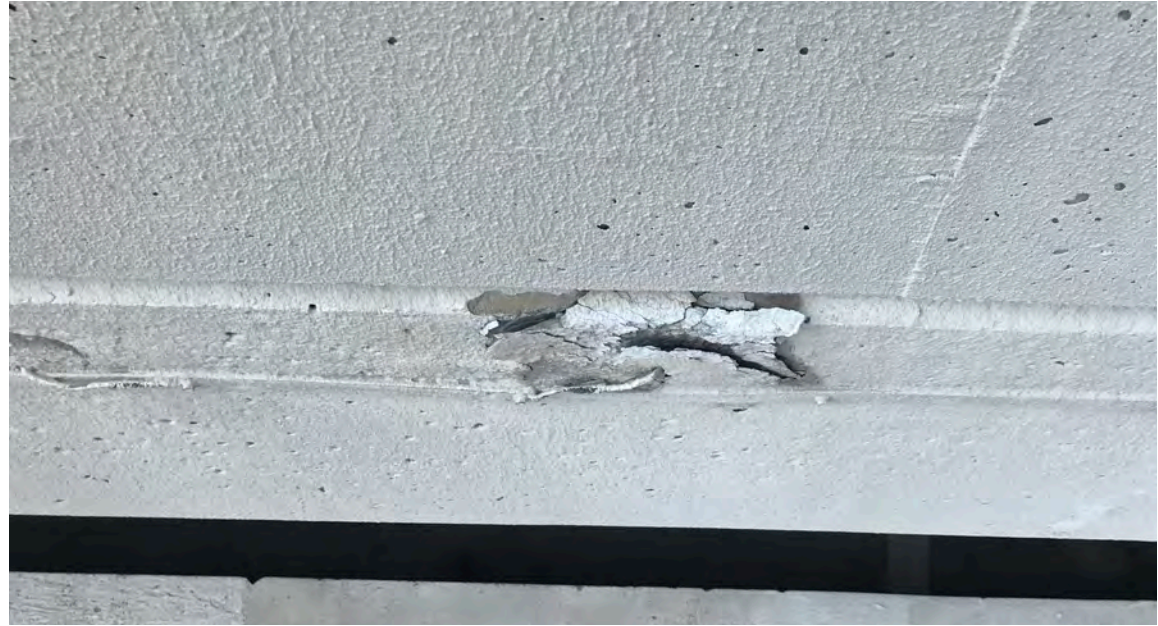
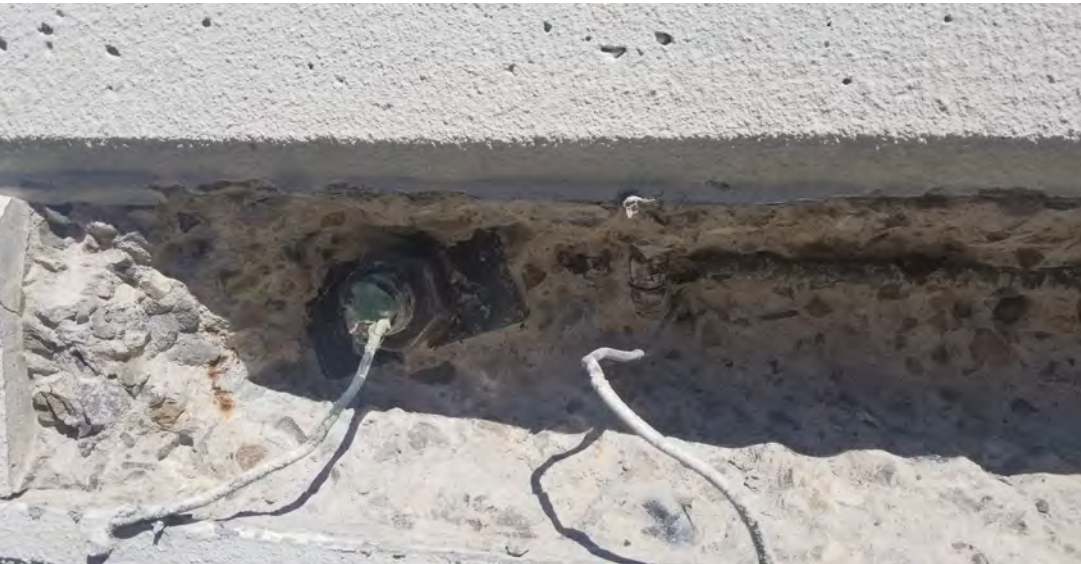
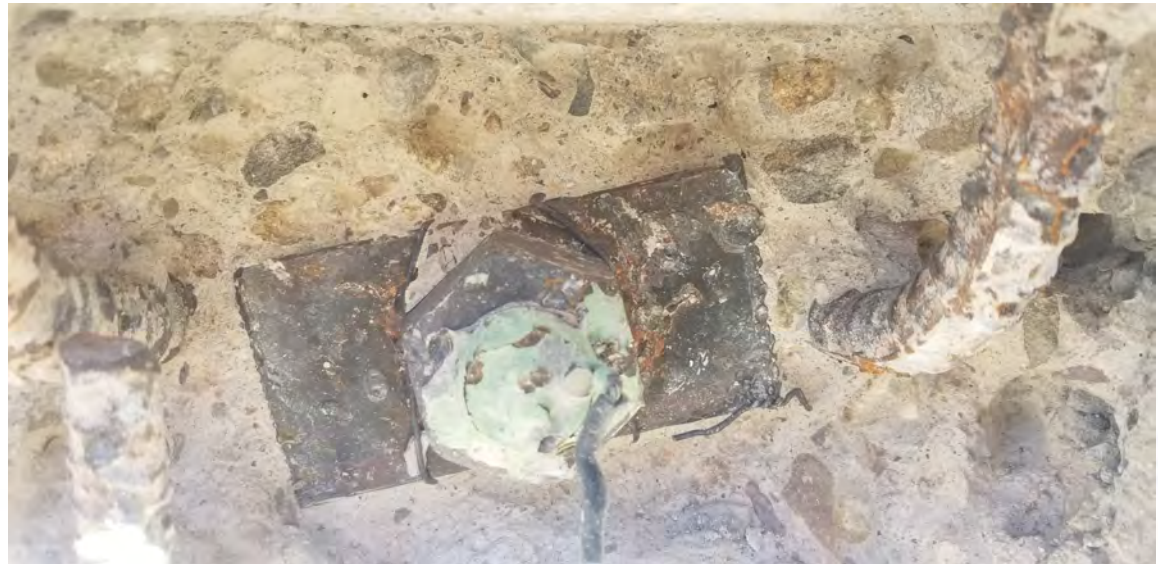
- Structural Repairs
 - PT Slab Failures at Façade
 - Primary Tendons
 - Broken Strand at Interior – Release of Energy Caused Exterior Spall
 - Not Anchorage Zone Failure

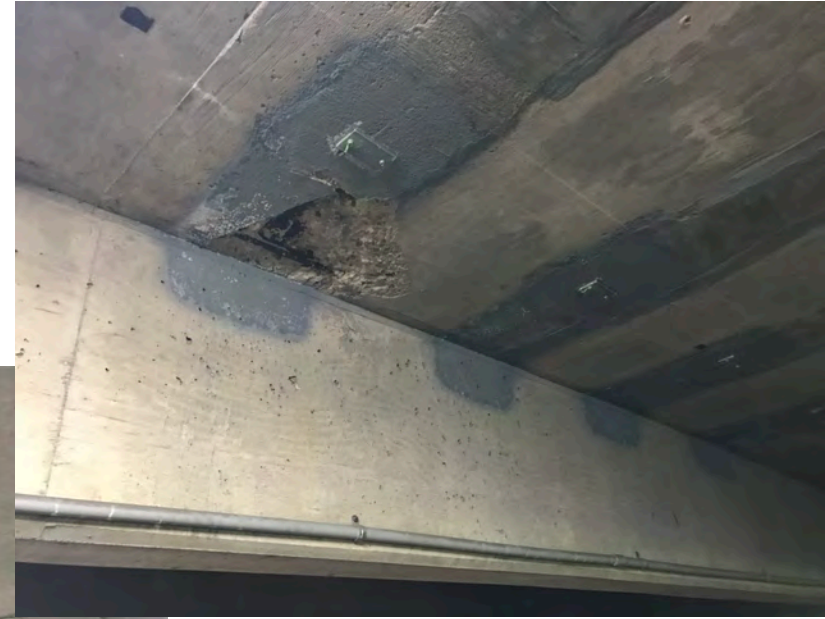
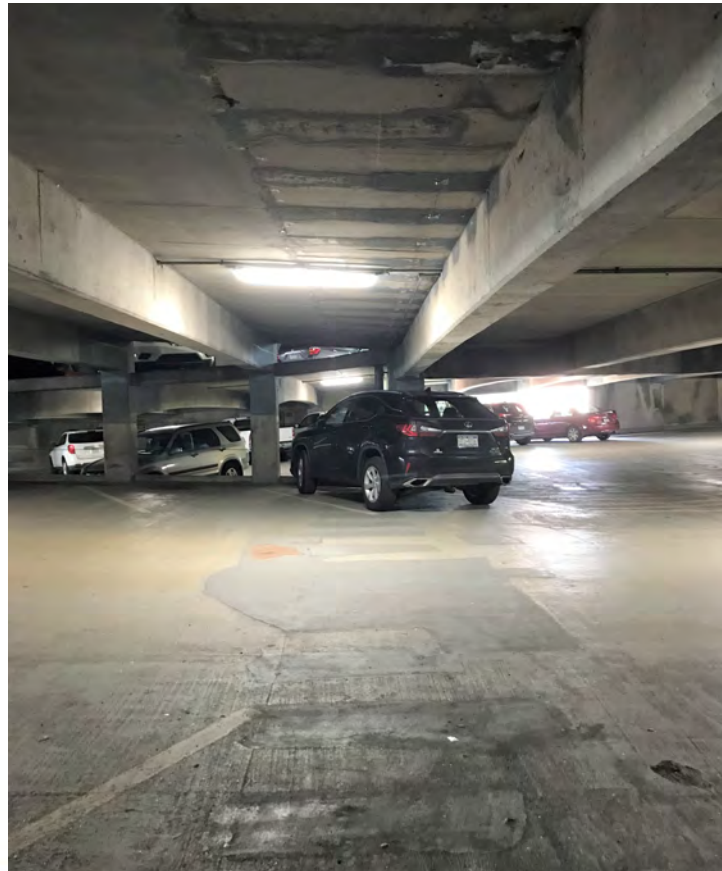
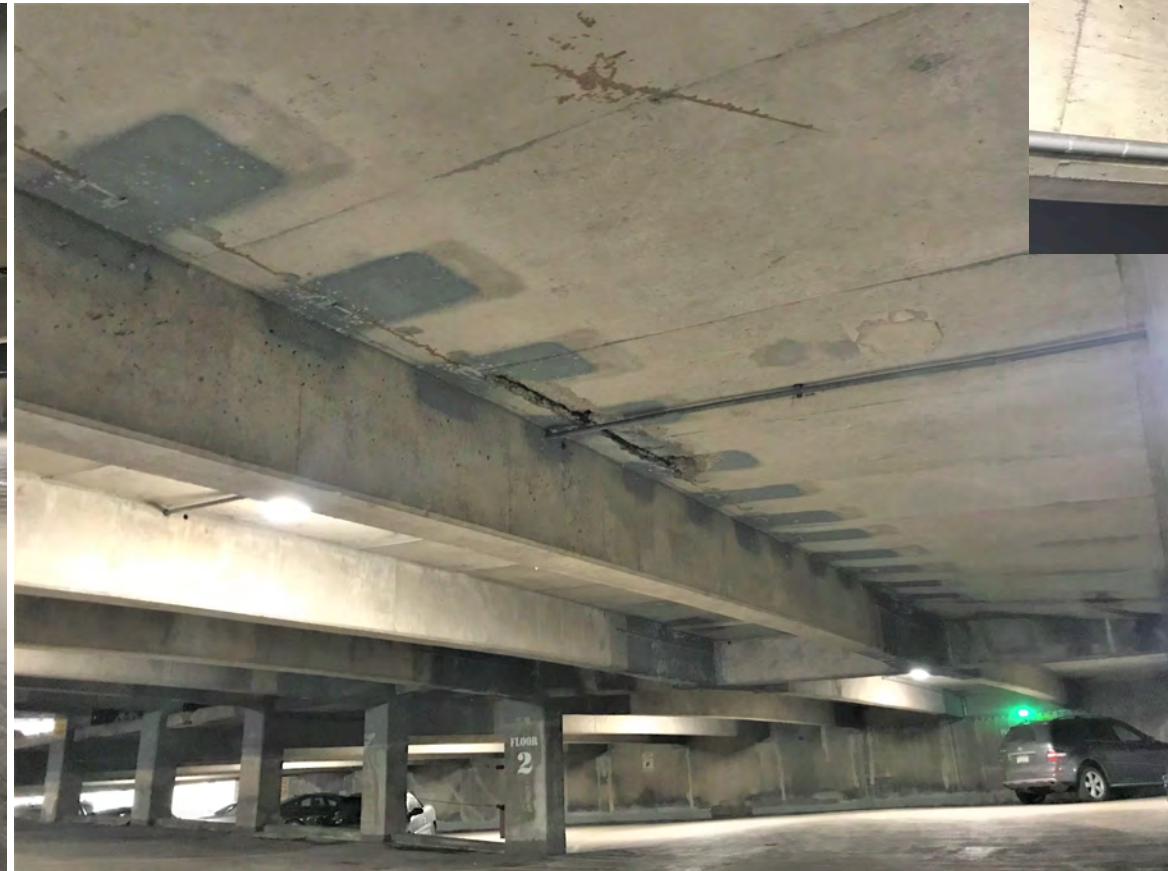
- Structural Repairs
 - PT Slab Failures at Interior Slab
 - Primary Tendons

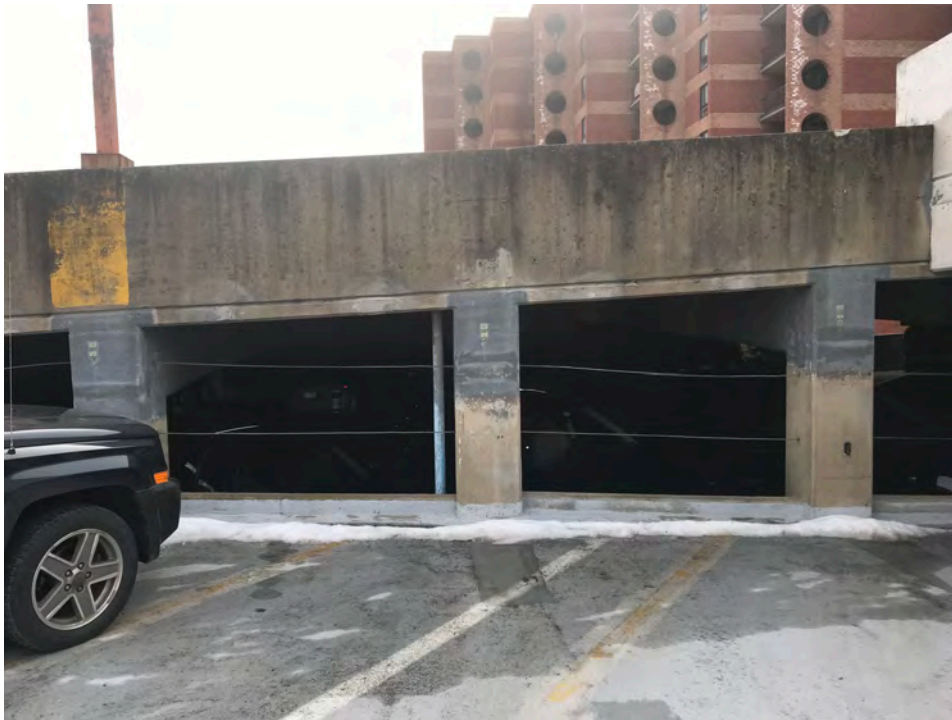
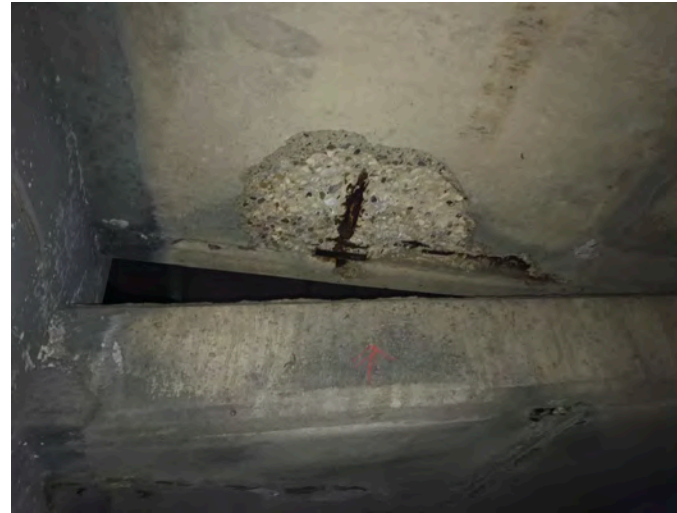
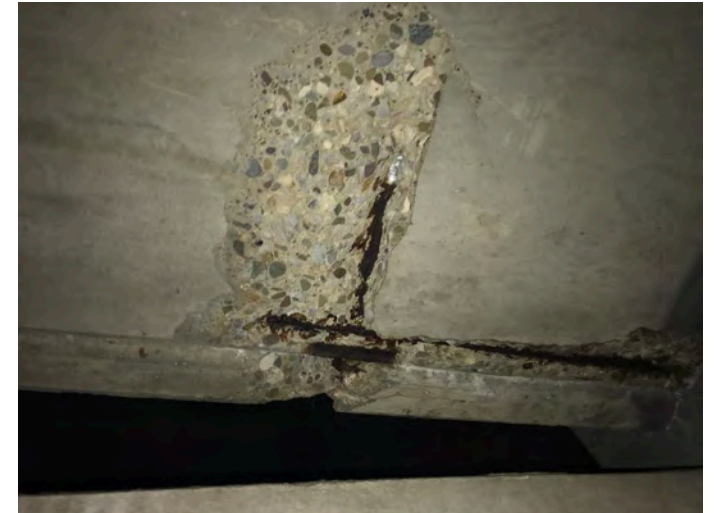
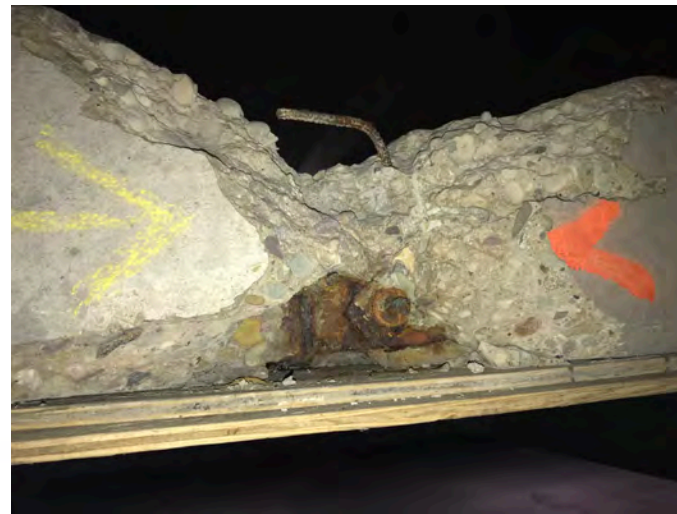
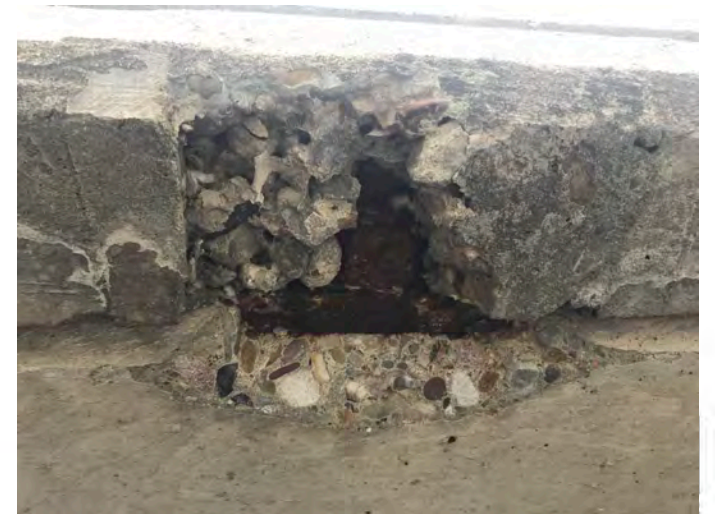
- Structural Repairs
 - PT Slab Failures at Interior Slab
 - Shrinkage & Temperature Tendons

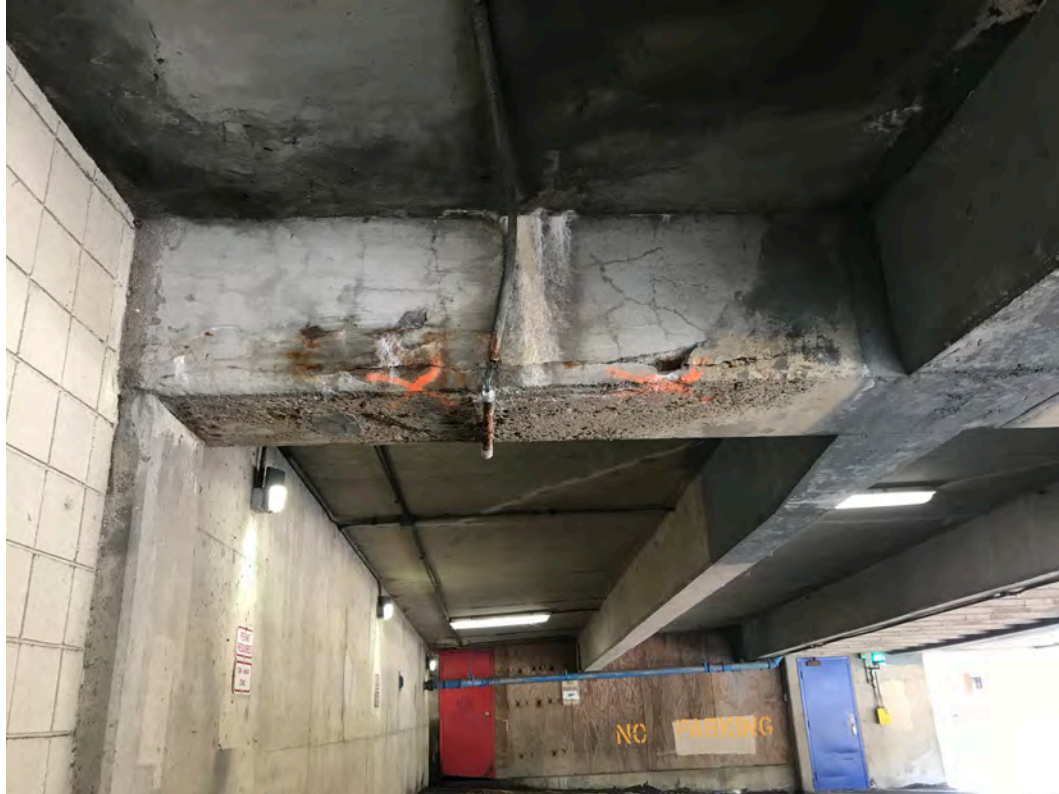
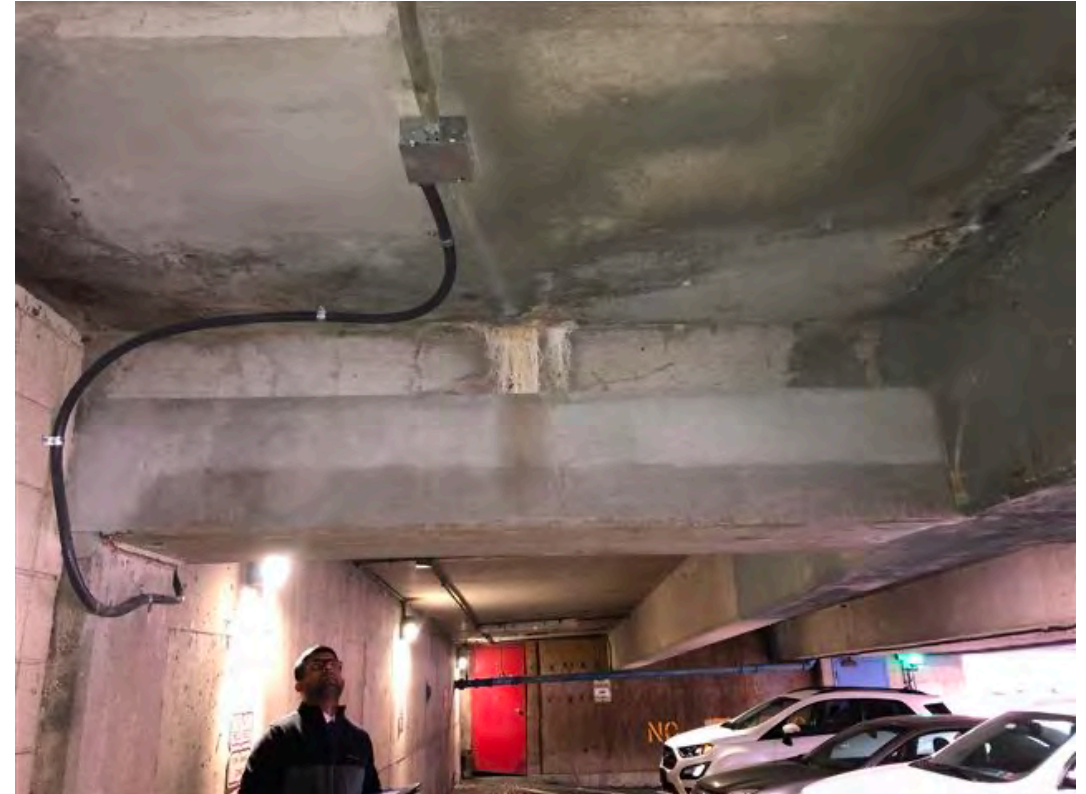
- Structural Repairs – PT Girder Repairs

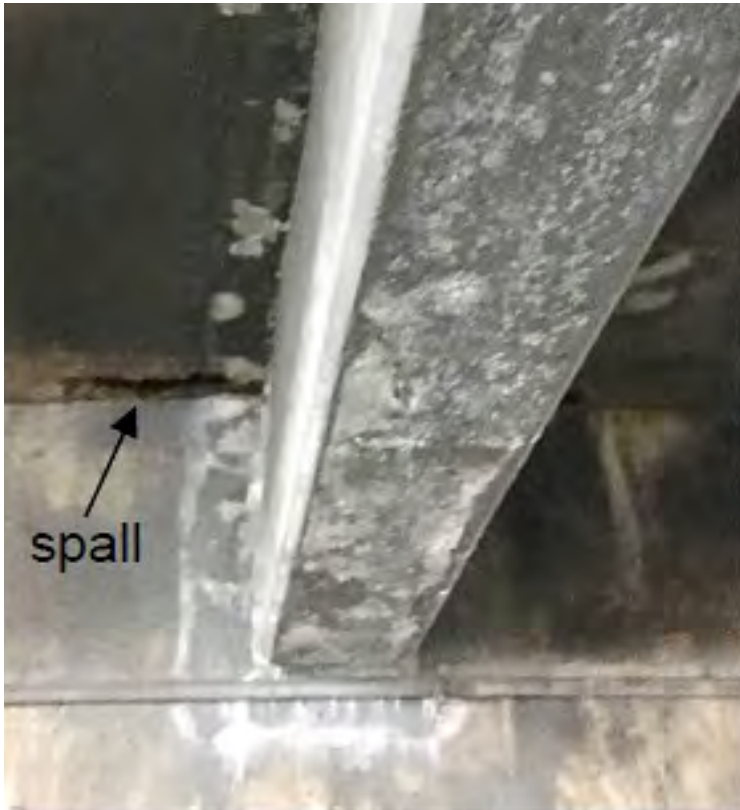
Spalling around CP System
White Zinc Oxide Film from corrosion of ZAS

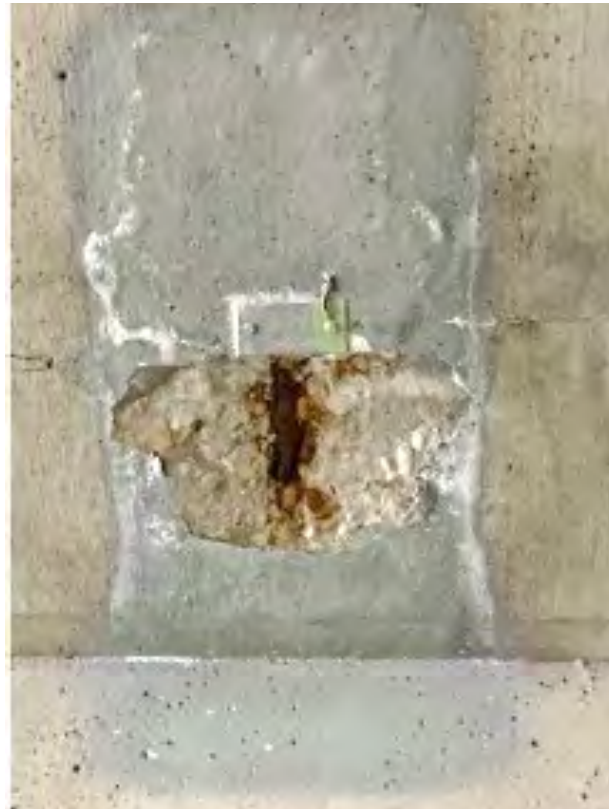
Spalled Concrete in the Metalized Area Showing Corroding Rebar

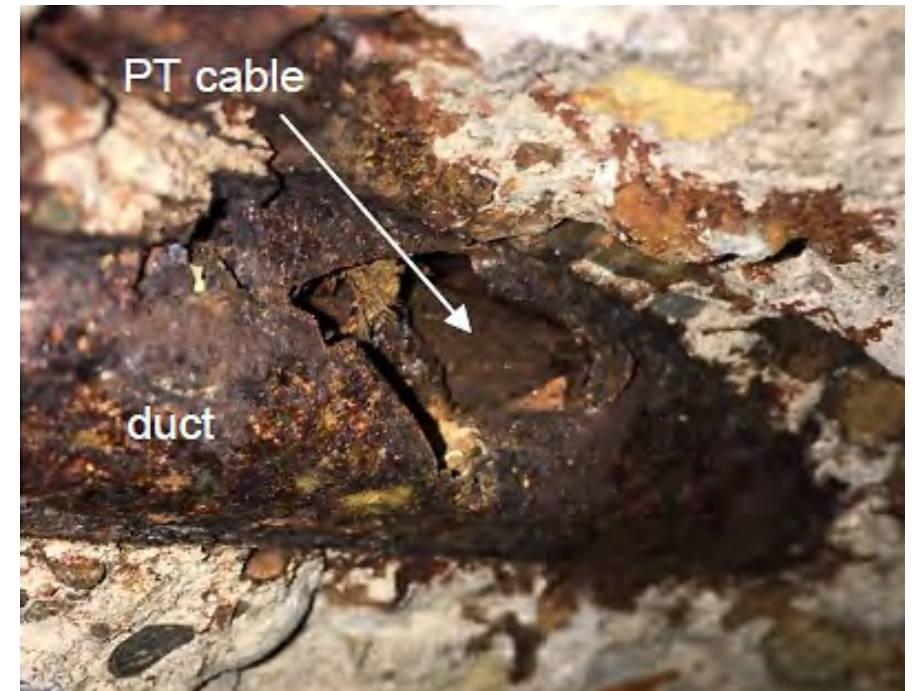
Corrosion of Post Tension System

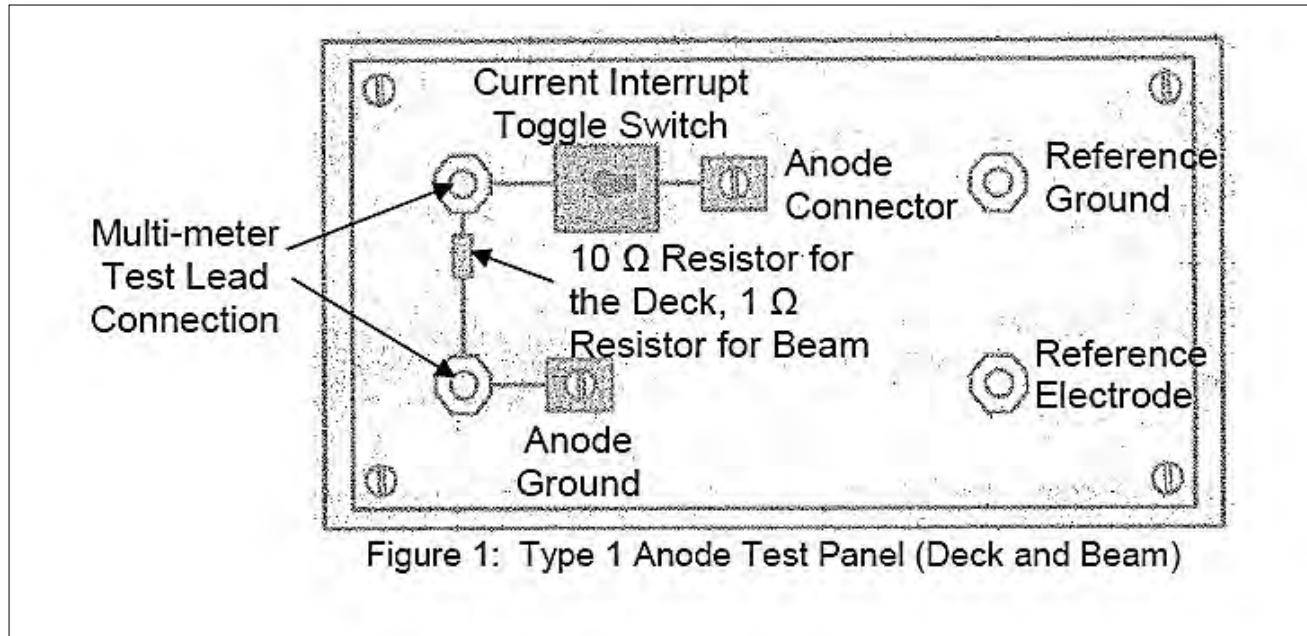
- PVC boxes that are attached to the ZAS system
- These boxes are test stations which provide the ability to determine if the ZAS is working properly

- 20 boxes in total within the garage – 11 were found to be in working condition (failed Reference Electrode)
- NACE criteria of a minimum of 100 mV of cathodic polarization criterion was primarily used for evaluation of the effectiveness of the CP system
- Only 1 out of 11 test panels displayed a polarization shift of at least 100 mV over the 24-hour period
- ZAS is still providing some current, though not sufficient to provide adequate corrosion protection

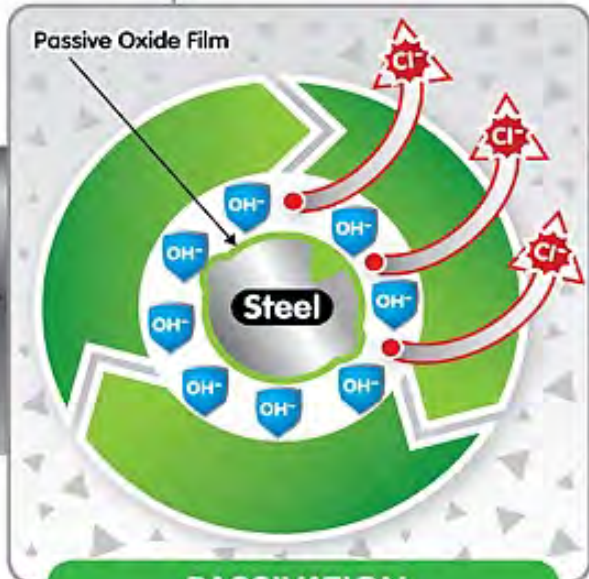
Stage 1 Electrochemical Treatment
50+ Days

- Concrete repairs carried out as required
- High charge density delivered
- Alkalinity restored around steel
- Chlorides pushed away from steel surface
- Corrosion mitigated in pits
- Steel passivity is restored
- Stage 1 can be repeated

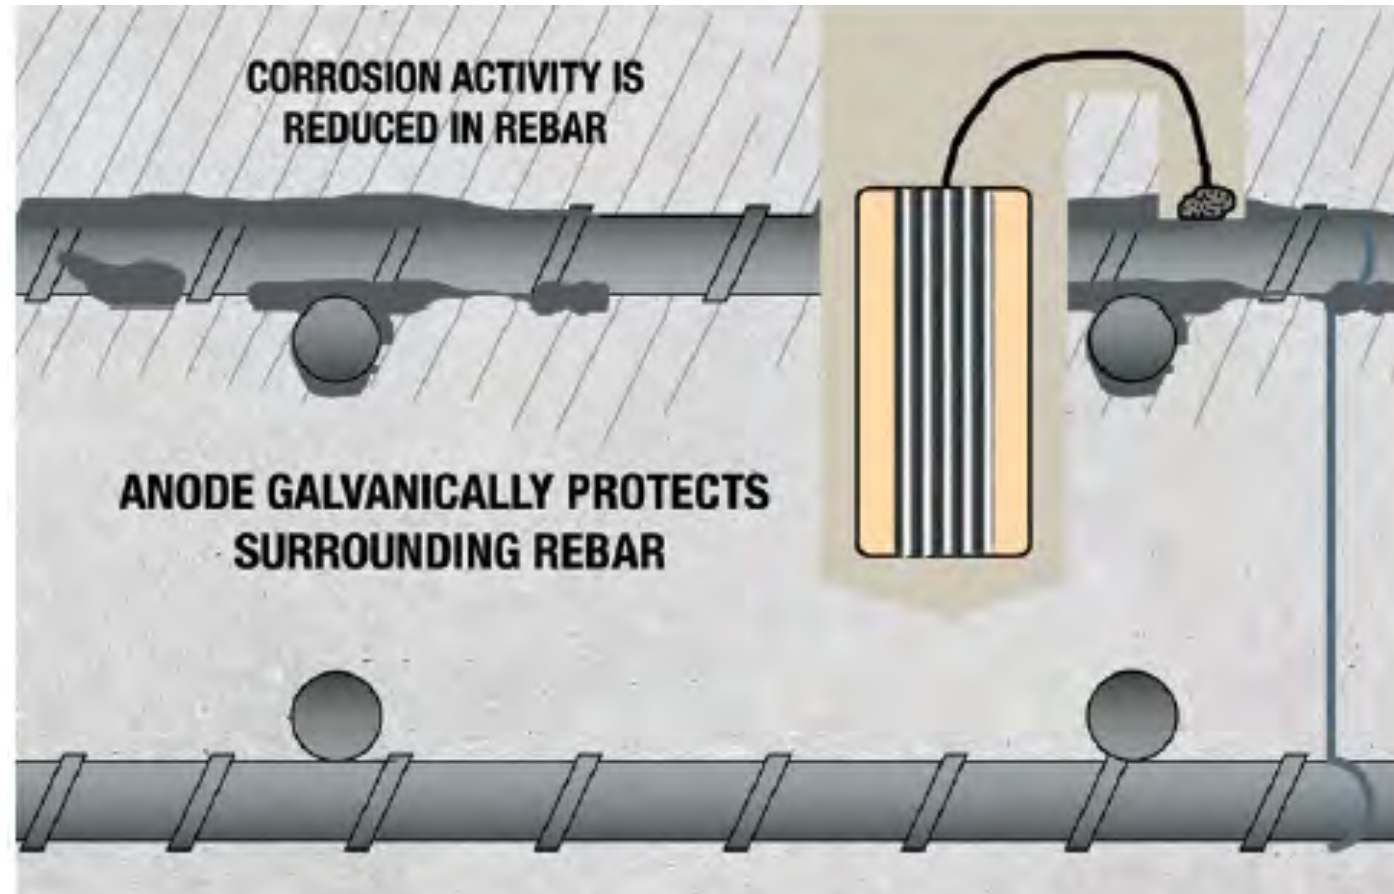
- Control on-going corrosion /prevent the initiation of new corrosion
- Type 2A Embedded anodes are alkali-activated and consist of a sacrificial zinc anode core
- Installed into concrete that is mechanically sound but has ongoing corrosion activity
- Once installed, the zinc anode corrodes preferentially to the surrounding steel
