# FAIR PARK ESPLANADE

After so many years of heavy use, a repair strategy was necessary; this entailed a 5-month scope of work for both roofing and waterproofing the Parry Gate entrance, ticket booths, Central Tower, Esplanade, and pylons.

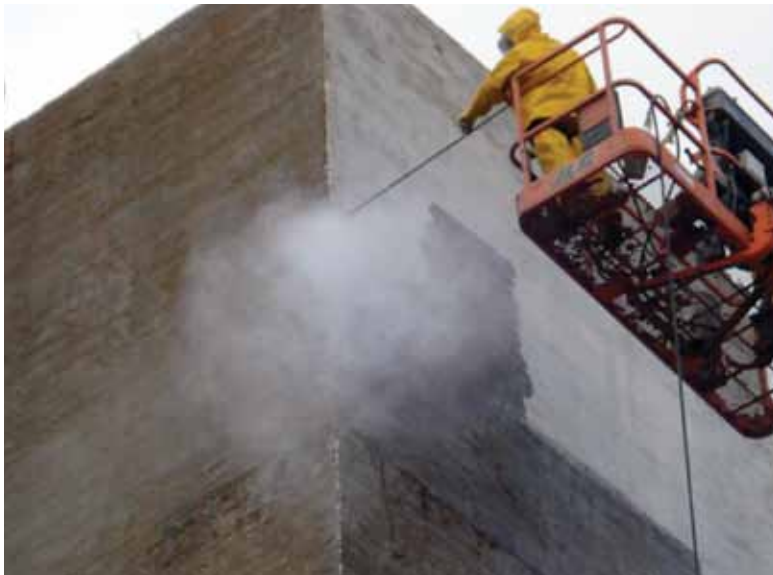
*Parry Avenue Central Tower being cleaned*

A registered historical building requires certain approved methods for the remedial process. The Parry Avenue Central Tower had at least four layers of paint and putty caked on the walls and in the crevices. Due to the historical nature of the project, the waterproofing contractor was limited to certain means of chemical removal. No abrasive or high-pressure equipment was allowed, and this presented a challenge: how do you go about removing multiple layers of paint while being restricted from using certain types of chemicals? The short answer is testing every different type of paint stripper available in the market. After sampling multiple paint strippers, two were found that could remove the majority of the paint without damaging the substrate and were also approved by the THC.

The next step in the project was to complete the Central Tower in the shortest amount of time possible. This involved determining the amount of time it took to place the paint stripper on the wall and the amount of time it took to dry—the “dwell time.” After the dwell time, the paint stripper then had to be removed but could only be done so using a low-pressure wash. This too created a problem, limiting the amount of area that could be completed at one time. As a result, the project was broken down into sections. Once the work areas were divided, work began at the top of the tower, where one coat of paint stripper was applied; this was then repeated on the second section. By the time the second section was coated with the painting stripper, it was time to pressure-wash the first section. This cycle was repeated on all sections of the tower until it was completed.

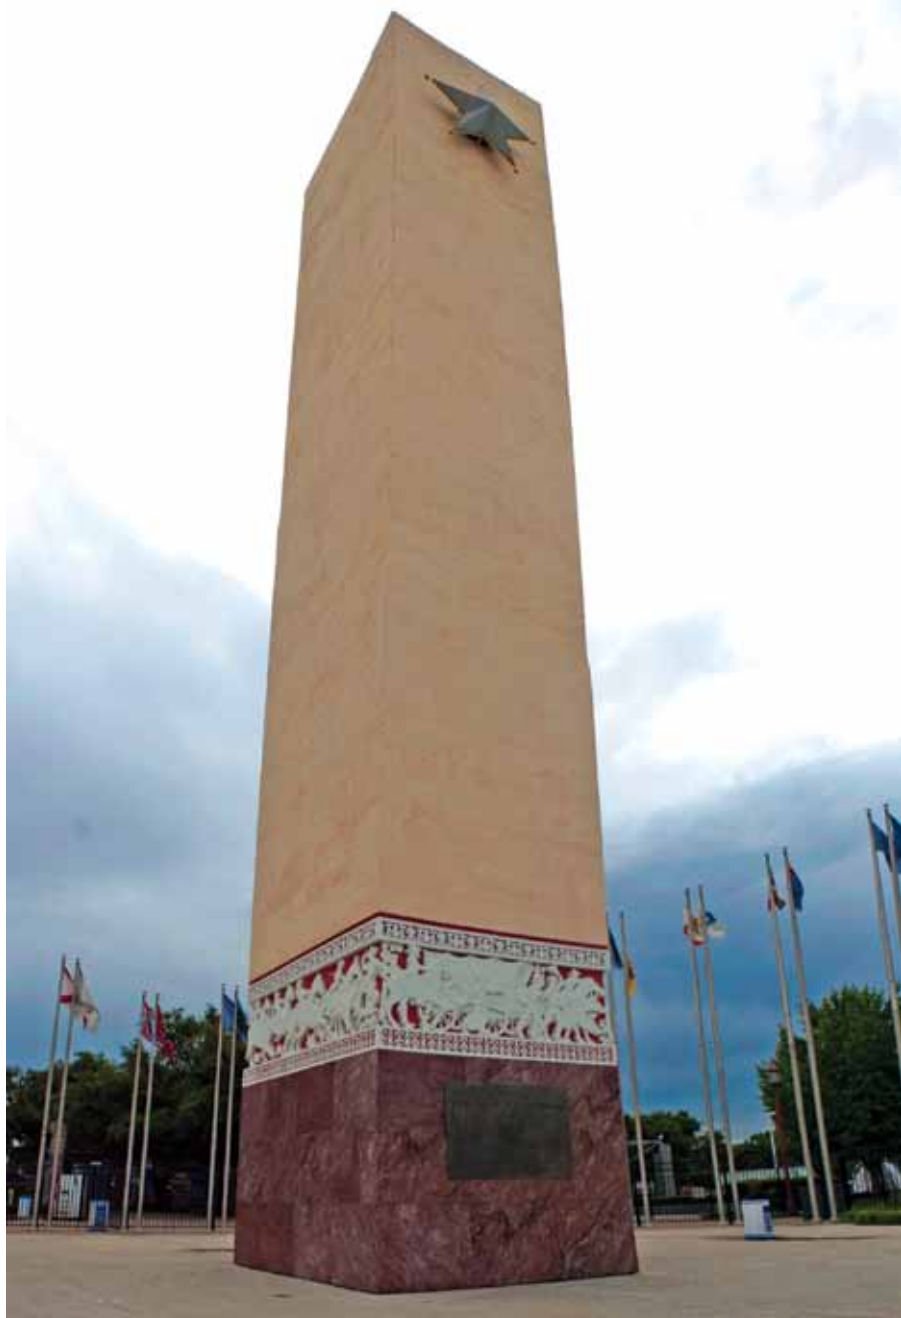
*Central Tower after restoration*

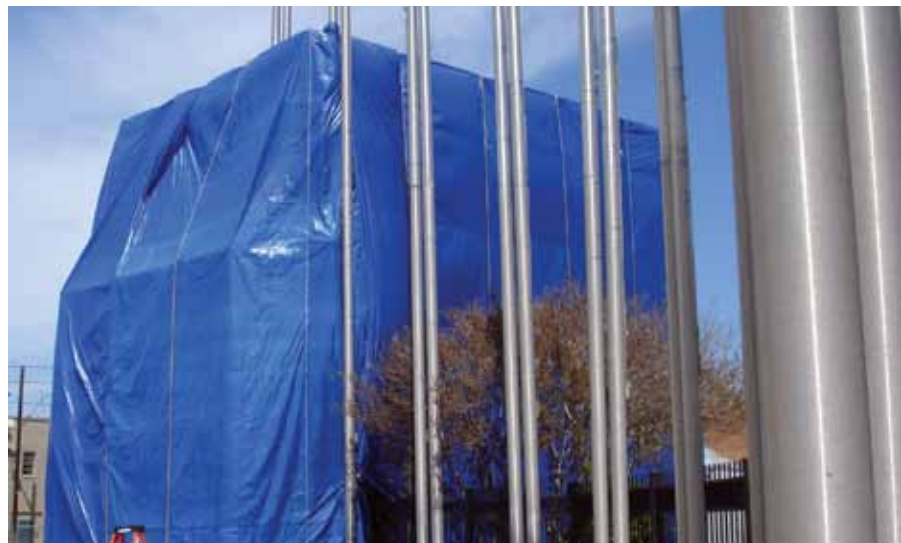
*Ticket booth with tarp covering for containment of lead-paint removal*

Another key element of this project involved the restoration of the two ticket booths that sit in the front entrance. During initial investigation, it became apparent that both ticket booths had been previously painted with a lead paint. As a result, a method was devised to remove the paint yet keep the toxic material contained for removal. The removal process began by placing a scaffold on each side of the building and connecting the scaffolding to create a walkway all the way around the building. Then a large plastic tarp was wrapped around the building, creating an enclosed “dome” with only one way in or out. By designing this dome, the lead-based paint could be safely abated while

creating a safe place for employees to work outside of the booth. The lead abatement process consisted of water and sand-blasting, which prevented damage to the booths. After the abatement was completed, the employees properly disposed of all debris.

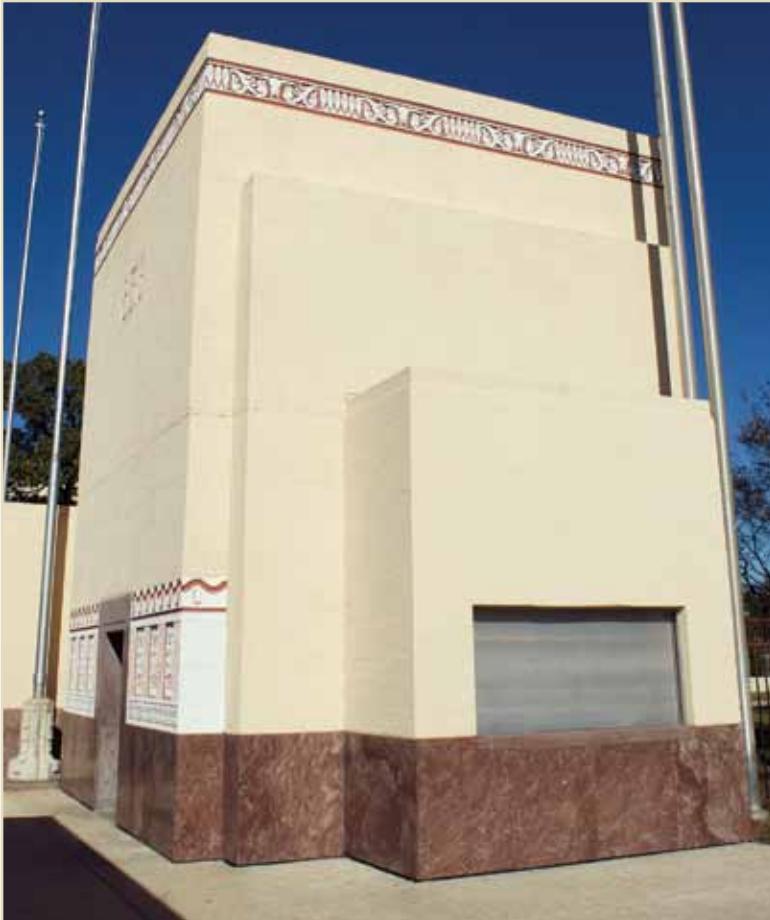
*Ticket booth after restoration*

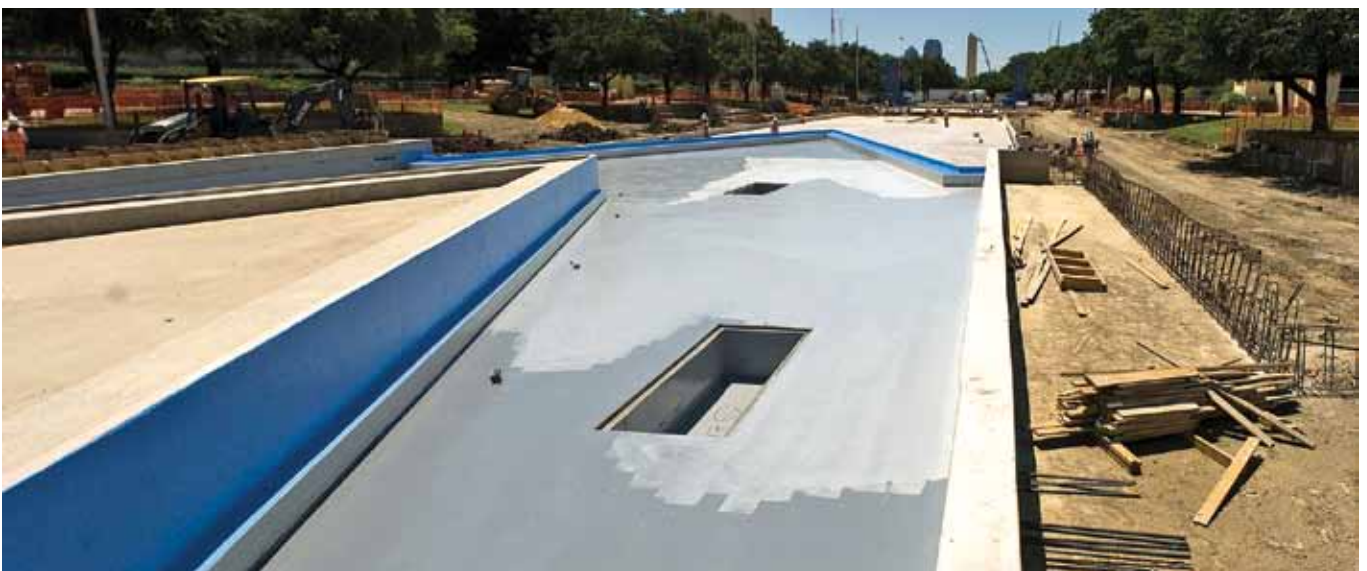
*Waterproofing the Esplanade fountain and reflecting pool*

The waterproofing of the Esplanade fountain involved seven different stages of work. Work began by shot-blasting the concrete slab and grinding all vertical walls and edges to obtain the proper profile for waterproofing adhesion. Next, the vapor barrier was applied—a product that required 24 hours of cure time before any other product could be applied over it. Once the vapor barrier had cured, a waterproofing primer and neoprene flashing were applied. Once the flashing was completed, another 24 hours of cure time was required. The fourth step involved two separate base coats of another type of waterproofing to the primed concrete, which then had to cure for 48 hours. Finally, the process was finished by applying two top coats of waterproofing with 48 hours of cure time between each coat and 72 hours of cure time after final application. Due

to this multistep process, there was a great risk of creating significant construction delays. To maximize production and maintain a steady workflow, the development and use of an application schedule was critical to the timely completion of this project; without it, work could have been completed incorrectly, resulting in costly rework and project delays.

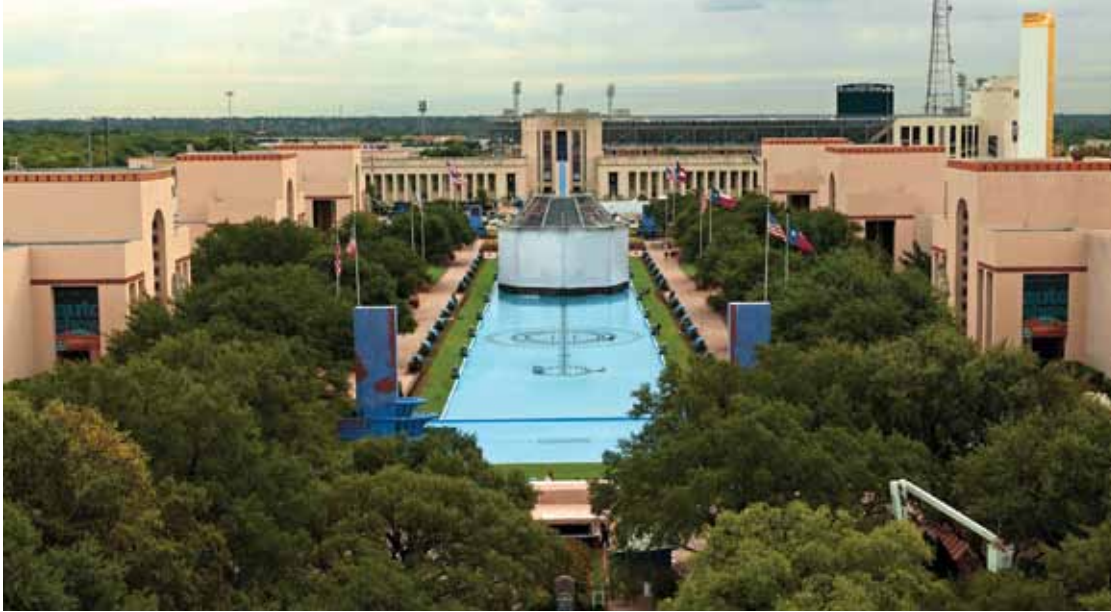
Completed Esplanade fountain and reflecting pool
