ROYAL MILLS RIVER POINT APARTMENT REHABILITATION

BY KEVIN YUFRS

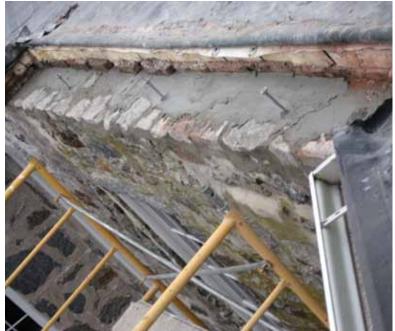
Royal Mills survived many years of harsh weather and industrial use

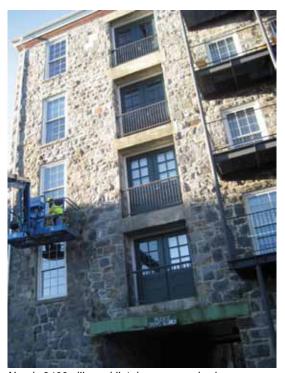
Nearly 2400 sills and lintels were repaired

- Several slabs poured using the same crystalline admixture to provide a permanent waterproofing solution and eliminate the need for an external membrane;
- Extensive windowsill and lintel repair with a variety of crystalline material;
- Several concrete and rubble elevator pit repairs; and
- Mold remediation to the areas that required it.

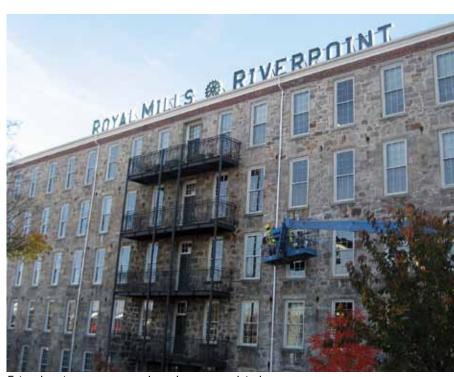
Extensive stone veneer repair work was completed

- 1000 linear ft (305 linear m) of sealed cracks;
- Cementitious concrete waterproofing slurry applied to interior walls to waterproof below the river level;
- 250,000 ft² (23,225 m²) of water-repellent sealer used to seal the original stone exterior and reduce water absorption;
- A crystalline admixture added to the mortar used to repair the historic stone veneer to reduce permeability;

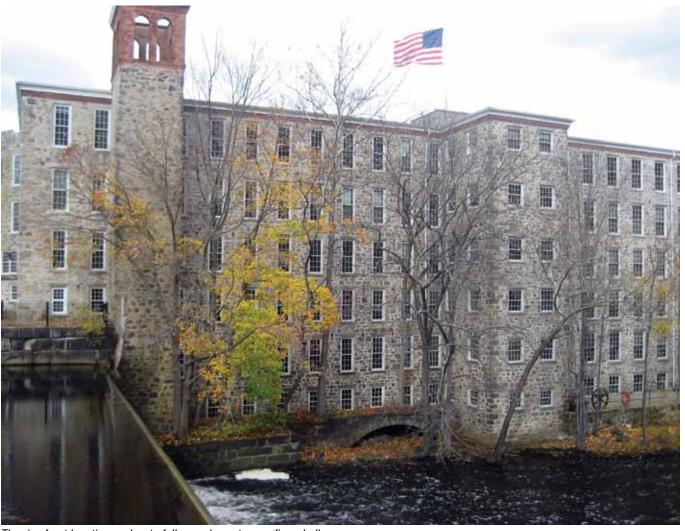
The riverfront location and waterfall posed a waterproofing challenge

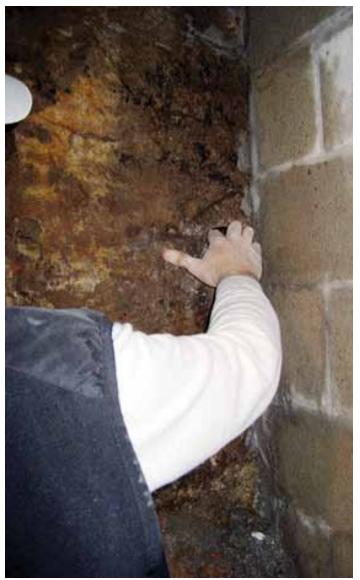
Crack repair was needed in elevator pits

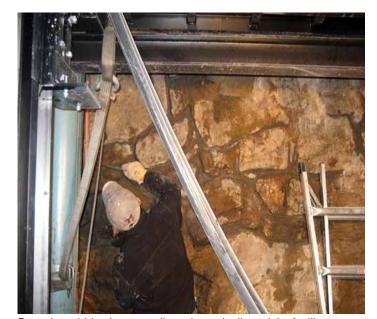
Extensive rubble elevator wall crack repair allowed the facility to pass inspection from authorities

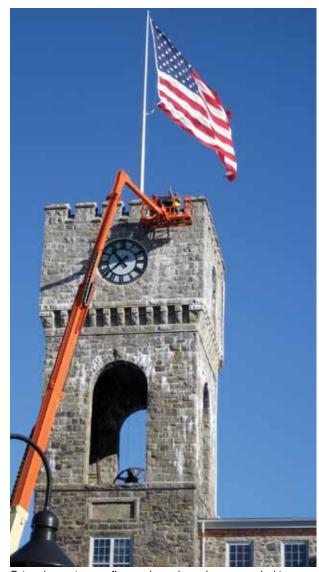
Extensive waterproofing and repair work was needed to revive the old mill

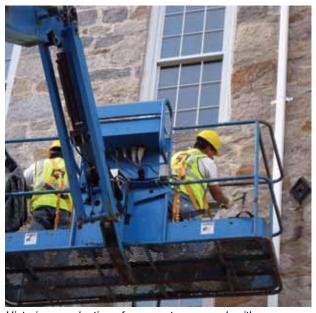
Historic reproduction of veneer stone—much with crystalline mortar

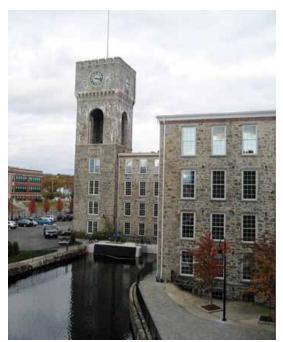
Canal dam head section received extensive reconstruction to stave off canal head pressure from lower apartment units

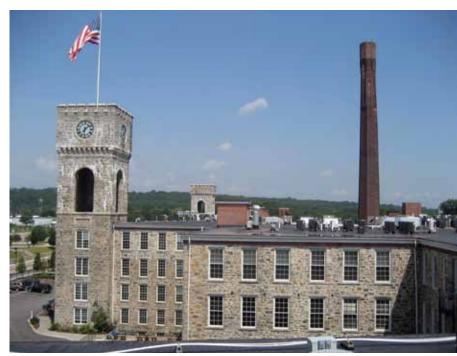
The waterproofing project was finished ahead of schedule and on budget
