INNOVATIVE METHOD USED TO EVALUATE THE EFFECT OF POWER WASHING ON MARINE CONCRETE

A UK SITE STUDY

BY PETER HUGHES

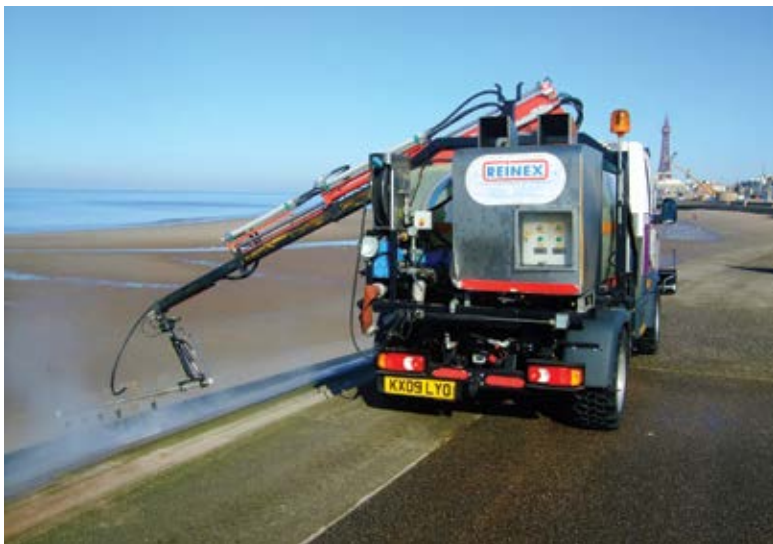
Fig. 1: Equipment used to manage biofouling at the study site

term durability of many material surfaces.¹ This article reports early findings from an ongoing study into the effects of power washing concrete. The study was conducted at a site on the northwest coast of England (Fig. 1), where concrete revetment armor with a design life of 100 years has been monitored for surface changes over a period of 3 years (Fig. 2).

Water-jet applications can be distinguished according to the level of the applied operational pressure. Power washing can be defined as the use of pressurized water applied below 5000 psi (34.5 MPa),³ with or without the addition of other liquids or solid particles, to remove unwanted matter from various surfaces. Dated UK published guidance tackles the removal of algae from concrete recommending power washing at velocities between 725 to 2175 psi (5 to 15 MPa).⁴ This type of pressure is applied to clean marine structures, jetties, and steps to combat biofouling and reduce slip hazard. A modest 1200 psi (8.2 MPa) was used at the UK study site.

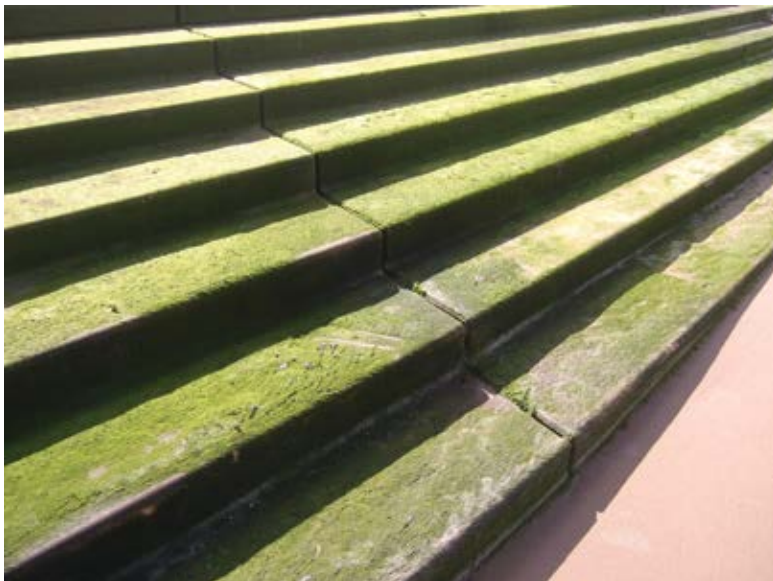
Fig. 2: Revetment armor steps colonized with algae

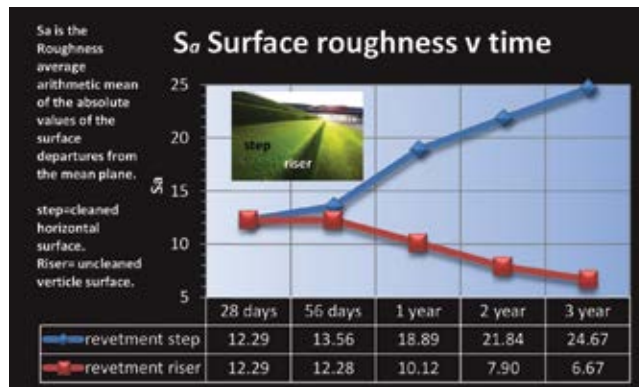
The surface roughness of the revetment armor was measured over time (Fig. 3). While no standard method for measuring surface roughness of concrete has currently been adopted, a range of nondestructive testing (NDT) methods are available. These methods are in use for measuring the surface texture of concrete floors, but no method is accepted as a standard and different organizations use different methods.

Surface roughness measurements were taken with an interferometer on 28-day; 56-day; and 1-, 2-, and 3-year concrete samples. Semi-direct paths for interferometric readings were chosen using an angle of 45 degrees and a modest path. Readings were taken on 10 surface-dry units with ambient temperatures at 70°F (21°C). At 3 years, the poor condition of the surface at the nose of the units

Fig. 3: Revetment armor surface roughness measurements

Surface roughness measurements were taken on the step (horizontal) and the riser (vertical). Areas of testing were focused away from the nose of the step. The surface roughness increase on the step, rather than the riser, indicates that power washing the step has altered the surface. The marine environment in which this surface exists should have partly been responsible; however, over time, the riser that was not power washed became smoother. Results showed that in 3 years the surface roughness on the steps doubled from $S_a12.29$ to $S_a24.67$. The steps were power washed approximately 150 times at 1200 psi (8.2 MPa) over the course of the 3 years. The risers of the steps were not power washed and were subject to the same tidal impacts, but they showed a smooth erosion pattern—from $S_a12.29$ to $S_a6.67$.

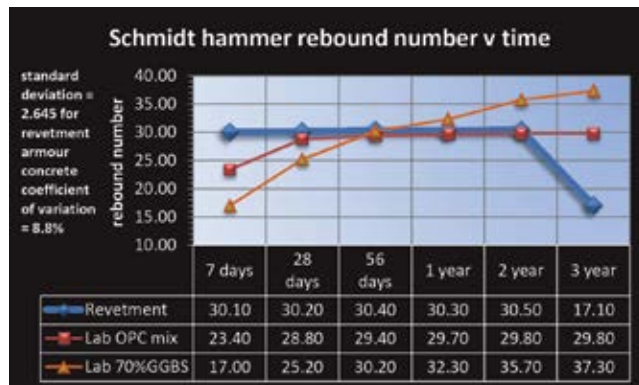
Fig. 4: Revetment armor surface hardness measurements

Schmidt/rebound hammer tests were used to evaluate the surface hardness of the concrete (Fig. 4). Tests were performed on site on 1-, 2-, and 3-year placed revetment armor units. For hardness comparisons, replicas were cast and tested in the laboratory. Two laboratory control mixtures were used: an ordinary portland cement (OPC) mixture and a 70% ground-granulated blast-furnace slag (GGBS) mixture—neither of which containing synthetic fibers.

Schmidt/rebound hammer readings from the surface of the armor units remained consistent at around 30r. After 2 years, a common pattern of degradation appeared on the units. An area or band of liberated aggregate approximately 3.9 in. (100 mm) wide occurred on the leading edge of the step and the impact hammer could no longer be used because the hammer would have further damaged the surface.

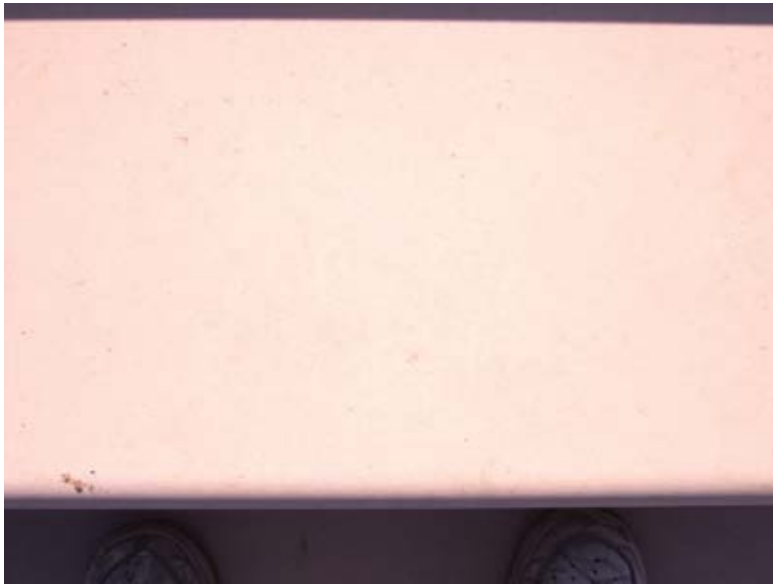
Fig. 6: Newly placed concrete tested in this research

Weekly site surveys yielded a comprehensive photographic archive so visual evidence could also be observed. Figure 6 shows a photo of the new unit at the test site and Fig. 7 shows the condition after 5 years of exposure.

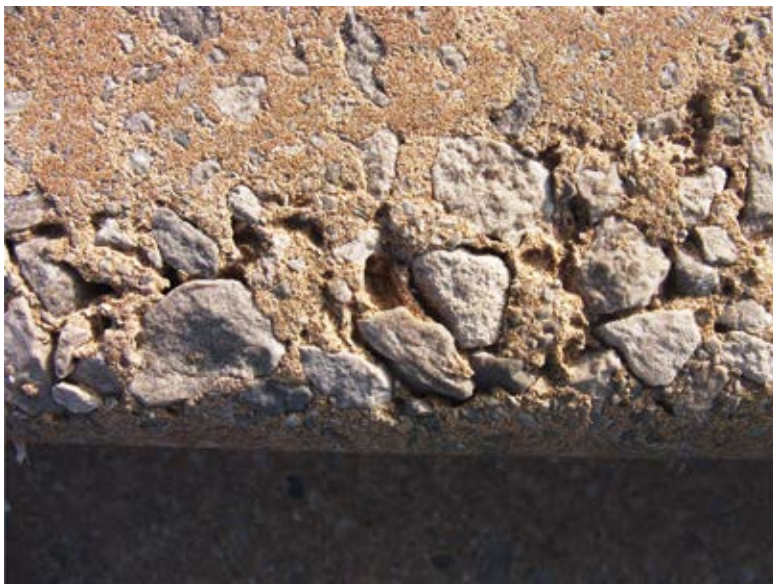
Fig. 7: Nose of the step of the unit shown in Fig. 6 after 5 years' exposure

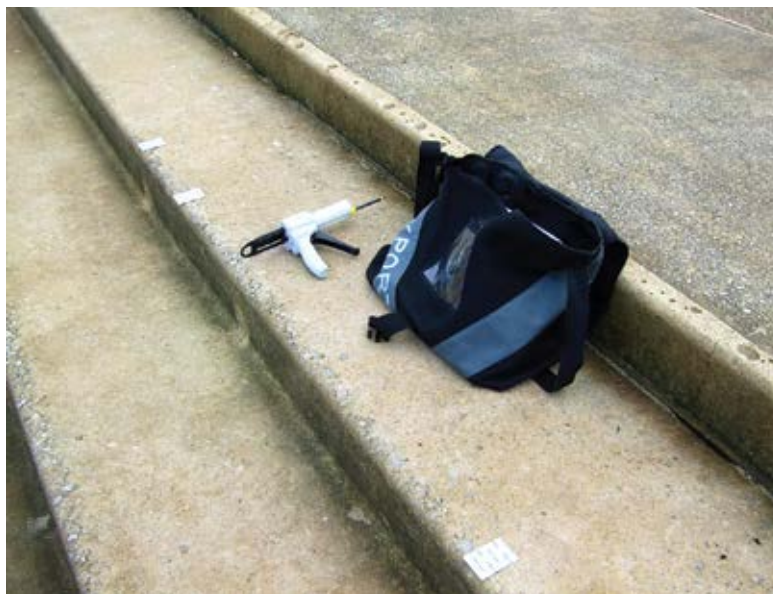
Replication was used as a means of performing a comparative surface analysis. This technique uses

silicone-based replicating polymers and produces an exact copy of the surface (Fig. 8). After curing, the sample is removed and examined microscopically in the laboratory.

Fig. 8: Surface that was copied using silicone-based replicating polymers

Replication techniques proved to be extremely useful and adaptable. The ability of the polymers used for replication to provide a visual microscopic picture of three-dimensional surfaces while, at the same time, yielding accurate dimensional data, was useful as a permanent record for subsequent reference or monitoring purposes and could lay the foundation for the development of a new NDT method for concrete surface analysis.¹⁶

The replicating compounds used had a resolution better than 0.1 microns¹⁷ and were able to accurately recreate the surfaces being studied. Confirmation of this accuracy can be found in a comprehensive study of three different materials used for surface roughness replication on five different types of machined surfaces. The results were reported in Reference 18.
