# THE USE OF ELECTRONIC LEAK DETECTION ON WATERPROOFING MEMBRANES OVER CONCRETE SURFACES

BY DANIELLE CZYZEWSKI AND CAROLE CUMMINGS

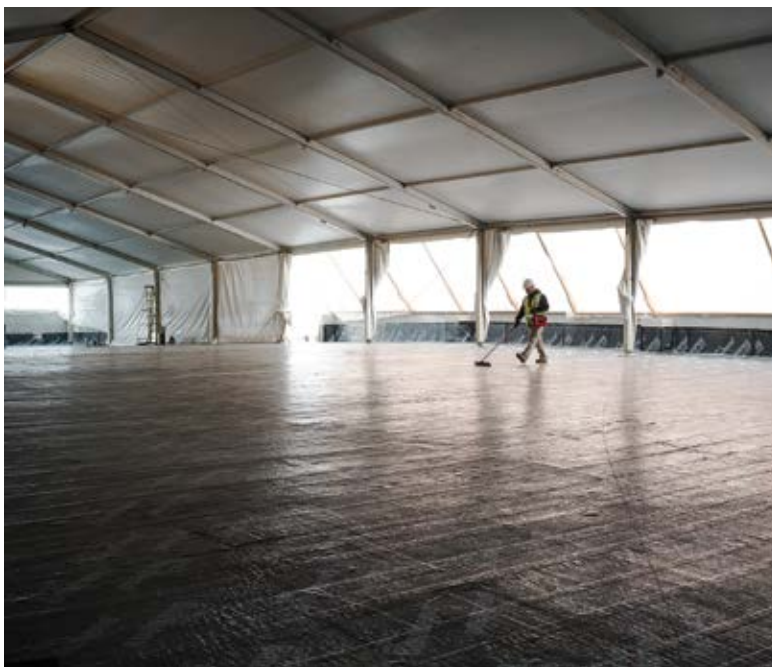
Fig. 1: HVELD testing in progress

High-voltage electronic leak detection (HVELD) can be performed on vertical or horizontal surfaces under dry conditions (Fig. 1). The principle of the HVELD process involves a generator that delivers an adjustable stabilized direct current (DC) output voltage for the detection of breaches to the electrically insulated roof or waterproofing membrane.

The generator emits a calibrated voltage discharge which conducts through membrane penetrations to a grounded earth lead, such as a metal drain body or steel reinforcing embedded in the concrete slab. Should the current make contact with the ground, this will complete the circuit emitted by the generator. An audible beep from the test equipment alerts the technician of the breach. Small sparks can sometimes be seen or heard when a breach location is contacted by the probe.

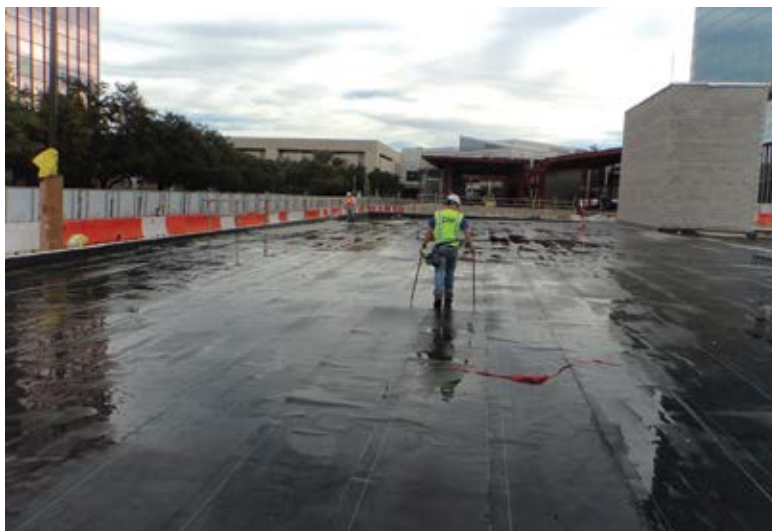
Fig. 2: LVELD testing in progress

Low-voltage electronic leak detection (LVELD) is performed on horizontal surfaces using water as a conductive medium on the surface of the waterproofing membrane (Fig. 2). Multiple types of LVELD testing equipment and setups are available. The principle of the LVELD process involves a perimeter conductor loop placed on the surface of the membrane. The conductor loop is then connected to an electrical pulse generator. The generator is also connected to the grounded portion (for example, reinforcing steel or a metal drain body) of the substrate below the membrane.

During LVELD testing, the top surface of the membrane is lightly wetted. The thin layer of moisture creates a continuous surface plane of electrical current within the established perimeter conductor loop and allows the electrical pulse from the generator to pulse across the membrane. Once the generator is set up and activated, it sends a low voltage electrical pulse through the water on the surface of the membrane. Should any water make contact with the ground, this will complete the circuit emitted by the generator. Because the electrical current is directional, the testing technician can use hand-held probes to determine the direction of the current flow and follow the flow until the breach is located.

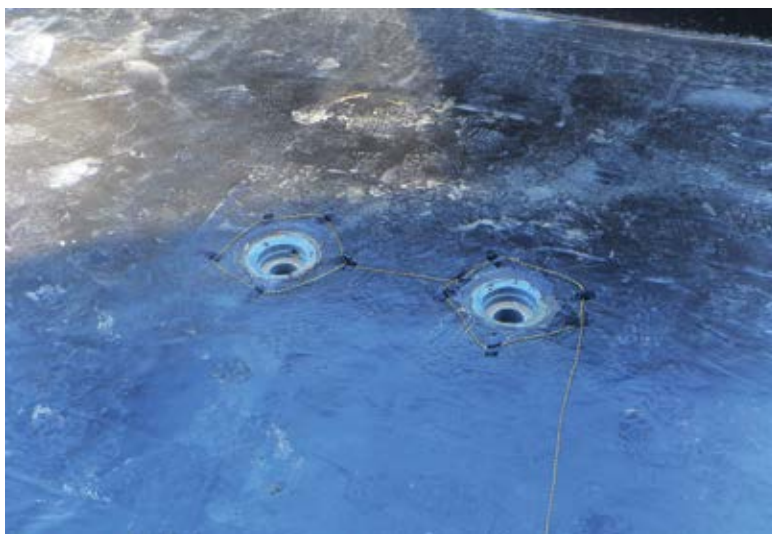
Fig. 3: Drains isolated with perimeter conductor loop

be isolated from the test area during testing with a separate perimeter conductor loop (Fig. 3). This includes drains, metal pipe penetrations, fasteners, and so on.

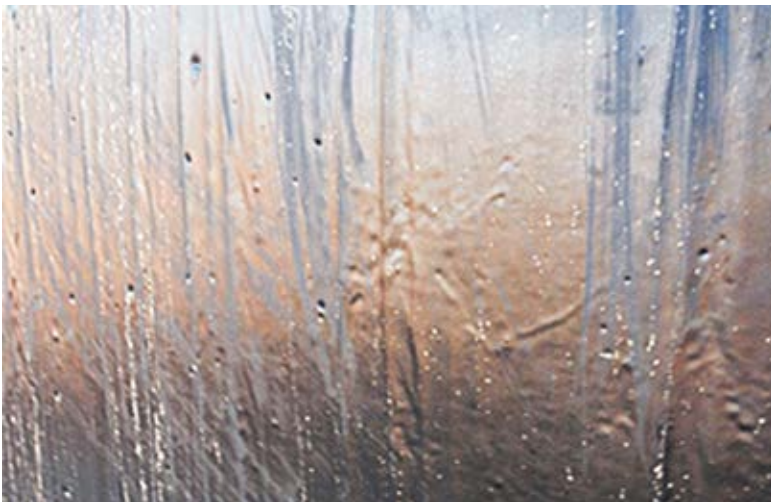
Fig. 4: Pinholes observed on vertical surface

Testing of a 15,000 ft<sup>2</sup> (1395 m<sup>2</sup>) area was completed over the course of eight mobilizations. During testing, the consulting firm detected an excessive number of pinhole breaches in the installation of the membrane on vertical surfaces. Some of the breaches were large enough to be visually observed without ELD (Fig. 4), while others were much smaller (approximately the size of a pencil tip) and required the use of ELD for detection. It was determined that the cause of the pinholes on the vertical surfaces was due to the irregular surface of the formed concrete substrate. To correct this deficiency at locations where the waterproofing membrane had already been installed, an expensive and time-consuming retroactive application of repair sealant was applied on the waterproofed vertical surfaces (Fig. 5). Once the sealant had cured, the vertical areas were retested using ELD and confirmed to be watertight. To prevent similar pinholing at future locations, a pre-treatment of the concrete surface with extra waterproofing material or repair sealant was implemented to create a smooth surface for the waterproofing application.

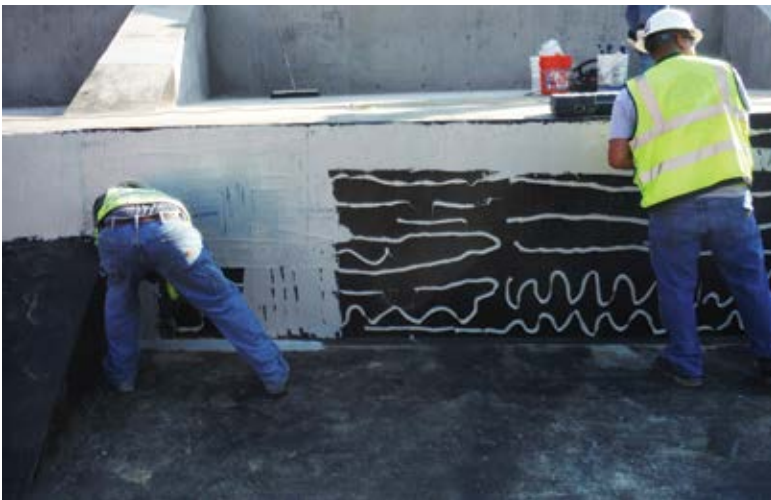
Fig. 5: Retroactive sealant application to repair pinholes

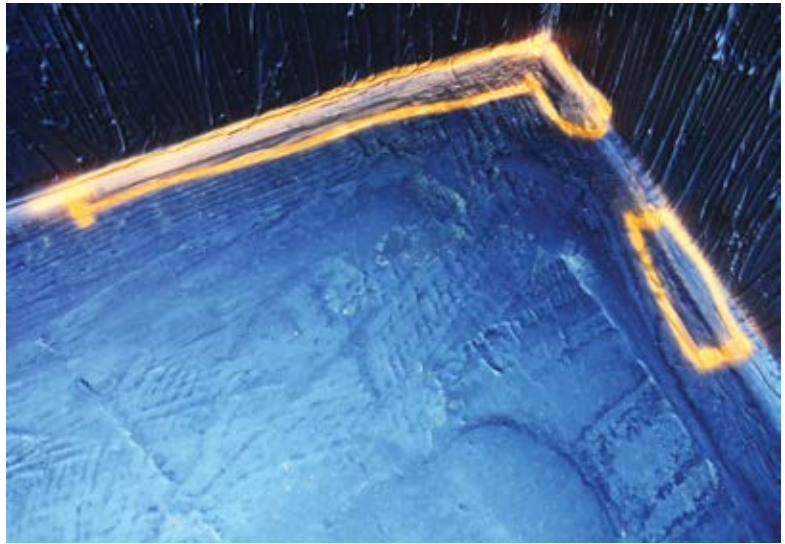
Fig. 6: Material thickness deficiency at transition

In addition to pinholes, a material thickness deficiency at the transition from vertical to horizontal surfaces was detected using ELD during the first two (of eight) testing zones (Fig. 6). This information was relayed to the waterproofing contractor, and a thicker application was installed in these and the remaining zones.

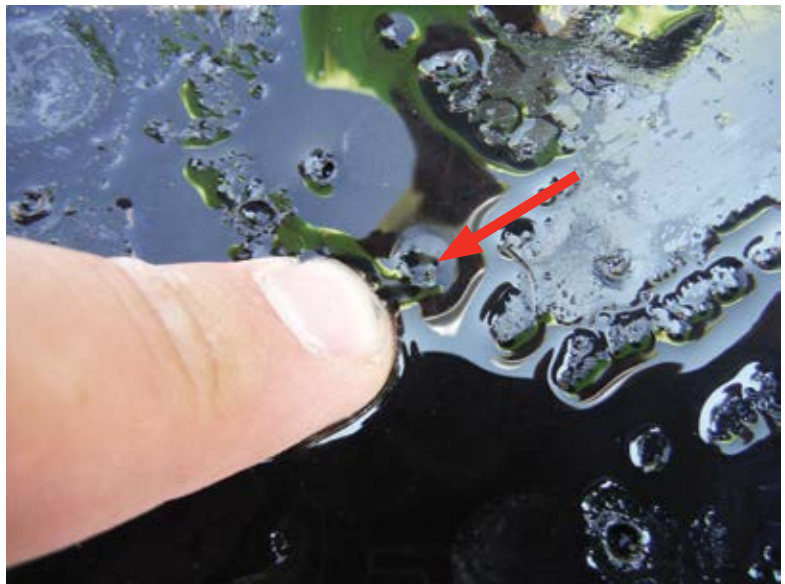
Fig. 7: Pinhole detected with LVELD

of the eight mobilizations. Breaches were up to approximately 1/16 in. (1.6 mm) in diameter (Fig. 7). In some cases, the breaches were detected at locations where a protection board had already been installed (Fig. 8). The contractors were able to expose the breaches (where covered) and repair the waterproofing membrane while testing was ongoing at other locations. The repaired areas were retested prior to leaving the site.

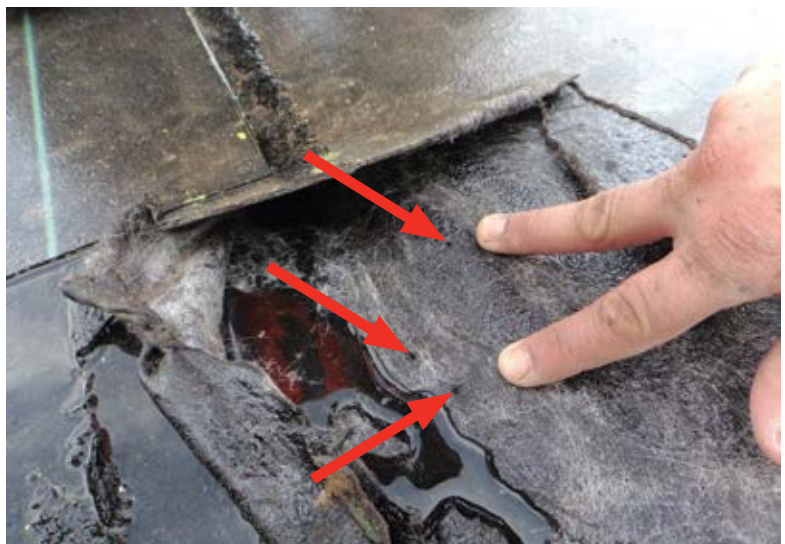
Fig. 8: Breaches in waterproofing membrane detected with LVELD through undamaged protection board
