EXTERIOR WATERPROOFING AND STORM DRAIN REPAIRS

AT THE KAY BAILEY HUTCHISON CONVENTION CENTER

BY RYAN GRIGSBY

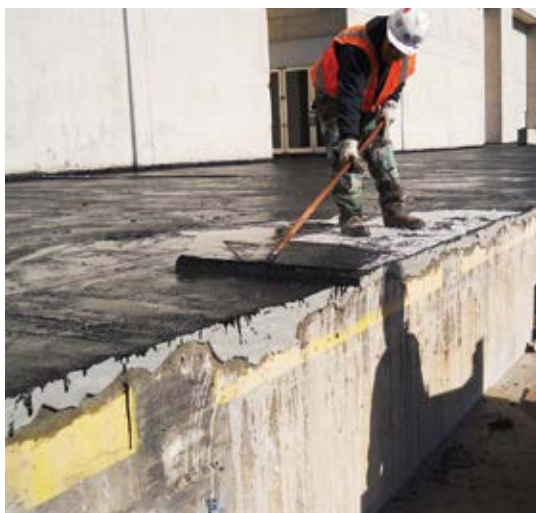
Fig. 1: Hot fluid rubberized waterproofing was applied at approximately 450°F (232°C) to achieve a 90 mil (0.09 in.) layer

Once the concrete was repaired, a hot fluid rubberized waterproofing was installed (Fig. 1 and 2). This product started as chunks of asphalt, which were heated in a kettle at 425 to 450°F (218 to 232°C). The melted asphalt was placed into steel buckets, poured onto the substrate, and leveled with squeegees to provide a 90 mil (0.09 in.) layer. A geotextile reinforcing fabric was installed followed by another 125 mil (0.125 in.) layer of hot fluid waterproofing. The quick cure time for this material made it possible to install a multi-composite drainage and protection board the next day.

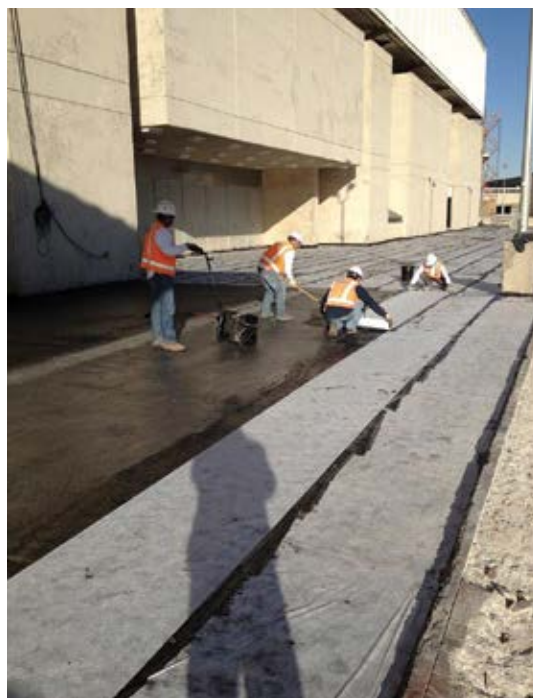
Fig. 2: A geotextile reinforcing fabric was applied between layers of the hot fluid rubberized waterproofing

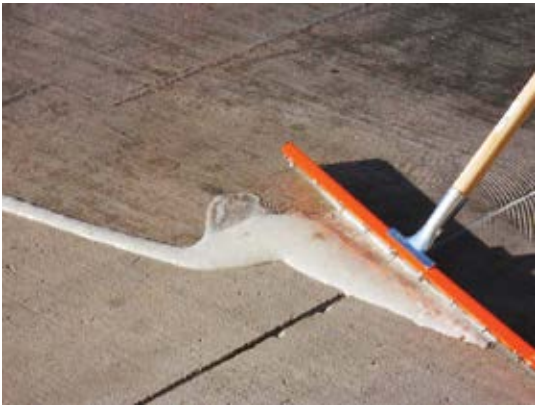
Fig. 3: A low-modulus epoxy resin binder was applied to the loading dock to allow for movement of the substrate and withstand the heavy traffic sustained during multiple events at the convention center

With the new waterproofing system in place, reinforcing steel was installed and the new topping slab poured. Then, a two-component, 100 percent solids, moisture-tolerant epoxy resin binder with an aggregate broadcast was applied to the topping slab (Fig. 3 and 4). The low-modulus coating system allows for movement of the substrate, such as the loading dock's expansion and contraction based on the ambient temperature. Finally, control joints were sealed, new dock bumpers installed, and the loading dock was striped. The same waterproofing scope detailed previously was also performed on the 10,000 ft² (929 m²) A/B Hall exterior terrace (Fig. 5).

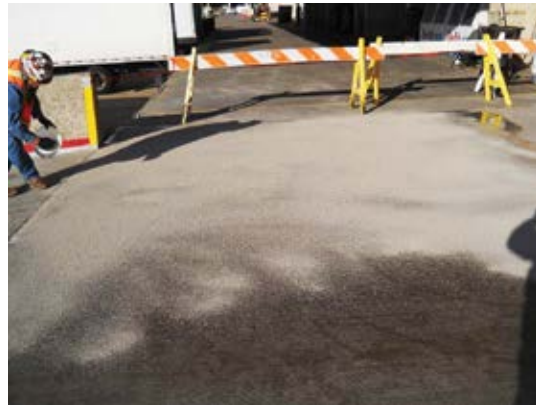
Fig. 4: An aggregate broadcast was applied into the epoxy coating for slip resistance

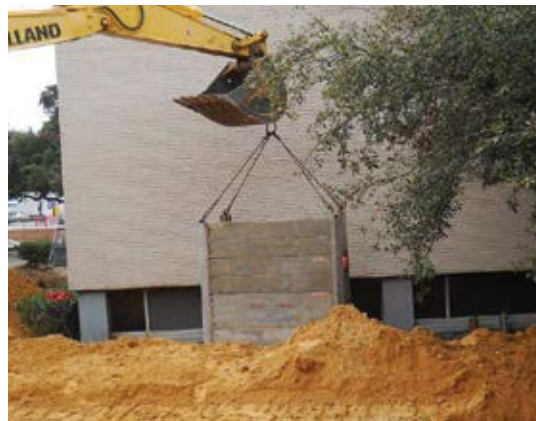
Fig. 6: Trench boxes were placed in the narrow excavation at The Black Academy of Arts Building to allow for safe completion of the repairs in the limited areas where shoring or benching was not a possibility

In one narrow area measuring approximately 1400 ft² (130 m²), trench boxes were used as a cave-in protective system (Fig. 6, 7, and 8). For safety purposes, the excavated soil was transported and stored off site until it could be placed back in the ground. Another remedial measure incorporated a sheet pile system. I-beams were inserted into drilled pier holes and shored with rock. Then, metal panels were placed between each I-beam to safely secure the soil.

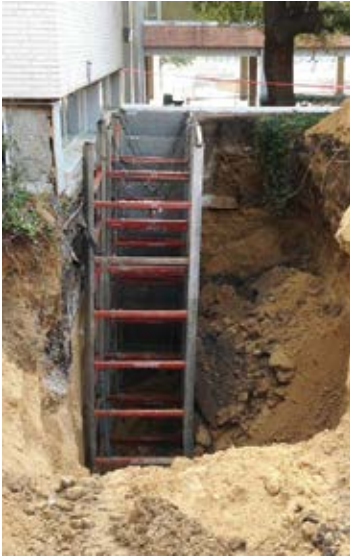
Fig. 7: Trench box in the narrow excavation site

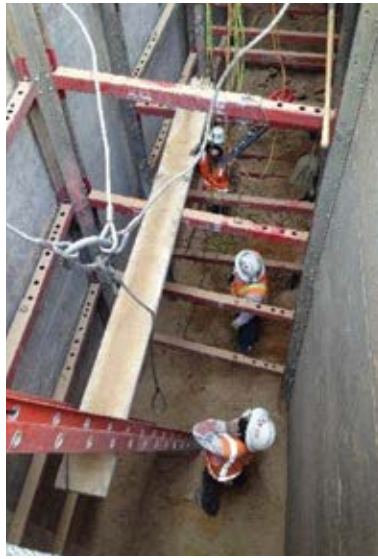
Fig. 8: The crew worked safely in the trench box to apply the below-grade waterproofing to the basement of The Black Academy of Arts Building

Once the excavated area was safely secured, a self-adhered sheet waterproofing was applied to the basement of the building. To remedy persistent leaks caused by the old waterproofing system stopping short, just beyond the wall's cold joint, the new waterproofing extends 30 ft (9 m) below grade.

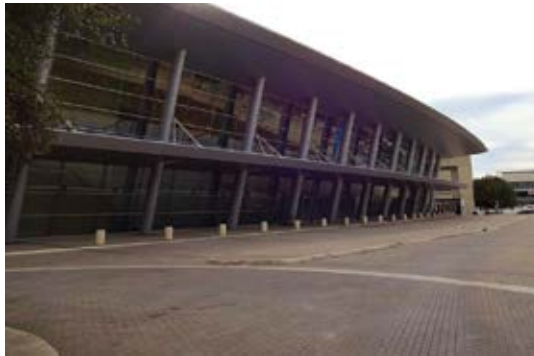
Fig. 9: The area of Ceremonial Drive under which the convention center's storm drain system resides

An additional drain pipe was added to the convention center's existing storm drain system to expand its capacity, and the new pipe was tied in with existing utilities. The storm drain system resides under Ceremonial Drive, a main road leading to the convention center (Fig. 9), making this utility work especially challenging to complete. To allow use of the road for each event, construction had to be halted and the excavation filled in. To create a driving surface, concrete was poured where possible and road base filled the rest. When the event was over, the road was re-excavated and construction continued.
