A Short History Of Unbonded Post-Tensioning Specifications

By Gail S. Kelley

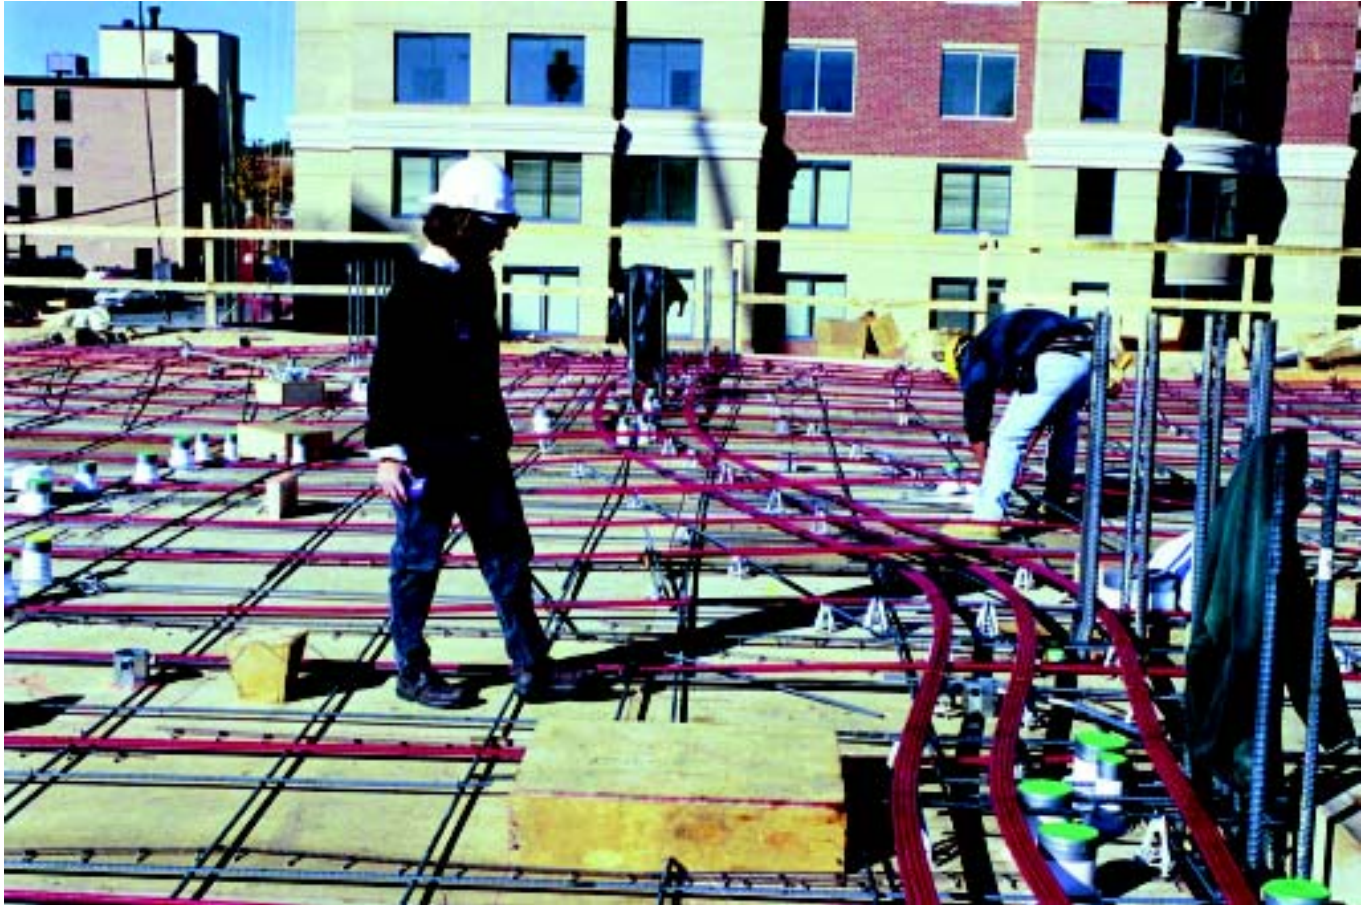
Fig. 1: A 20-story condominium building under construction. Unbonded tendons for a two-way slab are being laid out in a 'banded' configuration. Tendons in one direction are banded over the column lines. Tendons in the other direction are uniformly spaced approximately 3 feet on center

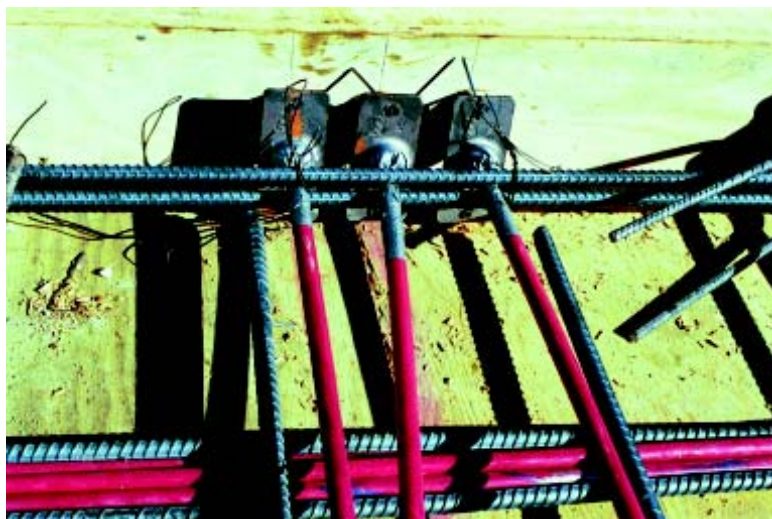
Fig. 2: Stressing-end anchorages of the tendons shown in Fig 1. Since the structure will be enclosed, the tendons are not considered exposed to an aggressive environment; the anchorages are therefore not required to be encapsulated. The ends of the tendons have been taped to avoid exposing the strand

In addition, the importance of corrosion protection of the anchorage was emphasized. The minimum concrete cover to the wedge cavity of the anchorages was increased, and the permissible length of strand projecting from the face of the wedges was reduced. A stipulation requiring anchorages intended for use in aggressive environments be fully protected against corrosion was added, and the definition of an aggressive environment was expanded. The 2000 edition of the Specification defines an aggressive environment as one in which structures are exposed to direct or indirect applications of deicing chemicals, seawater, brackish water, spray from these sources, or salt-laden air. Structures or parts of structures where the anchorage pockets are wetted or in direct contact with soils are also considered as exposed to an aggressive environment.

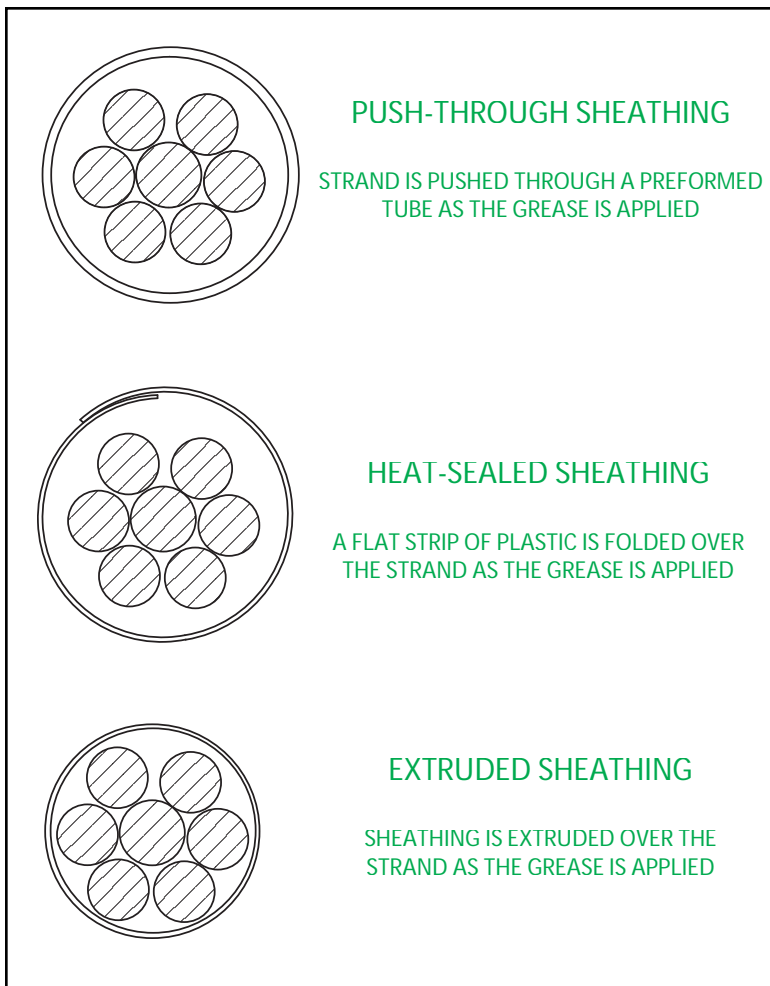
Fig. 3: Plastic sheathings used for unbonded tendons. Virtually all post-tensioning systems currently sold use extruded sheathing

Although the first strand systems were paper-wrapped, by the early 1970s, most strand systems were using plastic sheathing. Initially, there were two types of sheathing: “heat-sealed” and “push-through.” In the heat-sealed system (sometimes referred to as a “cigarette wrap”), the sheathing was fabricated from a plastic tape 20 to 40 mils (0.5 to 1 mm) thick. The tape was lapped longitudinally along the strand and the seam was heated to weld it shut. The plastic was not actually melted; it was just heated enough to become sticky. In the push-through or “stuffed” system, the coated strand was pushed into a preformed plastic tube. The heat-sealed system was more common in the United States; the push-through system was more common in the Canada.

A process for producing an extruded sheathing was patented in the early 1970s. This resulted in a much more durable system, since the sheathing fit closely around the greased strand and there was no seam. Since it was a patented system, the other types of sheathing continued to be used. By the late 1970s, however, most unbonded post-tensioning systems used extruded sheathing.

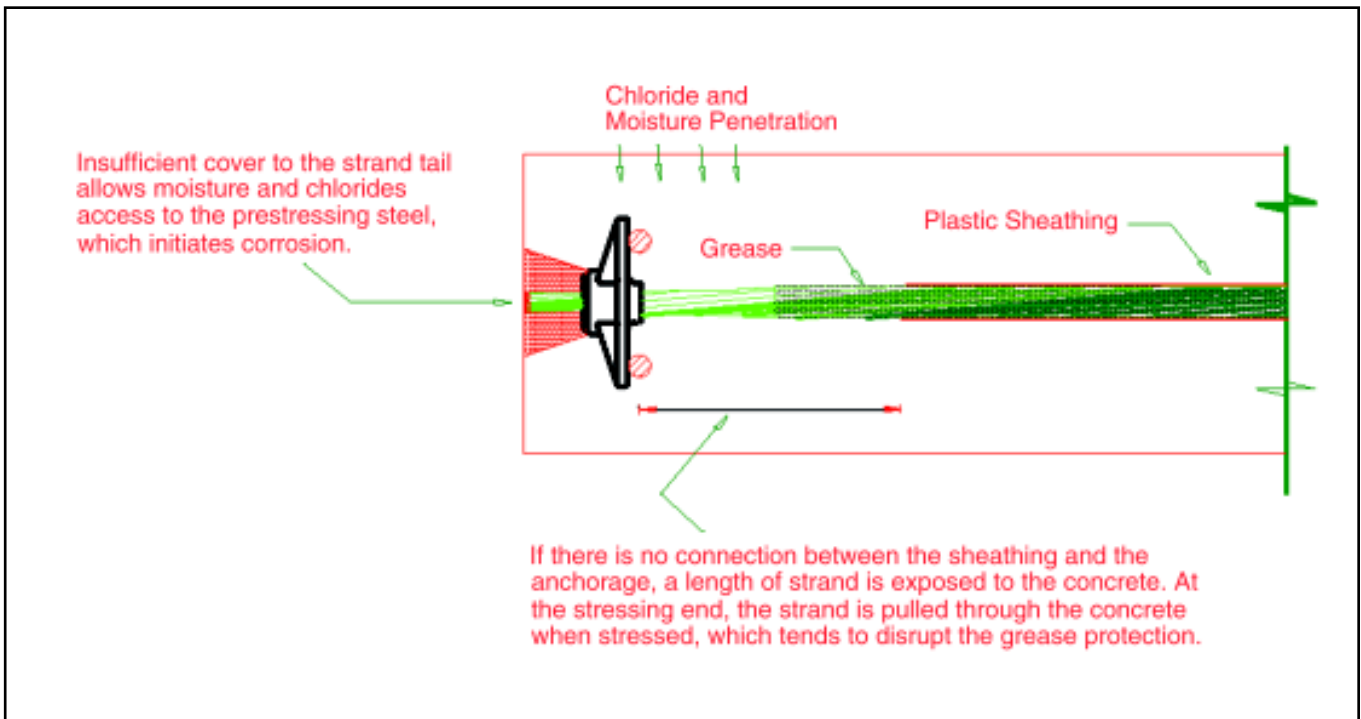
Fig. 4: Potential corrosion problems at the stressing end of an unbonded tendon in an aggressive environment
