Parking Garage Repair: Two Case Studies

Ohio State University Medical Center Parking Facility

Cook County Department of Corrections Parking Garage

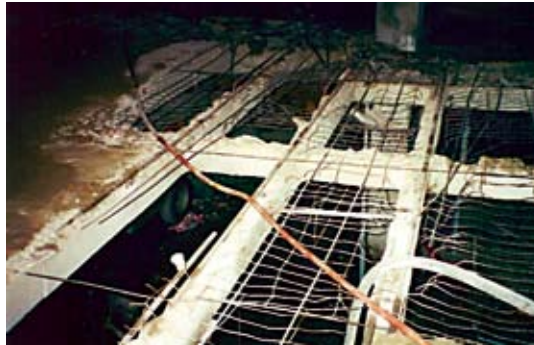
Concrete removal using hydrodemolition

190,000 ft² (17,650 m²). Because of the sheer volume of demolition required, and because the deck was a pan and joist design, it was decided that hydrodemolition would be used.

Hydrodemolition was chosen for several reasons. The technology provides better quality control in regard to concrete removal, reduced use of shoring (due to the pan and joist design), flexible and predictable scheduling, and a vast reduction of airborne particles generated via the demolition process.

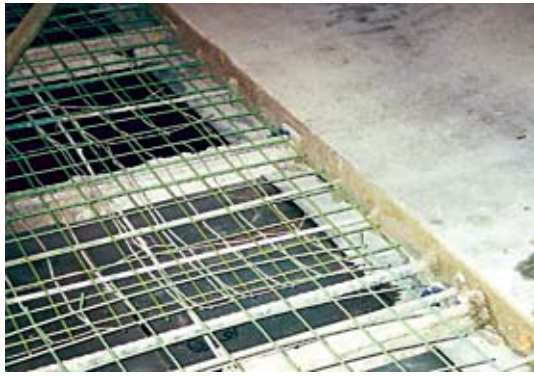
New reinforcing steel on pan and joist system

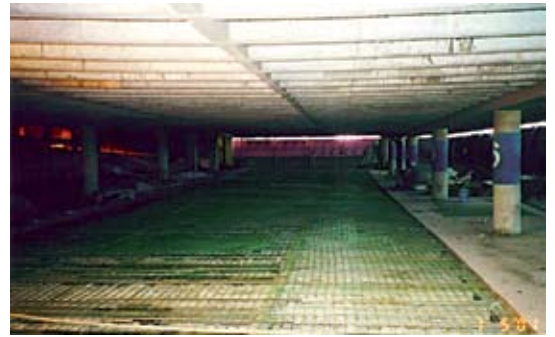
Full-depth slab replacement

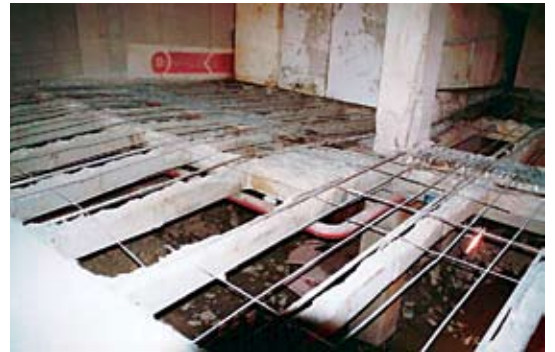
Full-depth concrete removal

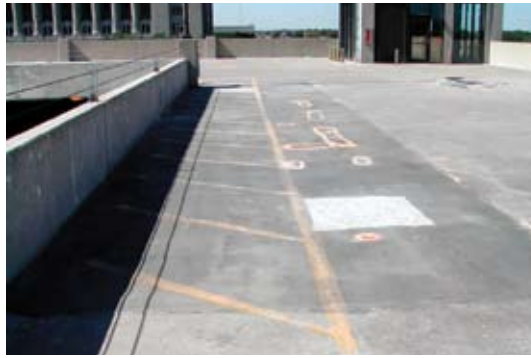
Concrete marked for removal after evaluation

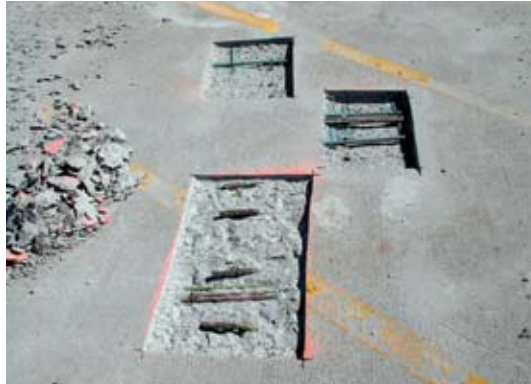
Removal of deteriorated concrete

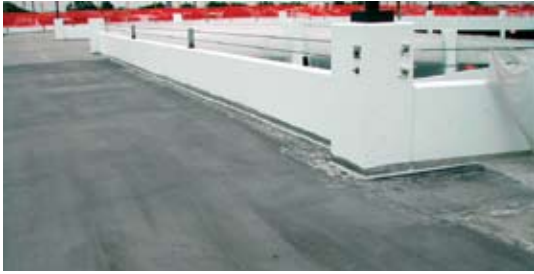
New deck coating

Specifically, this 2002-2003 project consisted of 225,000 ft² (20,900 m²) of waterproofing membrane, 150 linear ft (45 linear m) of expansion joint repair, 35,000 ft² (3250 m²) of patching material, 15,000 linear ft (4570 linear m) of elastomeric joint sealant, and 170,000 ft² (15,800 m²) of light-reflective coating. Success in the installation of each of these individual systems had some reliance on the performance of another. Therefore, understanding how these products work together was a key factor in this project's success. Because one manufacturer supplied all of these products required by the designer, that manufacturer was able to supply the designer and contractor with a comprehensive understanding of the qualities and limitations of these systems relative to the structure as a whole. Ultimately, a team of construction experts, all working in sync, provided
