HIGHWAY BRIDGE PIER CAPS STRENGTHENED WITH FIBER-REINFORCED POLYMER

BY TAREK ALKHRDAJI AND MATT FRYE

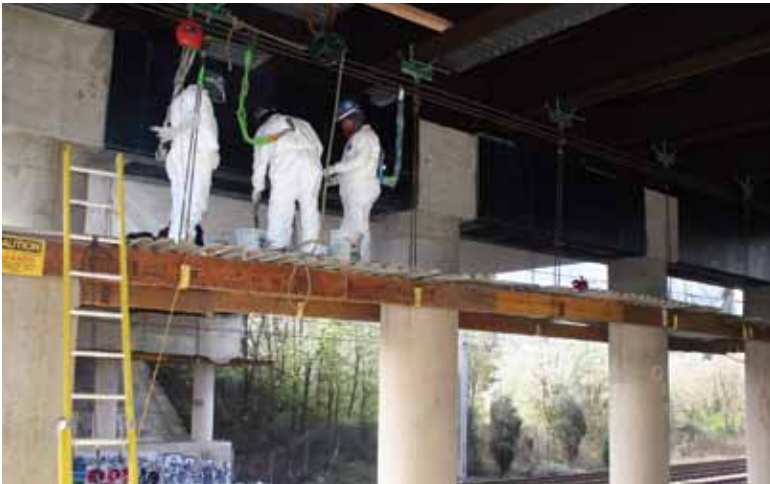
Elevated work deck allowed for access around entire work area

A challenge for working on the first bridge was access to the piers. The two outside piers could only be accessed from the embankments next to the bridge, which were covered mostly with rocks. Crews had to build wood access ladders on the embankment to allow for climbing up the steep slope. For the middle pier, the only way to access the work platform was to climb a 30 ft (9.1 m) tall ladder. Work platforms were constructed of wood frames suspended by steel cables clamped to the underside of the bridge. Corrugated metal decking was placed on top of the frame to form the work deck. To construct the work deck, crews first hung the support cables using a rough-terrain man lift. Then, the wooden frame was built and the metal decking was installed. Because all of the work decks were suspended from the underside of the bridges, minimal work was done from the ground. Crews accessed the work deck from the sides. This ensured that the installation crew was not near traffic and needed minimal access to the railroad property.

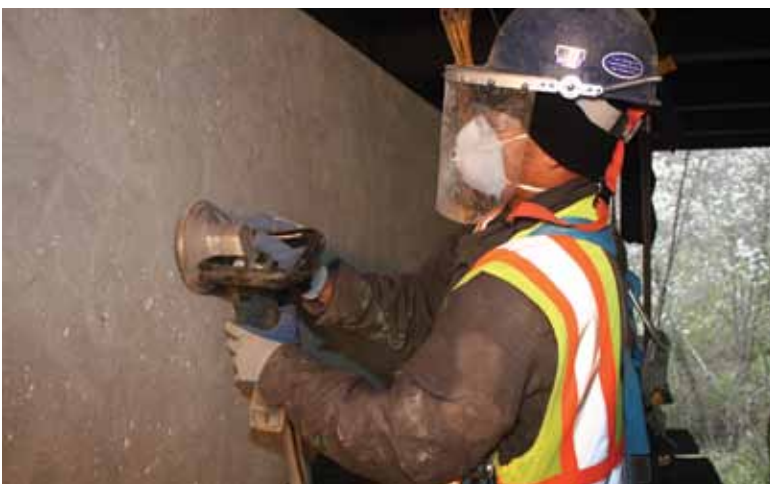
Surface preparation of concrete

To begin the work, construction crews prepared the surface of the piers with electric grinders to open the pores of the concrete, smooth form lines, and remove dirt and grime buildup so that the FRP would achieve the required bond with the concrete substrate. Several quality control measures were employed, including a series of pulloff tests to evaluate the quality of bond. These tests were used to measure the strength of the bond between the FRP reinforcement and the concrete substrate and also between subsequent layers of FRP reinforcement.

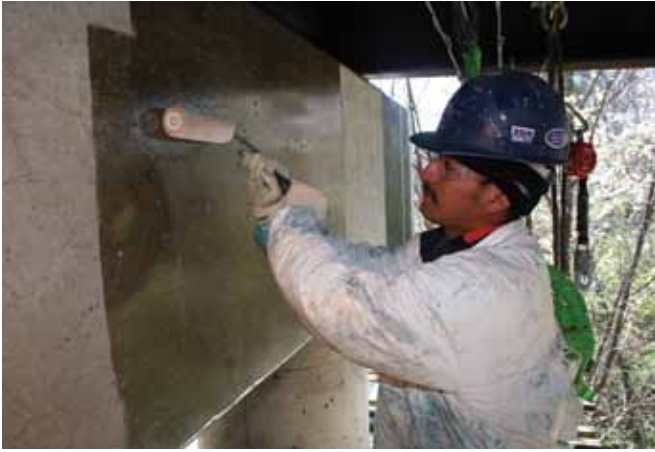
Application of surface primer

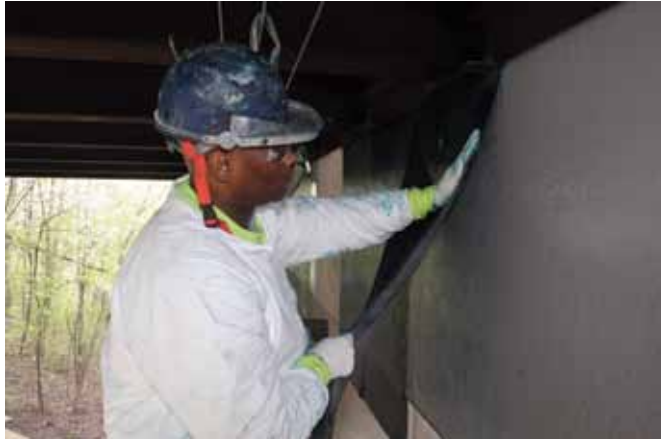
Saturated carbon fiber sheets are placed onto the primed surface

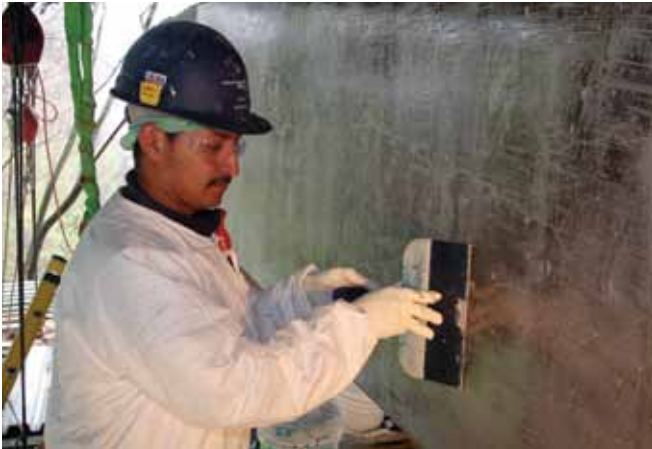
Smoothing of surface using putty filler for holes and cracks

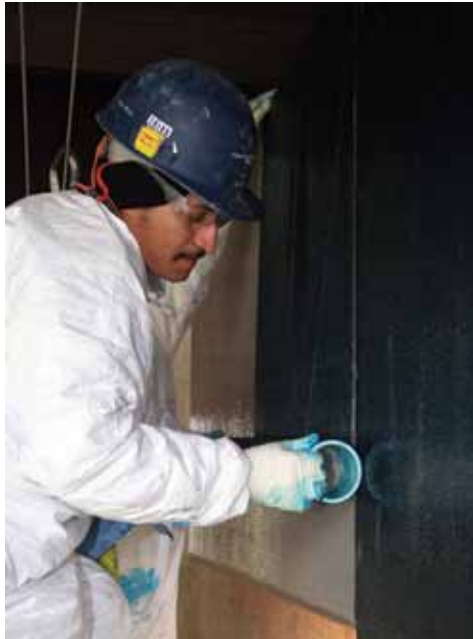
Saturated carbon fiber sheets are rolled onto the structure

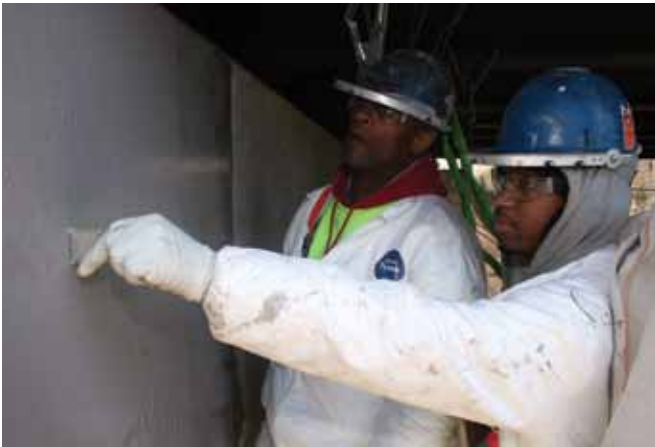
Application and quality control of tack coat prior to placement of carbon sheets

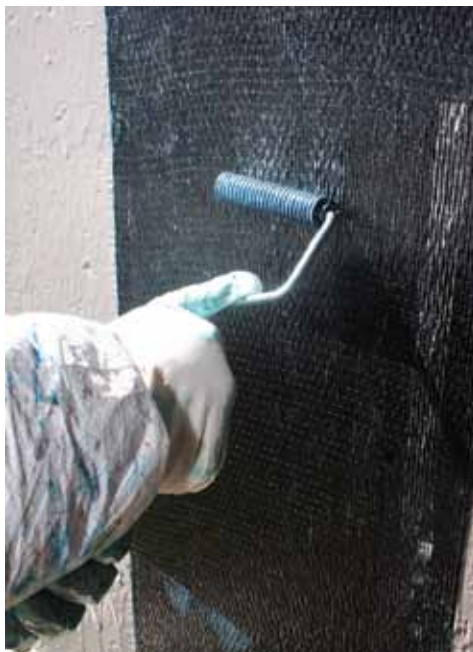
Carbon sheet material is pressed with a ribbed roller to ensure no air bubbles are trapped beneath the fabric

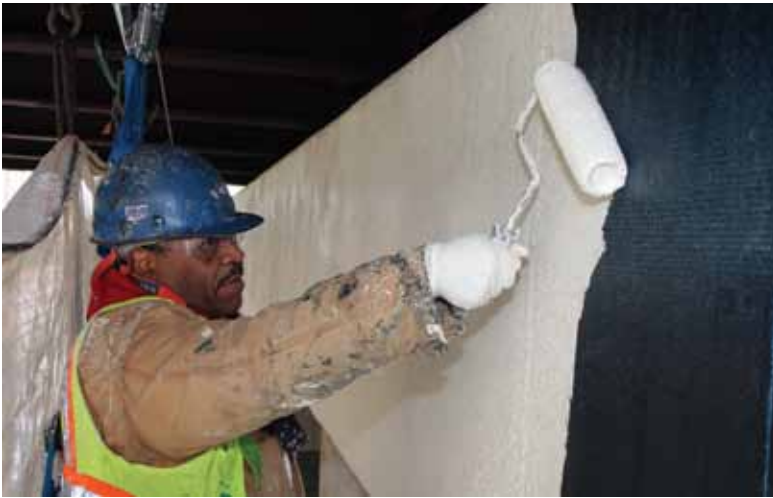
Application of topcoat for aesthetics and improved durability

All of the pulloff tests conducted on the surface-applied FRP confirmed that the surface preparation was done properly and that the carbon fiber was fully bonded to the concrete substrate. All pulloff tests resulted in a failure in the concrete substrate, indicating the bond between the carbon fiber and concrete is stronger than the tensile capacity of the concrete itself. The strengthened pier caps were then painted with a breathable acrylic coating to maintain a uniform appearance. The same process was performed for all three piers.

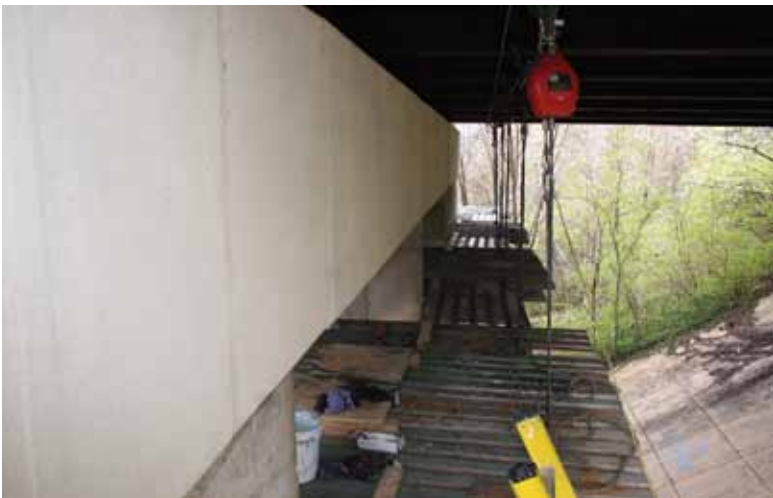
Completed installation
