# CROWN POINT PIER RESTORATION

BY RICHARD P. FARNAN JR., RONALD L. VOGT, AND MICHAEL WINGE

## Crown Point Pier Restoration

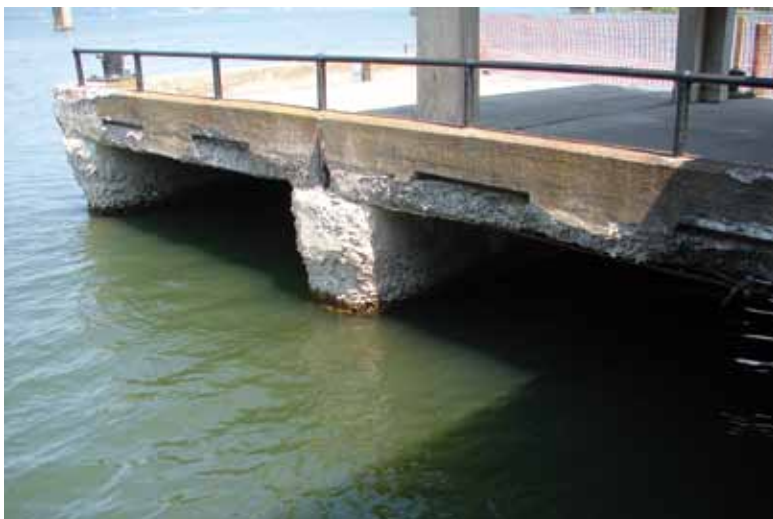
The concrete on the pier, which had never been repaired before, had large areas of spalls and cracks caused by the harsh winter climate and its location right on Lake Champlain. The specification called for the entire structure to be prepared by shot

*Severe deterioration of concrete due to location on Lake Champlain and harsh climates*

blasting and then the steel reinforcing bar to be coated with an anti-corrosion coating. The columns and beams were to be patched with polymer-modified repair mortars. Additional work included replacing sections of the concrete and railings and replacing the iron chains. Finally, the concrete structure was to be sealed using a silane/siloxane penetrating sealer.

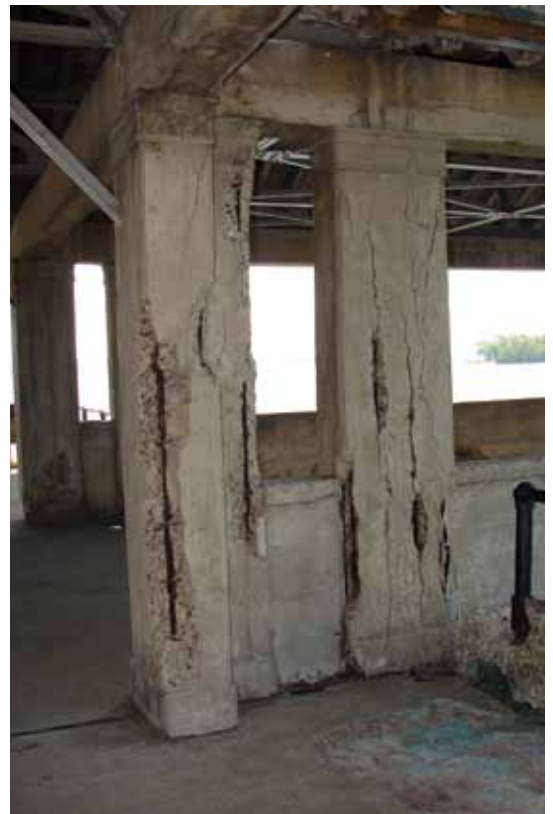
*Severe spalling and cracking of concrete columns with exposed reinforcing bar*

to the original square steel reinforcing in the concrete beams and columns. Because of the lack of concrete strength, several of the support columns had to be rebuilt after losing large sections of concrete during the surface preparation. This was accomplished by forming new columns and pouring a polymer-modified repair mortar extended with aggregate. In addition, large areas of the concrete deck had to be replaced with new concrete that contained an integral corrosion inhibitor. Next, a polymer-modified repair mortar was applied to the columns and beams, and a penetrating corrosion inhibitor was applied to all sections of the concrete structure that were not replaced to protect the steel reinforcing bar.

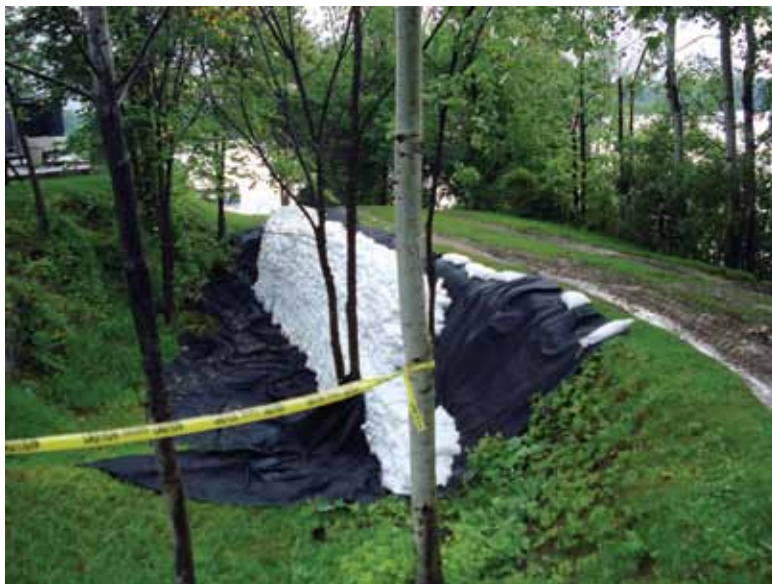
*Stone and earth walls of the historic fort redoubts being protected by sandbags*

On July 30, 2008, the entire Point Crown Lighthouse and pier areas closed to the public so repairs could begin. The first and most important part of the project mobilization consisted of protecting the Crown Point fort redoubts made from stone and earth along the north side of the access road to the pier. Over 4000 sand bags and several 1 in. (25 mm) steel plates were installed to protect the embattlements. A large 200 ton (181.4 metric ton) crane was to be used during the repair and would be brought in right through the fortifications.

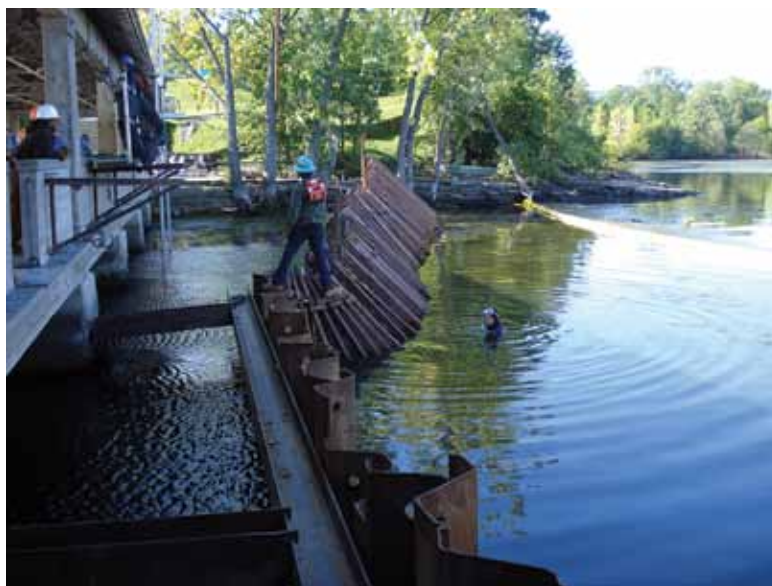
*Erection of portable fabric cofferdam in shallow areas*

Next, the repair required the construction of two types of cofferdams. The first was a steel sheet piling in the deeper water (up to 15 ft [4.6 m]) around the pier and a portable fabric dam system in the shallower water. Access for the pile driving equipment necessitated the construction of a 75 ft (23 m) long stone causeway into Lake Champlain. Once the cofferdam was completed, around-the-clock dewatering using a 6 in. (152 mm) submersible pump was conducted so the substructure restoration could be carried out in the dry with maximum protection for the workers. Over 1,000,000 gal. (3,785,400 L) of water were initially pumped out of the cofferdam.

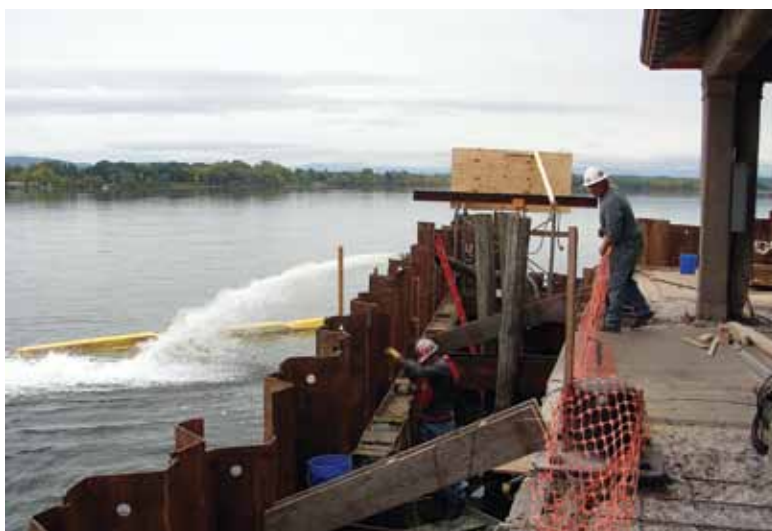
*Dewatering of the cofferdam*

After the dewatering was completed, it became evident that a 2 in. (51 mm) layer of zebra mussels on the concrete structure had to be removed by water blasting and bagged before the restoration work could begin. On several occasions during the course of the project, breaches occurred, requiring dewatering before the restoration work could continue. Two of the breaches in the dam were caused when muskrats ate through the sheeting of the fabric dam system. Finally, scaffolding was

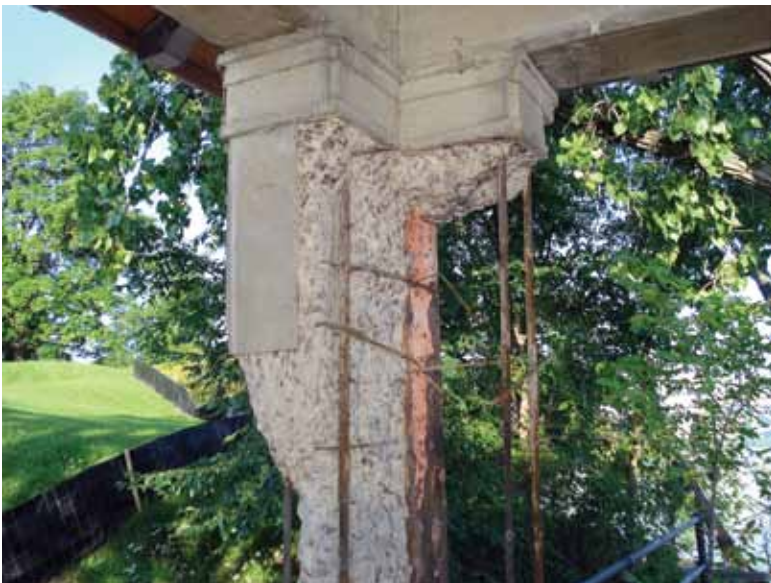
*Concrete column after surface preparation. Note the large loss of concrete sections*

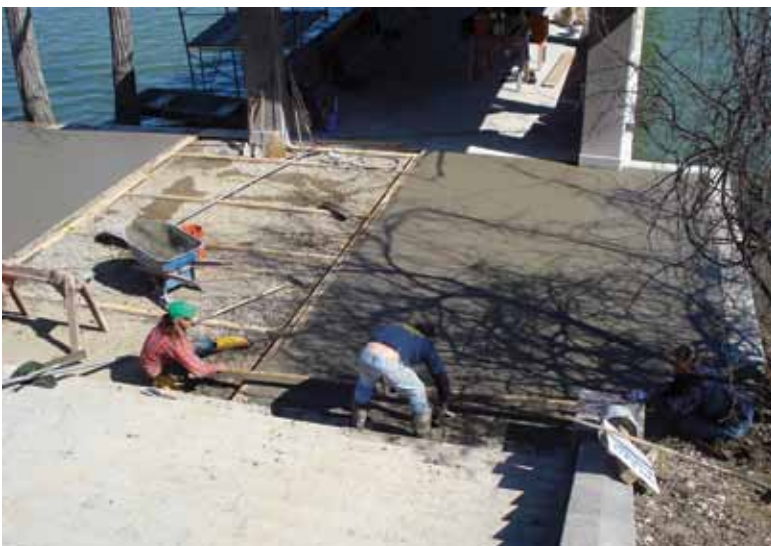
*Repairing the approach slab with new concrete*

Work resumed on the project in April 2009 with the goal of completing the project by the summer for the Quadricentennial celebration. The work now focused on repairing the superstructure. The approach slab was also replaced with new concrete and new sections of railings and chain were installed on the pier. The contractor then received approval from the engineers to replace the penetrating sealer with a spray-applied, polymer-modified cementitious waterproof coating to all concrete surfaces above and below the water line. This was chosen for its durability versus weathering and physical attack. The final finish and appearance of the waterproof coating had to be approved by the NYS DEC before the project could be completed.

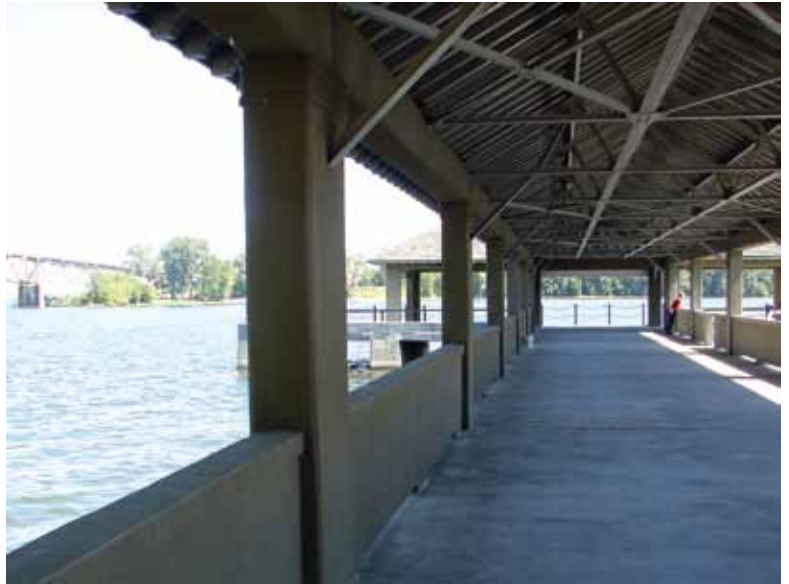
The finished pier, completed on time and on budget
