# FRP Repairs to Steam Tunnel

By Richard R. McGuire and William J. Gold

### MU Steam Tunnels

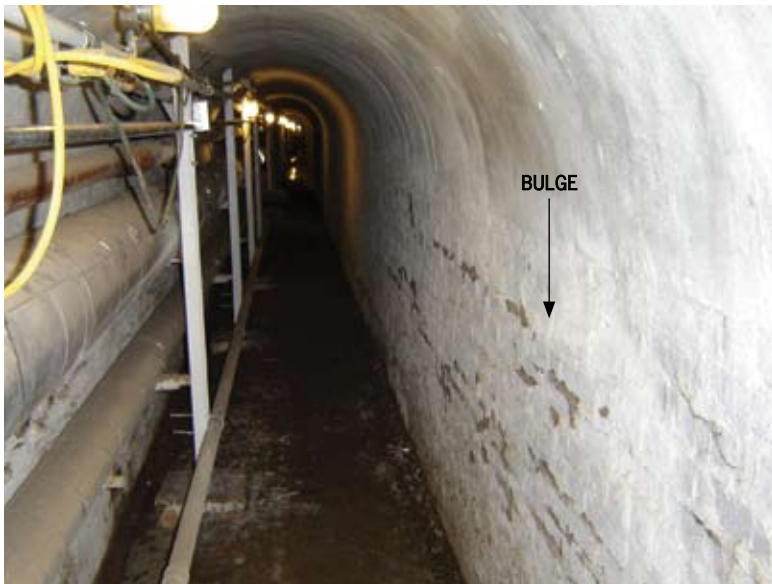
Fig. 1

The original campus area, known as the Quad, is served by very old brick-arch steam tunnels. It was in this area that a pronounced lateral bulge projecting inward was discovered on the multiwythe brick unreinforced masonry wall (URM) during field surveys of the study tunnels (refer to Fig. 1).

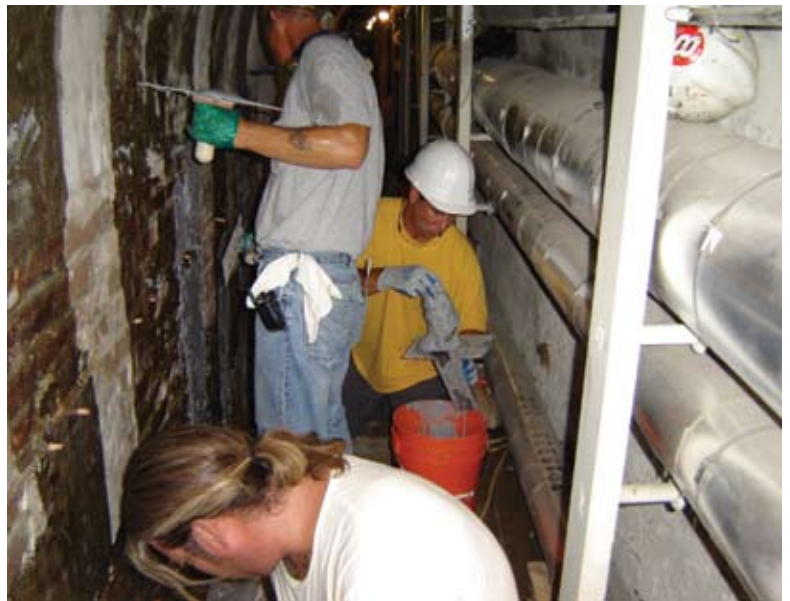
Fig. 6

In general, FRP systems installed to resist horizontal forces in walls function best when the bond surface is smooth and flat. Neither condition was the case with the tunnel walls. The mortar joints and variations in brick placement resulted in a very rough surface condition. This was addressed by using a paste epoxy filled with silica flour as a leveling material to provide a smooth bond surface. The greater challenge, however, was the fact that the tunnel wall was not a flat surface. The large permanent deflection in the tunnel wall created a severe surface undulation (refer to Fig. 6).

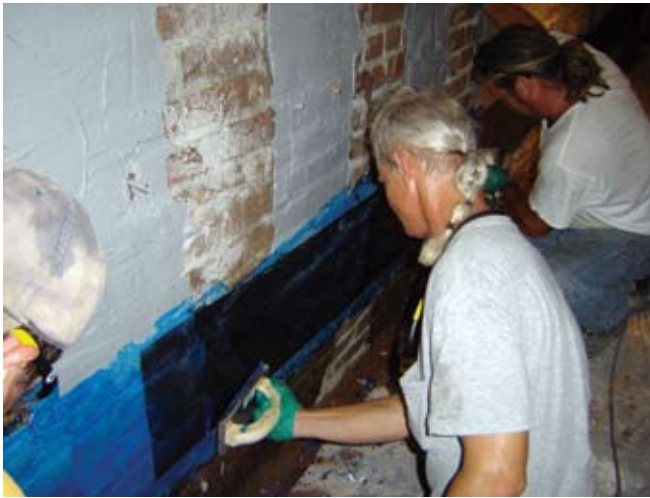
Fig. 7

Furthermore, it was determined that, to provide sufficient bond length for the FRP system, the FRP system would need to extend up onto the arched ceiling of the tunnel. These undulations in the surface result in very high out-of-plane or pull-off bond stresses in the FRP. To ensure that the FRP system would not debond in these high stress areas, strategically located mechanical anchors were also installed, that is, a belt-and-suspenders approach (refer to Fig. 7, 8, 9, and 10).
