BUCHANAN HOUSE PARKING STRUCTURE: REPAIR AND INSTALLATION OF POST-TENSIONING TENDONS

Buchanan House Parking Structure

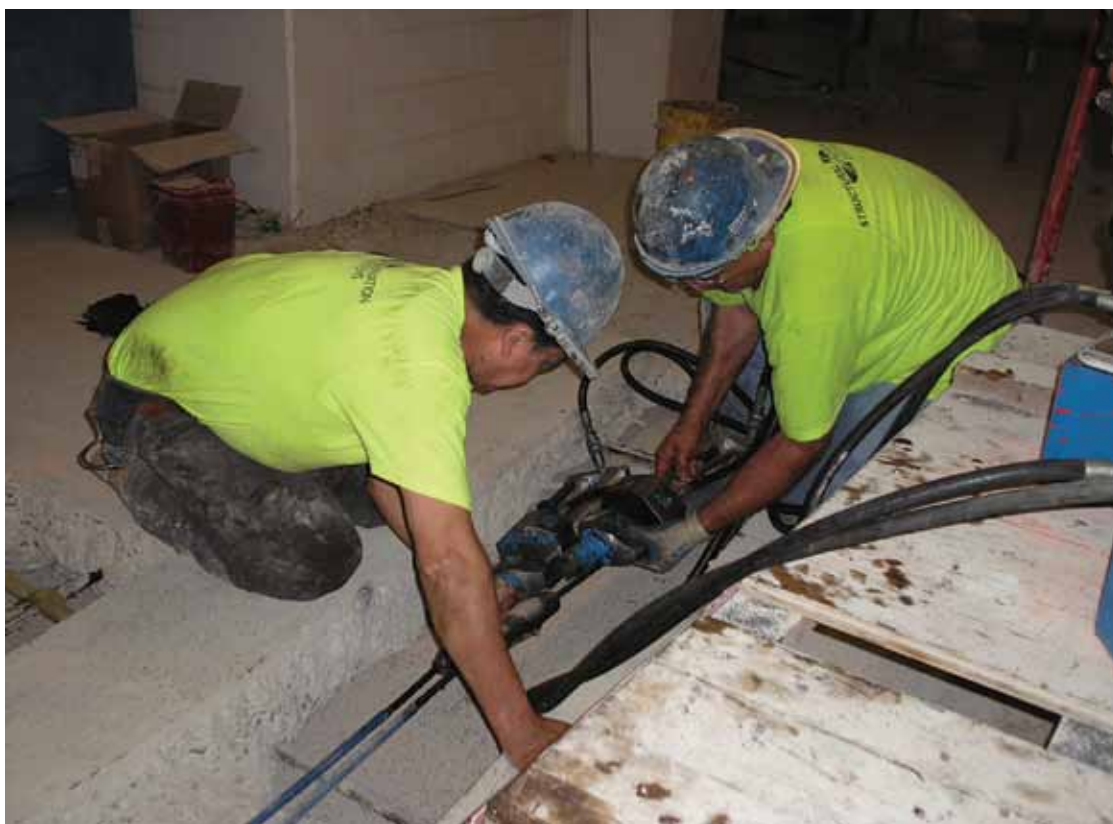
Stressing of post-tensioning cables

Overall, the repair contractor repaired 387 button-head post-tensioning tendons. To accomplish this, the repair contractor used a proprietary system from the post-tension system supplier that allowed the team to incorporate new monostrand post-tensioning materials without having to replace sections with a completely new button-head system.

This was a unique project because the repair contractor used monostrand and button-head post-tensioning together to regain the forces in the structure. By using the monostrand post-tensioning repair system, the team was able to reduce costs by requiring less labor on the project and decreasing the amount of concrete demolition needed to make the repairs. In addition to the post-tensioning repair, the repair contractor also performed partial and full-depth concrete repair, as well as soffit, wall, column, and beam repairs.

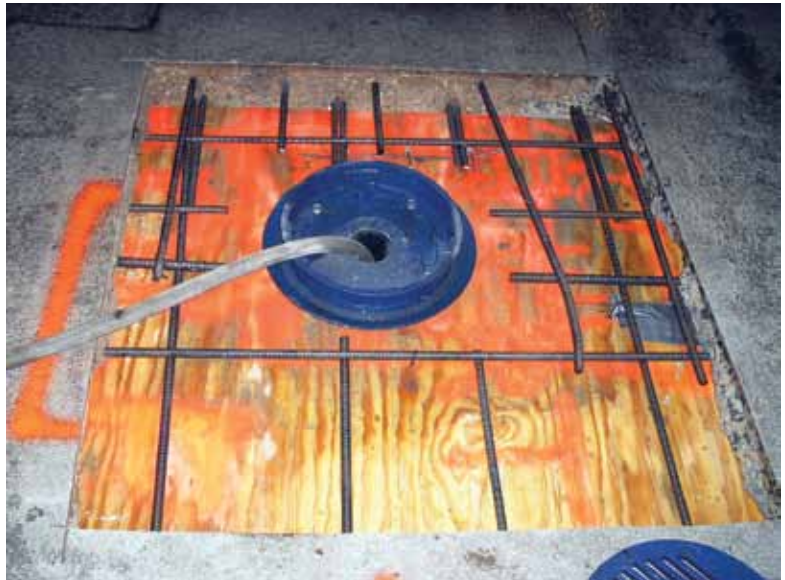
Full-depth hole for new drain installation

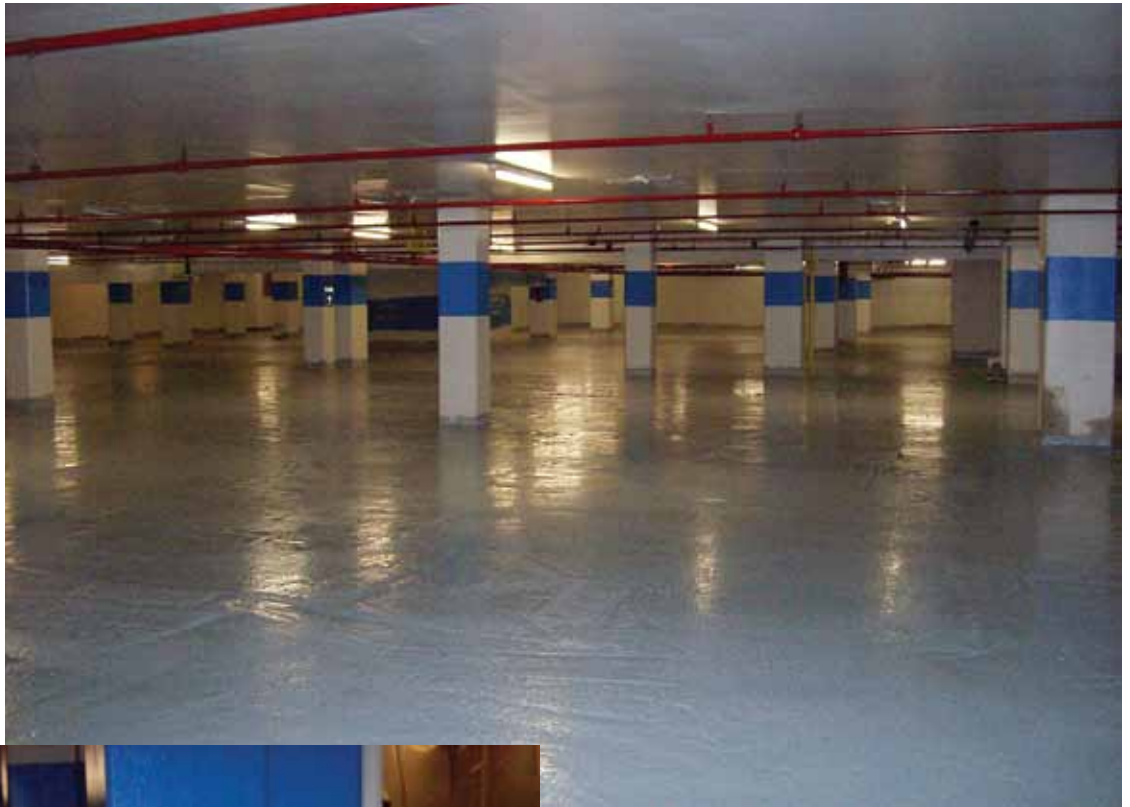
Installed base coat

In addition, a corrosion-inhibiting coating was applied to 300,000 ft² (27,870 m²) of the parking garage in two passes and a urethane coating system was

installed to 211,000 ft² (19,602 m²). These coatings will increase the service life of the structure.

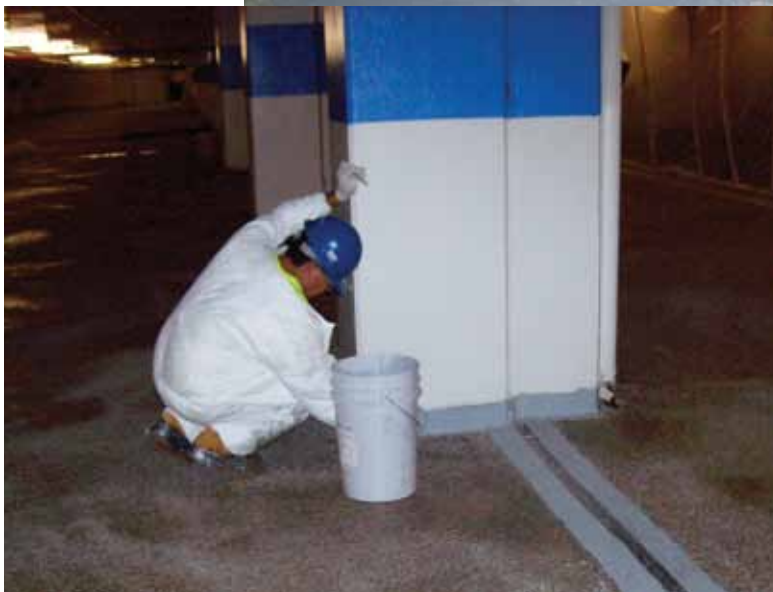
Installing coating detail on column
