REJUVENATING OUR AGING STRUCTURES: CUMBERLAND STREET PARKING GARAGE REHABILITATION

BY PHILIP SARVINIS

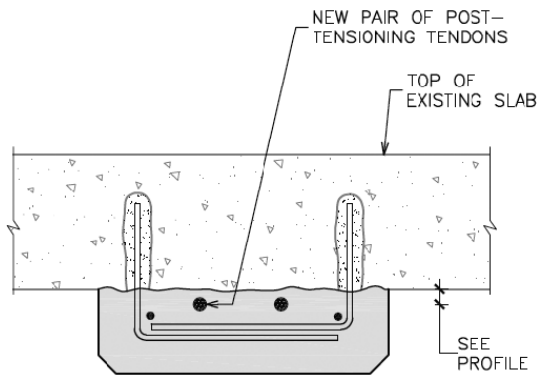
The exposed portion of the tendons below the existing slab were then encapsulated in reinforced concrete beams or ribs to provide the required slab-strand integration and overall fire protection to the system (refer to Fig. 12 and 13).
