NOBLESTOWN ROAD BRIDGE RESTORATION PROJECT

EDITED BY KELLY M. PAGE

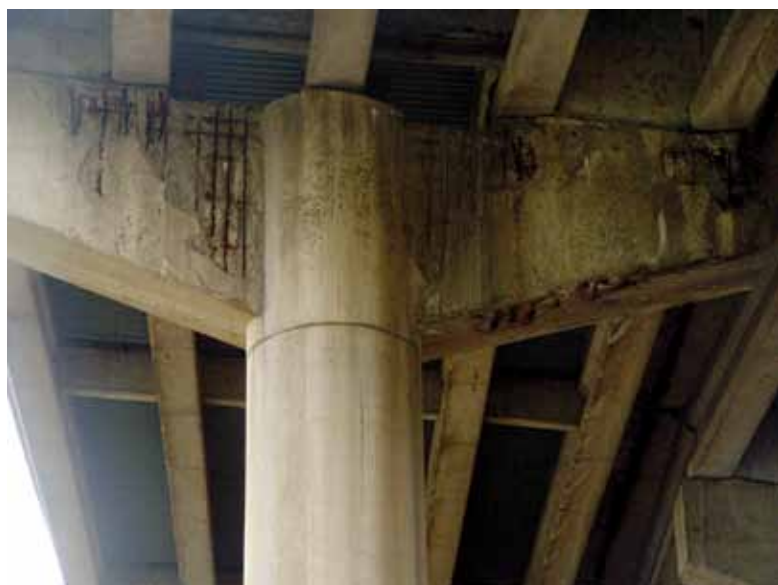
Mid-century bridge in need of repairs

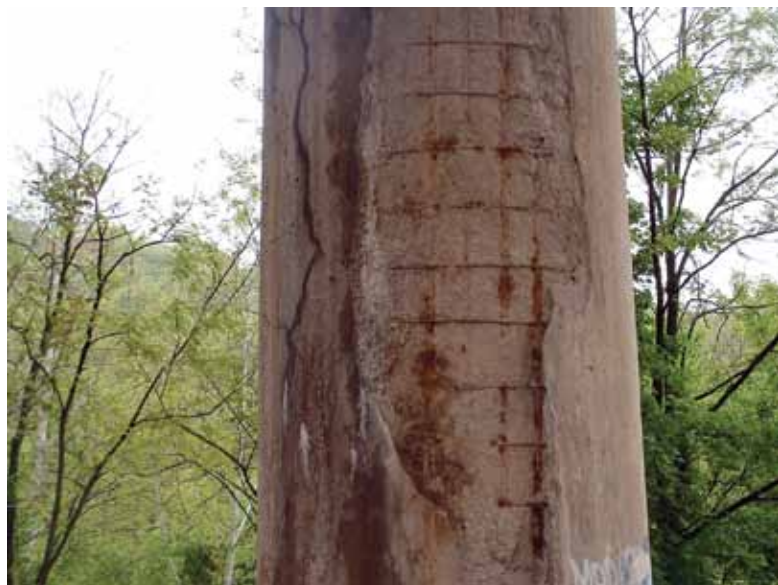
Bridge showed years of deterioration

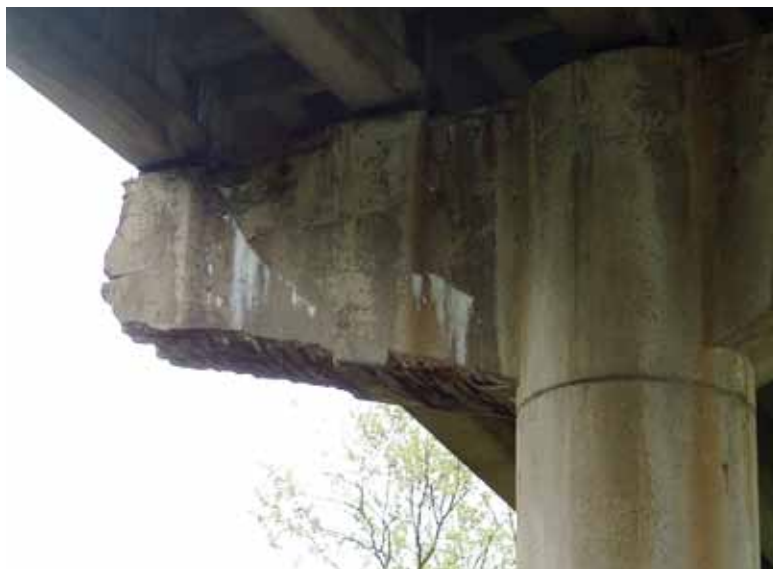
Before repairs, bridge showed major damage due to deterioration

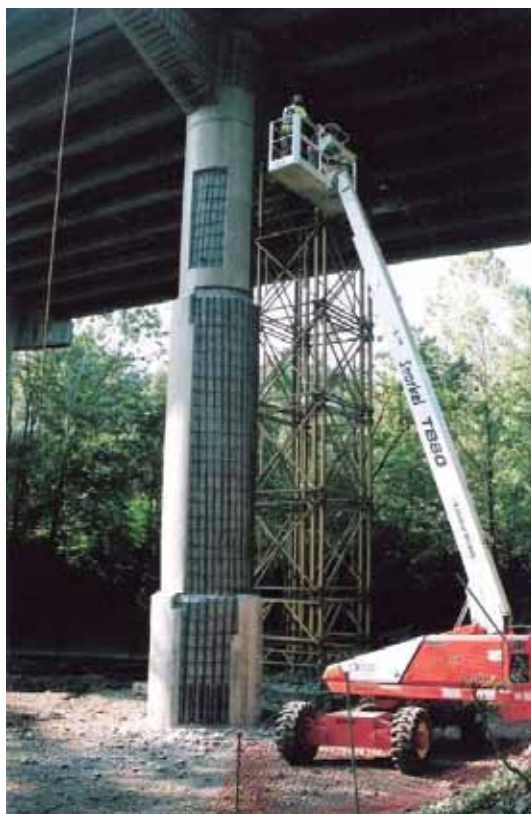
Bridge support ready for repair material

On this project, the shotcrete contractor was responsible for a number of tasks, including saw cutting the perimeter of the repair areas, tearing out the deteriorated concrete, and sandblasting the reinforcing bars. In addition, the shotcrete contractor added new reinforcing bars where needed, installed mesh, drilled and installed epoxy anchor bars, and concluded by placing shotcrete to restore the rounded concrete piers to their original contours.

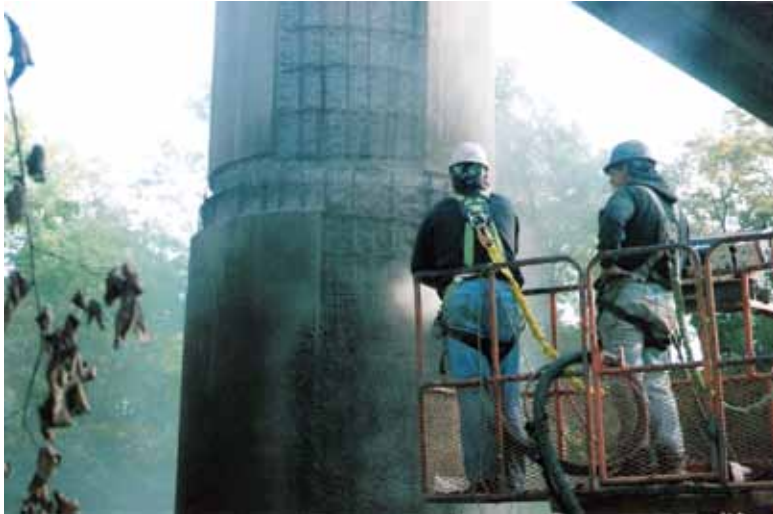
Shotcrete being applied to Noblestown Road Bridge

To rehabilitate the bridge, crews opted to use a dry-mix shotcrete process. Dry-process shotcrete is a very efficient method for making repairs to horizontal, vertical, and overhead surfaces. The process allows for the placement of the repair material at a very low water-cement ratio (w/c) with a high degree of compaction. The dry-mix process also allowed overhead and vertical areas to be shot to the full depth of the needed repair without using accelerators.

For this project, the premixed material was predampened with an auger-type predamper, and the shotcrete was shot with a rotary gunite machine. Both the auger-type predamper and the rotary gunite machine are continuous-feed devices. Once the premixed material was dampened, it was immediately conveyed into the gun and through the hose. Using this method also allowed the application to be as continuous as possible, although there were still a number of starts and stops given the nature of the job.

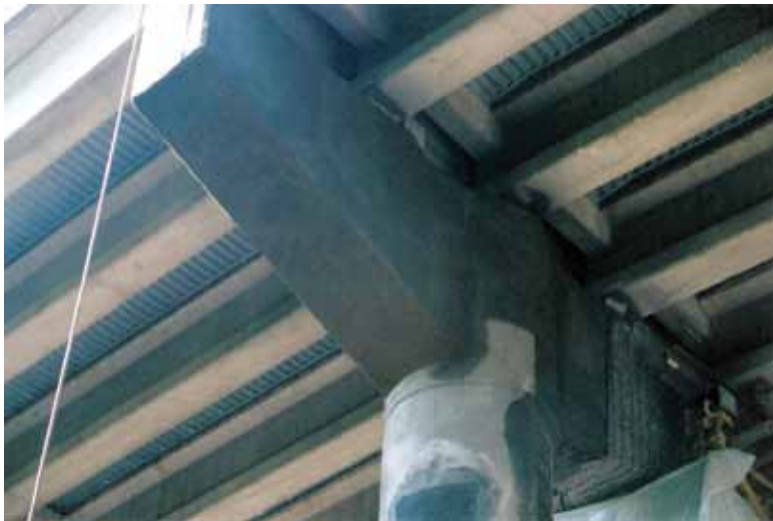
After shot of repair on bridge

As part of the repair process, the shotcrete contractor finished the piers with a gun or "flash finish" to give the concrete surface a lightly textured aesthetic.
