CHALLENGES AND SUCCESSSES AT THE KANSAS CITY MUNICIPAL AUDITORIUM

BY LURITA MCINTOSH BLANK AND DAVID T. FORD

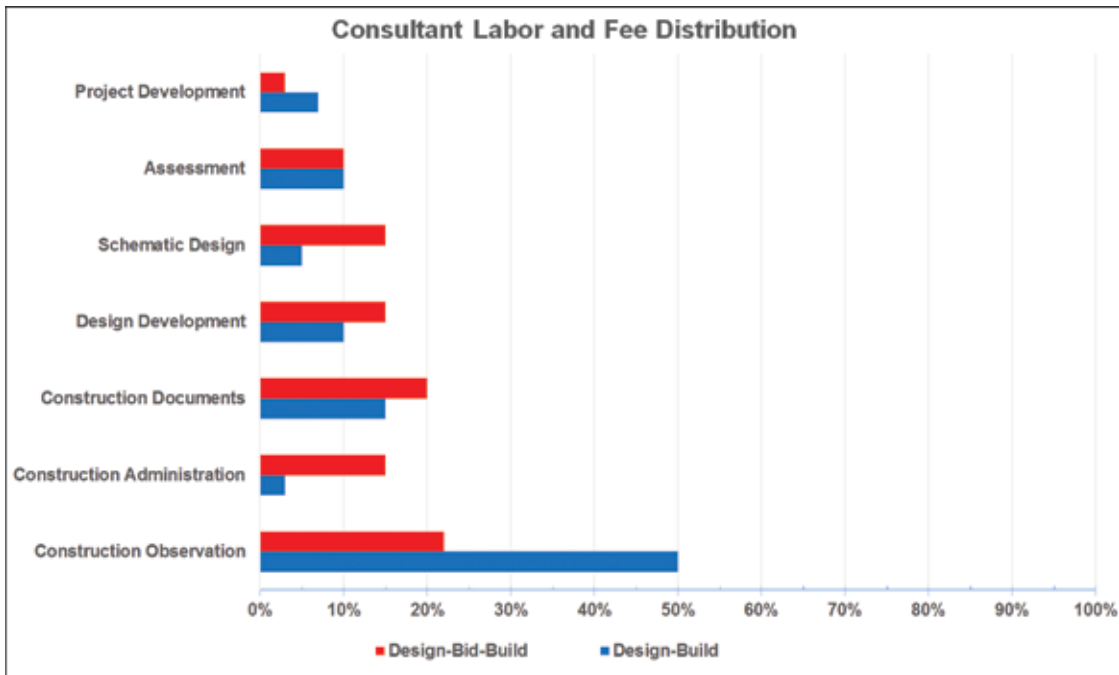
Fig. 2: Comparative breakdown of labor and fee allocation between design-bid-build and design-build

Aside from developing the technical scope, which benefited immensely from this collaboration, the difference in allocation of fee and effort between design-build and design-bid-build is perhaps the strongest argument in favor of design-build for restoration work (Fig. 2). From the consultant’s perspective, the highest value of their contribution to a project is provided in the design and construction observation. Because of the collaborative nature of design-build and no need to produce conservative bidding documents, developing the technical aspects of the project is far more efficient. Additionally, the design-build leader takes on responsibility for the majority of the project management and construction administration, reducing duplication of effort in these activities which would normally be provided concurrently but separately by the consultant and the general contractor. As a result, the consultant can rebalance fee and labor into higher-value efforts—specifically, construction observation. Quality of craftsmanship is critical for masonry restoration work, and when the consultant can dedicate more effort to this aspect, the overall project benefits exponentially, particularly for design-build, which eliminates much of the some-

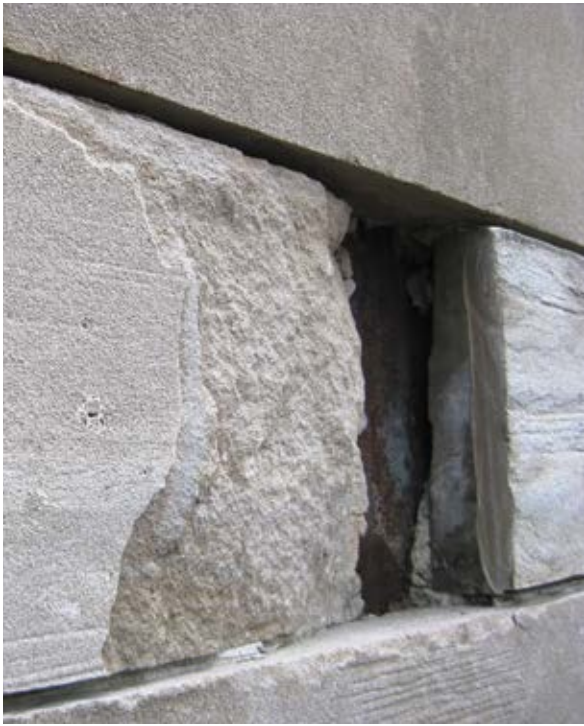
Fig. 4: Corrosion of a structural steel column that resulted in damage to the stone veneer. Note that steel is directly behind with veneer with no protection from moisture

Much of the required masonry repairs were related to deterioration of internal steel cramps and stone anchors. Spalling and crack repair were the most common repairs, and shot-sawn limestone surface repairs required an artistic eye from the masons. In addition to cracks and spalls, a number of overhead hazards were identified at the parapets, where coping and fascia stones had moved out of plane. Due to the movement, the stone anchors failed at the back of the panels, and the units needed to be re-anchored to the backup.

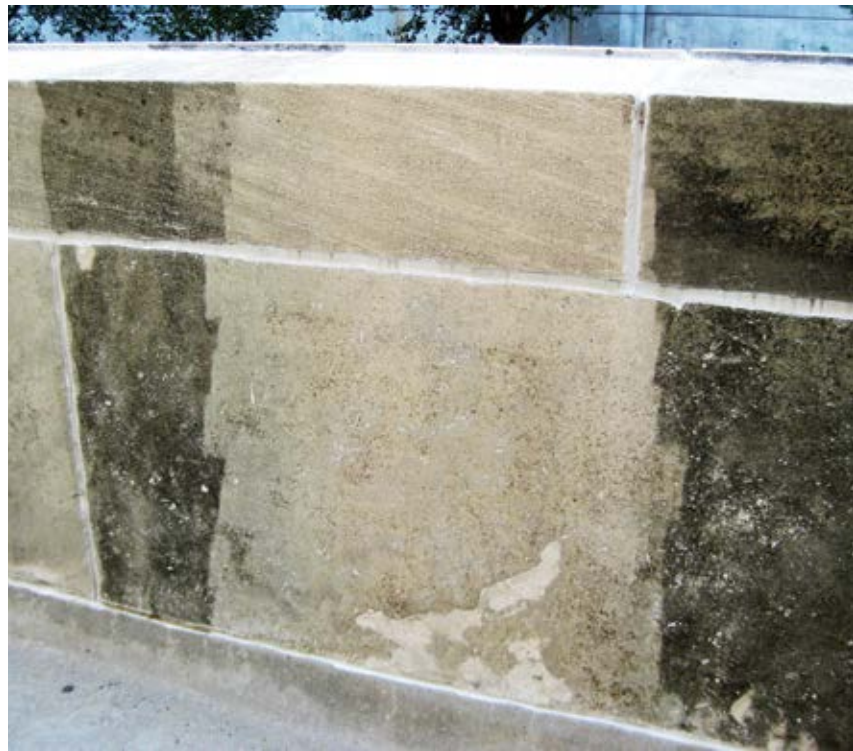
Fig. 5: Successful cleaning mockup, showing level of heavy soiling removed

Cleaning and weatherproofing the façades were the primary targets of the client. Decades of atmospheric soiling, likely composed of tenaciously adhered hydrocarbon pollutants, proved difficult to remove without resorting to overly aggressive cleaners, while the biological soiling was more easily treated. Through a long mockup process, a level of acceptable clean was established using a two-step biocide and detergent cleaner that did not damage the limestone surface (Fig. 5). During the

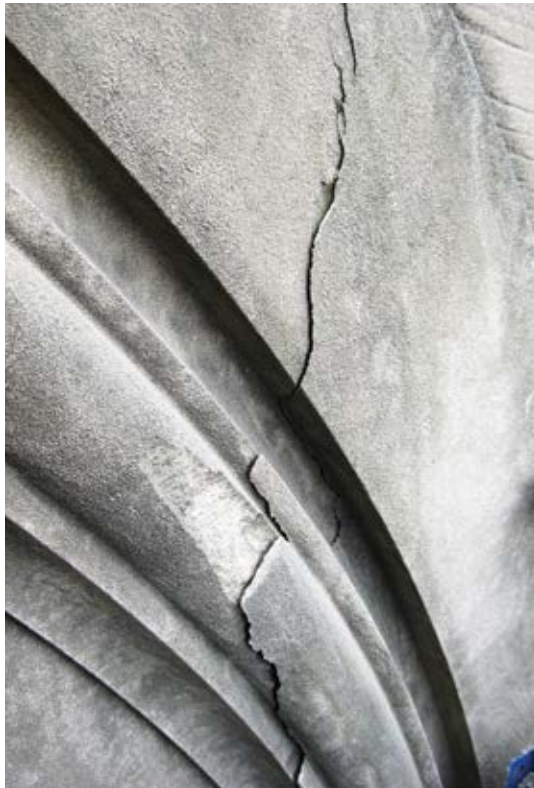
Damage and displacement of stone units was also observed at several of the sculptural panels. “Drama,” at the center of the North Elevation, directly over the main entry marquee, exhibited the worst distress with localized shattering of two perimeter units (Fig. 6). Because repair strategies had been developed during the proposal phase, products and methods already on hand were able to be employed for these somewhat on-the-fly repairs. The units were stabilized with a combination of pinning in place, installing repair materials, and grout injection.

Fig. 6: Severe damage to perimeter unit on right side of “Drama”
