# GUIDE FOR EVALUATION AND REPAIR OF UNBONDED POST-TENSIONED CONCRETE STRUCTURES

This new Guideline, PTI DC80.3-12/ICRI 320.6, "Guide for Evaluation and Repair of Unbonded Post-Tensioned Concrete Structures," is comprised of five sections:

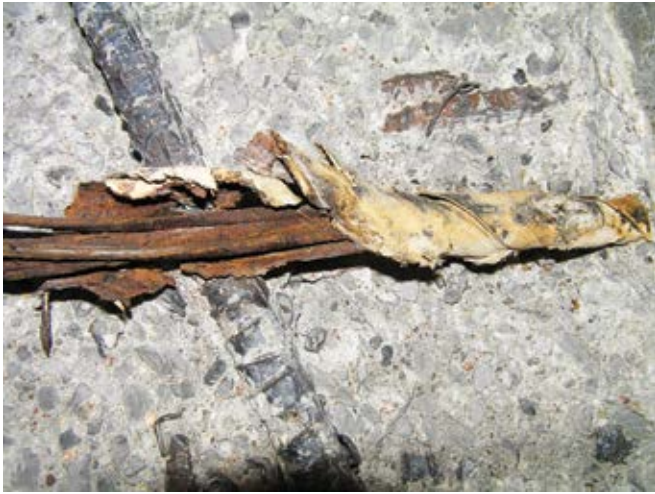
Fig. 1: Paper-wrapped tendon with corrosion deposits

Outlines of detailed protocols for the evaluation of PT systems are contained in Section 3. It begins by discussing the characteristics of PT concrete systems and the corrosion performance of paper-wrapped systems (Fig. 1), heat-sealed systems (Fig. 2), and button-headed wire tendons.

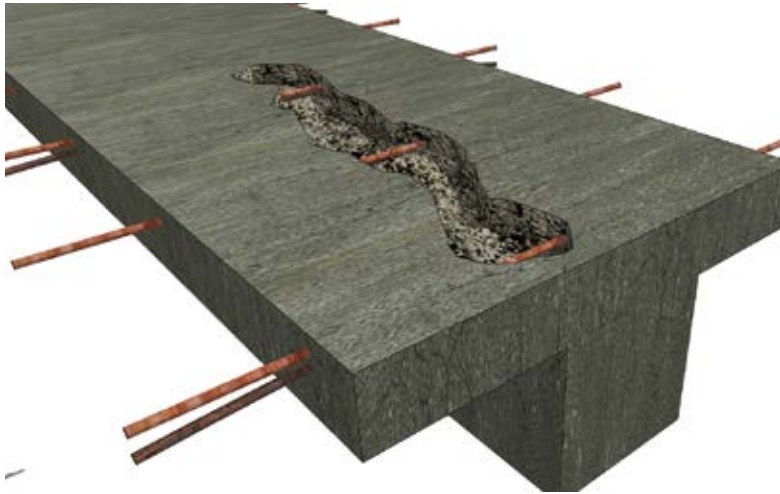
Fig. 3: Schematic view of concrete spalls in a PT slab

- Documenting the size, location, and depth of spalling and scaling on floor surfaces (Fig. 3), beams, columns, and ceilings;
- Recording cracks, crack patterns, types, widths, and lengths;
- Documenting the location and condition of the expansion and construction joint systems;
- Determining the location and condition of drains;
- Locations of exploratory openings; and
- Locations for material testing, including the locations for nondestructive evaluations.

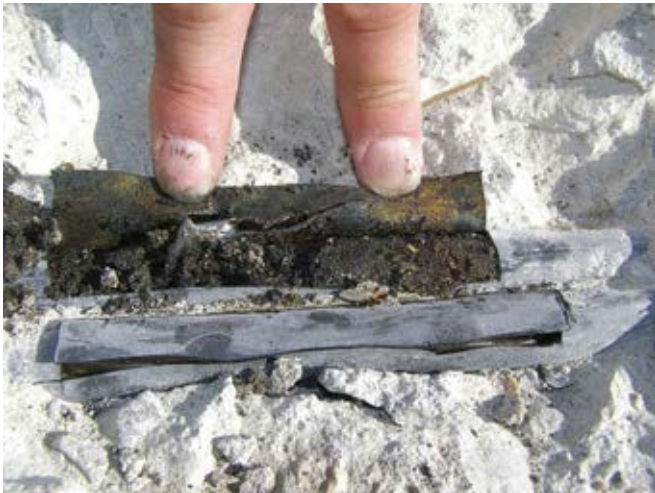
Fig. 2: Exposed strand with severe corrosion and wire section loss for a push-through system

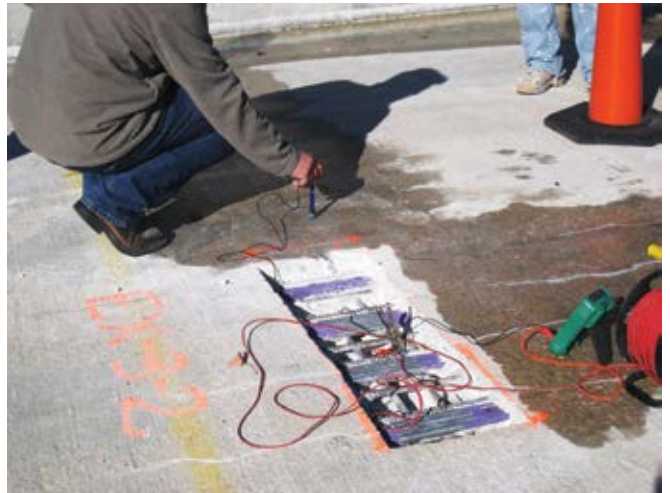
Fig. 4: Corrosion potential testing of mild reinforcement in the vicinity of PT tendons

- Rebound hammer
- Corrosion potential testing (Fig. 4)
- Acoustic monitoring

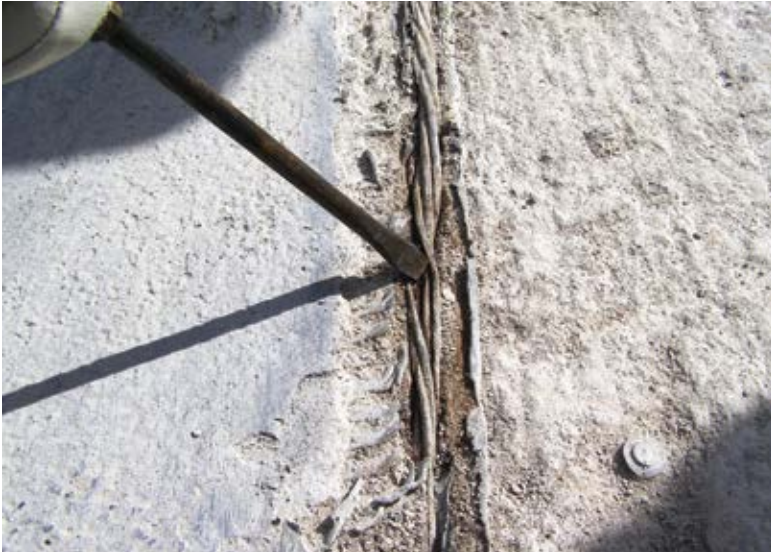
Fig. 5: Overview of screwdriver penetration test

- Screwdriver penetration test (Fig. 5)
- In-place strand tension test
- High-point/low-point inspections (Fig. 6)
- Anchor inspection
- Lift-off testing
- Strand extraction
- Grease inspection and testing
- Borescope (Fig. 7)
- Core sampling
- Load test

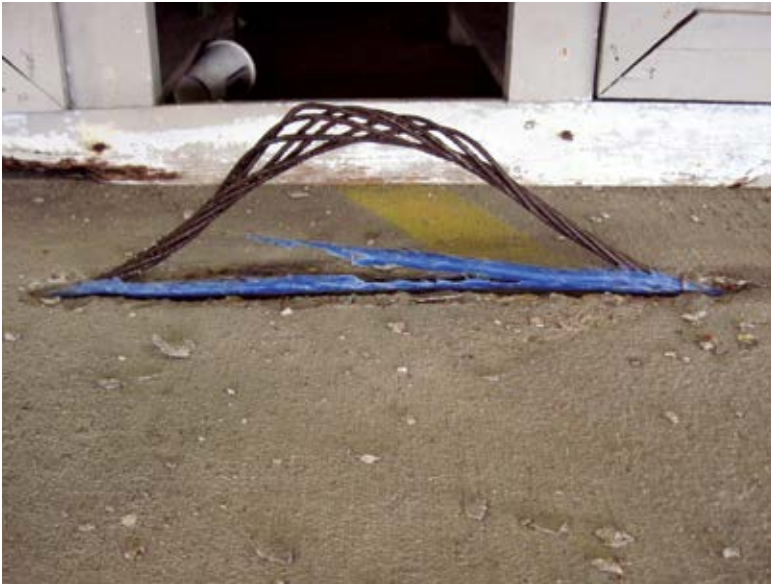
Fig. 6: Post-tensioning tendon failure due to corrosion at high point
