Strengthening Highway Bridges with CFRP Composites

By Tarek Alkhrdaji

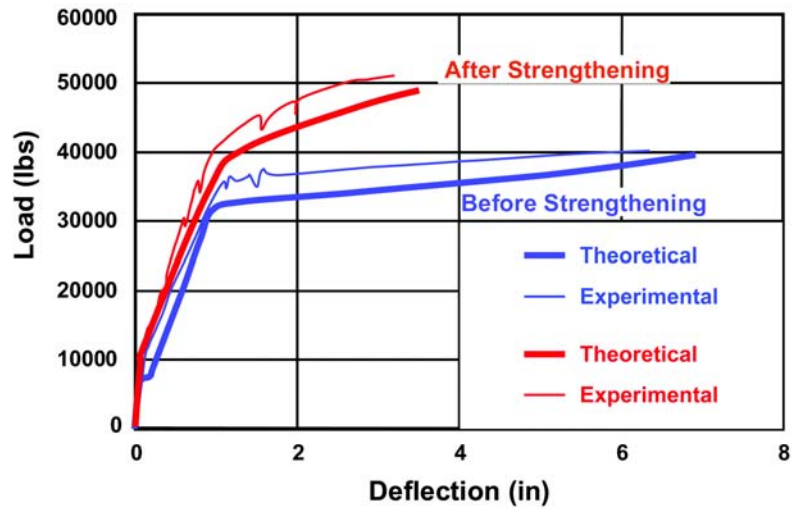
Figure 1: Experimental results of test beams

Since Bridge G270 had to remain in service, testing to verify capacity improvement was not an option. Instead, test beams were built to mimic the existing bridge dimensions and reinforcement. The beams were constructed at a length of 20 ft and a depth of 18.5 in. to replicate a strip of the bridge. A width of 15 in. was chosen to provide an adequate surface area for the application of FRP. Test beams were constructed with 1.5 in.² of tension steel and a concrete strength of 5770 psi. The objective of this test was to produce an increase in moment capacity equal in percentage to that required in the field.

Two beams were built for laboratory testing. For a baseline, one beam was without strengthening. The second beam was strengthened using one ply of carbon fiber-reinforced polymer (CFRP), 12 in. wide. The design of externally bonded FRP strengthening was achieved using CFRP reinforcement that has a design strength of 550 ksi, a modulus of 33,000 ksi, an ultimate strain at failure of 0.017 in./in., and a thickness of 0.0065 in. The load-deflection curves, shown in Figure 1, demonstrate the good agreement between the theoretical and experimental results. The curves also show that the design methodology used that was based on strain compatibility, force equilibrium, and laws of the constituent material, was effective in predicting the strength and failure modes of the beams. The failure modes, as predicted, were the yielding of steel reinforcement, followed by the crushing of the concrete (unstrengthened) or the rupture of the CFRP (strengthened).

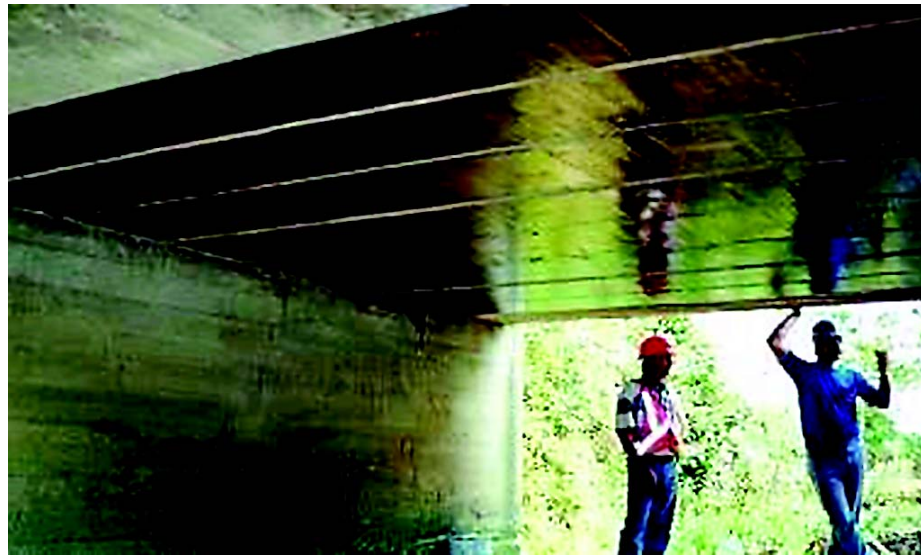
Figure 2: CFRP reinforcement bonded to the underside of Bridge G270

wide, bonded to the bottom side of the slab using the wet lay-up process. The wet lay-up systems were saturated and cured in place, and therefore, were analogous to cast-in-place concrete. A saturating resin, along with the compatible primer, was used to bond the FRP sheets to the concrete surface (Figure 2). The strengthening process was rapid with no interruption to traffic flow, and the entire process was completed in two days.

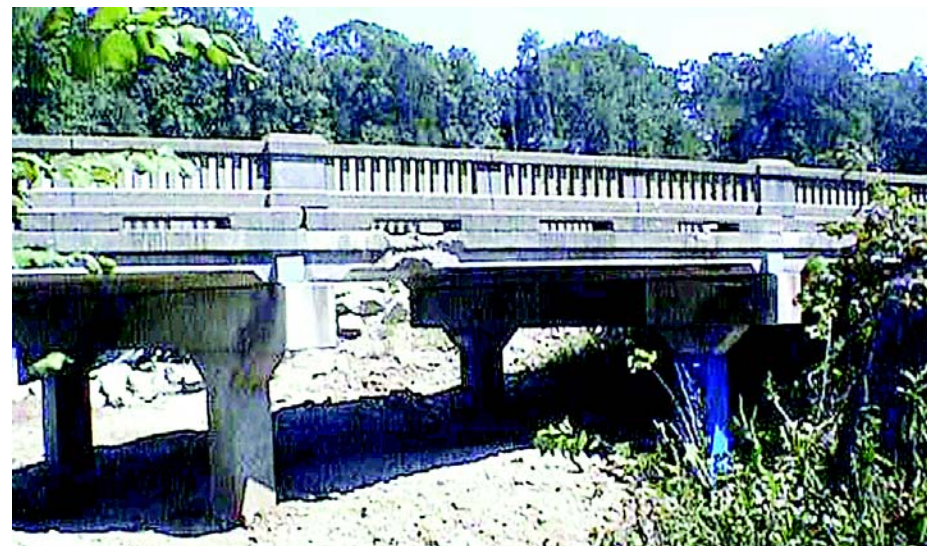
Figure 3: Bridge J857

The main objective of the Bridge J857 testing program was to investigate the effects of different strengthening techniques on the structural performance, ultimate capacity, and mode of failure of the bridge spans. The bridge was located on Route 72 in Phelps County, MO, as shown in Figure 3. Due to the realignment of Route 72, the bridge was decommissioned in December 1998 and scheduled for demolition. The bridge was built in the 1930s

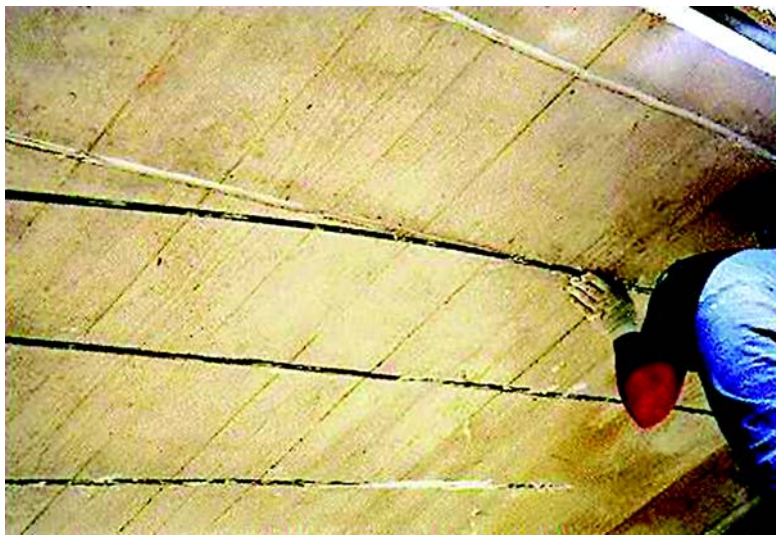
Figure 4: Strengthening of Bridge J857 spans

(a) Installing CFRP rods

Two of the three spans of the bridge were strengthened to the same level of nominal flexural capacity. Two FRP systems were used in strengthening the deck slabs: externally bonded FRP sheets, and near-surface mounted (NSM) FRP rods, as shown in Figure 4. The latter consists of FRP bars embedded in premade grooves and bonded in place with an epoxy-based paste. The NSM reinforcement used in this project consisted of CFRP rods with surfaces roughened by sandblasting. From a design point of view, a 29% increase in the nominal moment capacity would have been sufficient to upgrade the bridge decks to carry an HS20-modified truck loading. This level of strengthening would also provide a clear differentiation between performance of the strengthened and unstrengthened spans. Based on this approach, the design of externally bonded sheets called for eight 20-in. wide, single-ply CFRP strips bonded on the deck soffit using the wet lay-up procedure. Similarly, the required number of NSM rods of reinforcement was 20 rods, spaced at 15 in. on centers. The rods were embedded in 20 ft-long grooves cut into the soffit of the bridge deck parallel to its longitudinal axis.

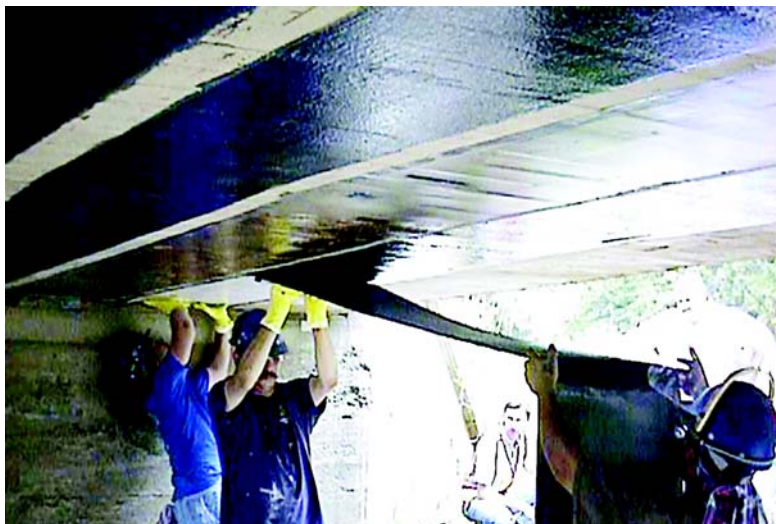
(b) Installing CFRP sheets

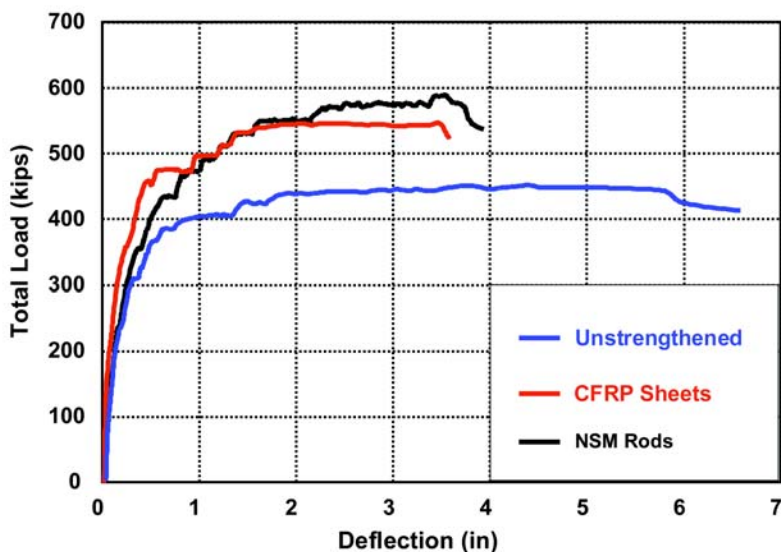
Figure 5: Full-scale testing results for Bridge J857

114.6 kips-ft for the unstrengthened span. For all three spans, the experimental values exceeded the theoretical predictions. Figure 5 shows the load-deflection curves for the three spans.

Comparing the performance of unstrengthened decks, the increase in the moment capacity for decks strengthened with CFRP sheets and NSM CFRP rods was 17 and 27%, respectively. However, test results indicate that the measured ultimate capacity of the unstrengthened deck is about 46% higher than initial prediction. Testing of concrete cores and steel coupons indicated that the actual concrete strength was 8147 psi compared to 2300 psi from the initial assumption, whereas for steel, the actual yield strength was 43,333 ksi compared to 30,000 ksi from the initial assumptions. Hence, the lower-than-anticipated percentage increase in the ultimate capacity was related to the higher actual strength of the original deck.

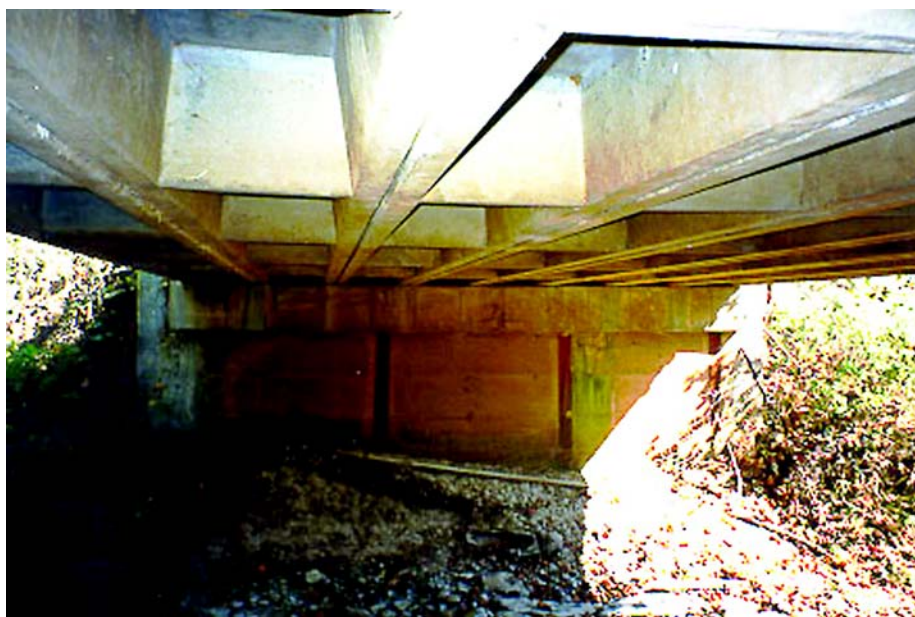
Figure 6: The underside of Coats Lane Bridge

Three bridges (Brown School Road Bridge, Creasy Springs Bridge, and Coats Lane Bridge) were constructed between 1970 and 1976. Each bridge consists of a single-span, simply supported deck with precast reinforced concrete (RC) channel sections, with a 4 in.-thick slab that runs the entire span of the bridge. Each channel has RC diaphragms spaced at 6 ft-3 in. that connect the two stems. The precast channels are tied together through the stems with 1 in.-diameter steel bolts and fasteners for composite action. In 1986, the lanes of Brown School Road Bridge were widened with two 18 in.-thick and 50 in.-wide RC slabs, one on each side of the deck. The edge slabs were designed for HS20 truck loading. The Creasy Springs and Brown School Road bridges are located on roads with a high traffic count. The Coats Lane Bridge is located on a gravel county road. Figure 6 shows a typical underside seen on these bridges. The three bridges were designed according to the standards of the American Association of State Highway and Transportation Officials (AASHTO). All bridges were evaluated in 1979, and a 15-ton load limit was determined based on load-posting criteria used at that time and based on the available information.

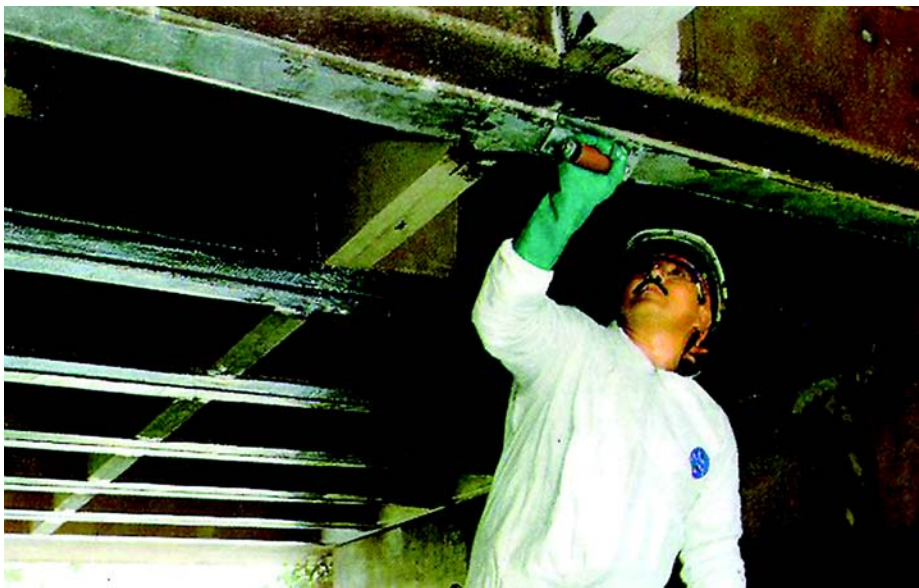
Figure 8: Application of CFRP strengthening

The design of externally bonded FRP strengthening was achieved using the same CFRP reinforcement. A typical CFRP layout is shown in Figure 7. The CFRP strengthening system was applied using the wet lay-up procedure, as shown in Figure 8. Figure 9 shows the Coats Lane Bridge before and after strengthening with CFRP.

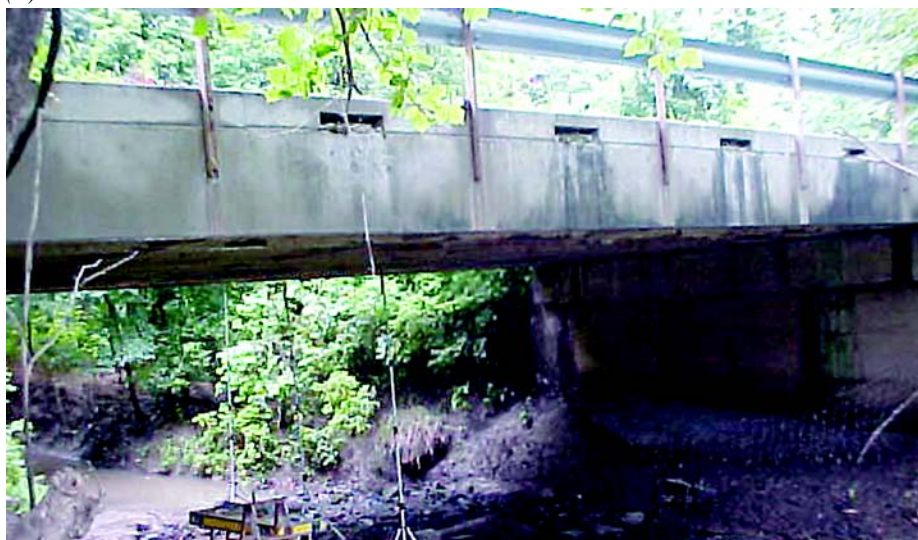
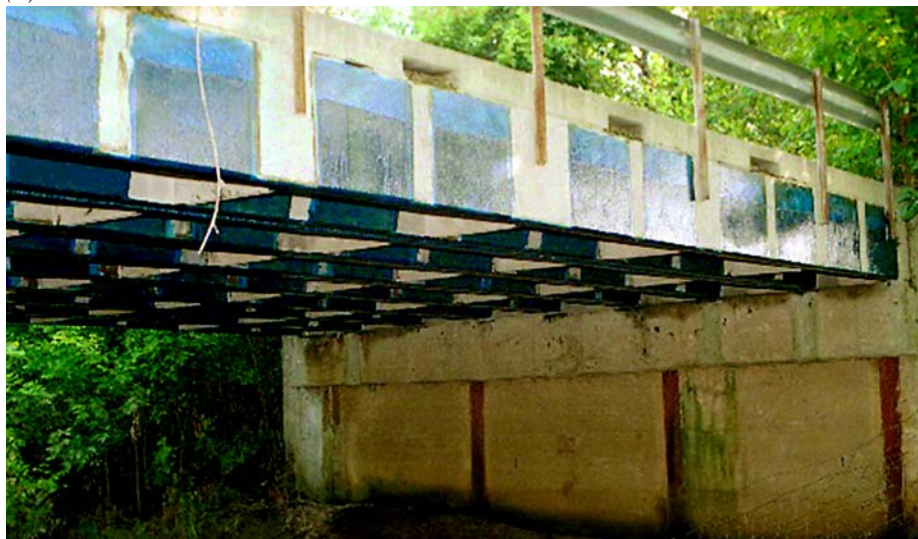
Figure 9: Coats Lane Bridge before (a) and after (b) strengthening

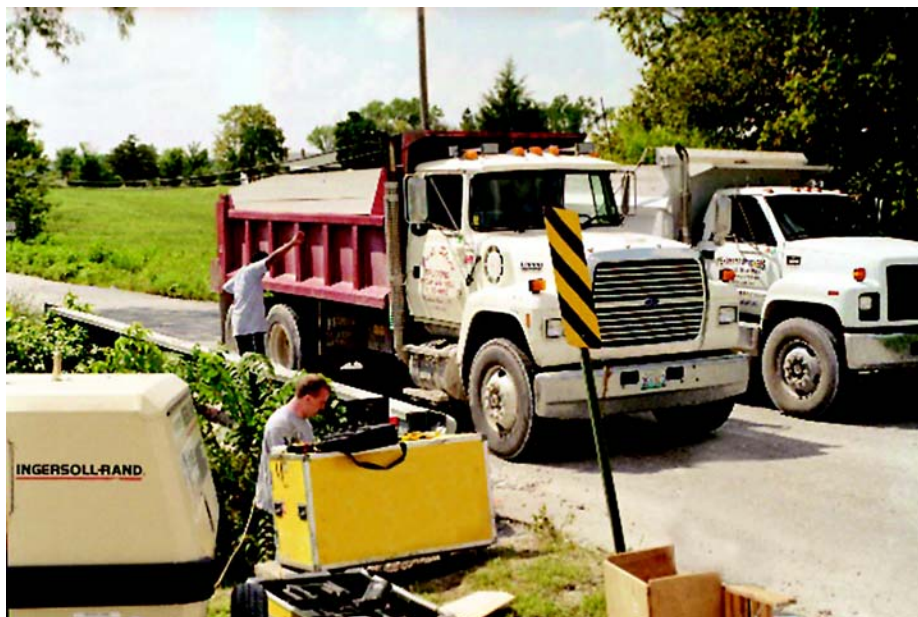
Figure 10: Bridge in-situ load testing

Four load tests (two tests per bridge) were performed on the Coats Lane Bridge and the Brown School Bridge to assess their performance before and after strengthening. The objective of the load tests was to investigate the performance of the strengthened bridges to allow for load posting removal. The load test did not seek to evaluate the safety or the ultimate load-carrying capacity of the entire structure. The in-situ load testing procedure involved applying vehicular loading to the bridges using two H20 trucks, as shown in Figure 10. The response of each bridge was monitored during the test and used to evaluate its performance. The effect of impact was not physically examined during the load testing.

Each of the four load tests was performed in a similar manner. The Linear Variable Differential Transducers (LVDTs) were installed to measure the horizontal strain at the midspan of three channel-members. In addition, three LVDTs were placed at three locations on the midspan (one lane only) to measure vertical displacements. Result comparisons presented in the following are based on live-load effects only. In-situ testing clearly indicates the improved deflection behavior due to FRP strengthening, with smaller deflections measured after CFRP strengthening. In addition, the measured strains indicated that, for the same load level, the internal stresses in the original member have been reduced from those before strengthening, thus increasing their load-carrying capacity.
