Strengthening of an Impact-Damaged PC Girder

By Antonio Nanni, PhD, PE

The objective of this project was to restore the original ultimate flexural capacity of an accidentally impact-damaged PC girder of Bridge A5657 located on Route 28 over the Gasconade River, south of Dixon, Missouri. Two prestressing tendons in the central girder of the north span of the bridge were fractured due to the impact.

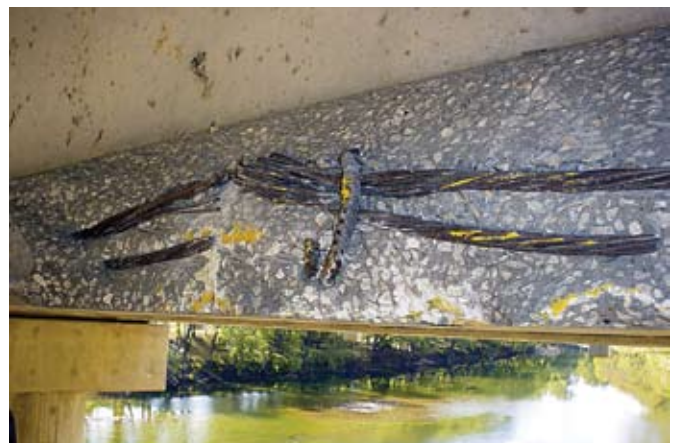
Impact-damaged PC girder of Bridge A5657

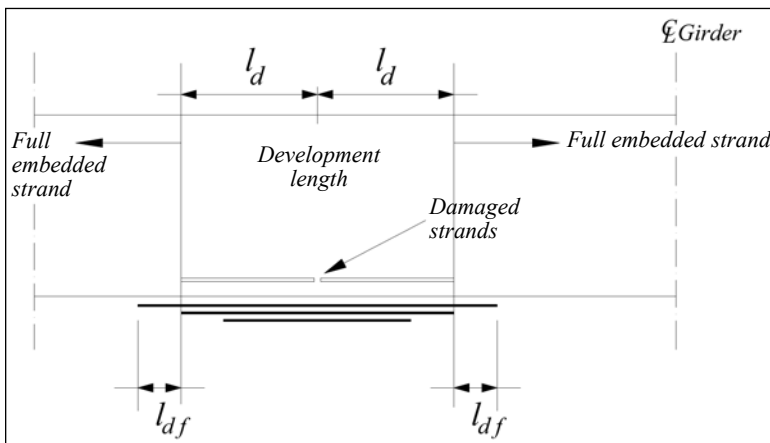
Fig. 4: Strand and FRP development length

FRP reinforcement was no longer needed at the cross section where the damaged strands again become fully effective. For the damaged strands, it is reasonable to assume a linear transition between the point of zero stress and full prestress transfer over their development length. The development length l_d is expressed as follows (refer to Fig. 4 and ACI 318-99)

where d_b is the strand diameter (in inches), f_{ps} is the stress in the prestressed reinforcement at nominal strength of member (in ksi), and f_{se} represents the effective stress in the prestressed steel after losses (in ksi). In turn, f_{ps} and f_{se} computed according to ACI 318-99 become equal to $f_{ps} = 253$ ksi (1744 MPa). From Eq. (4), the development length for the strand can be calculated equal to 5.5 ft (1.70 m).

The length of the first and longest FRP ply was then set equal to 12 ft (3.65 m), which corresponds to 11 ft (3.35 m) necessary to account for the tendons' development length plus 1 ft (0.3 m), corresponding to 6 in. (15 cm) at each end, deemed necessary for the FRP development length suggested by ACI 440.2R-02. The remaining two plies were set to have lengths of 11 and 10 ft (3.35 and 3.0 m).

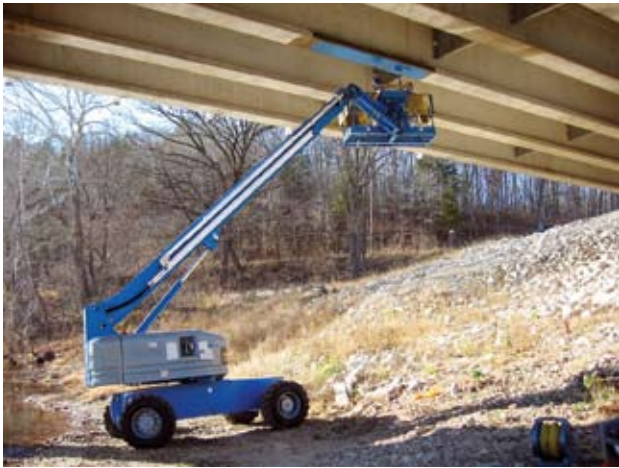
Application of primer

- **Application of primer:** A layer of epoxy-based primer is applied to the prepared concrete surface using a short nap roller to penetrate the concrete pores and to provide an improved substrate for the saturant;

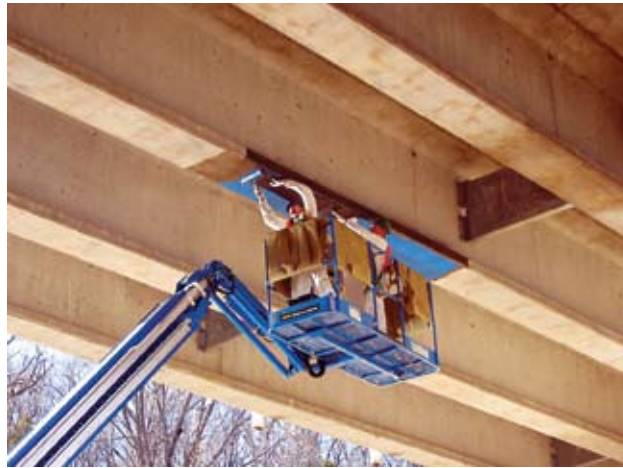
Application of first fiber sheet

- **Application of fiber sheet:** After the fiber sheet is measured and pre-cut, it is placed on the concrete surface and gently pressed into the saturant. Prior to removing the backing paper, a trowel is used to remove any air void. After the backing paper is removed, a ribbed roller is rolled in the fiber direction to facilitate impregnation by separating the fibers; and

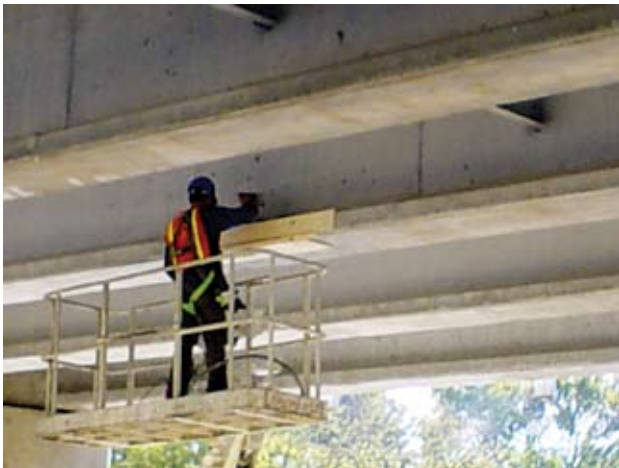
Patching

Before carrying out the CFRP laminate installation, the damaged area of the girder was restored with a rapid-setting, no-shrinkage, cementitious mortar. The sequential installation procedure was as follows:

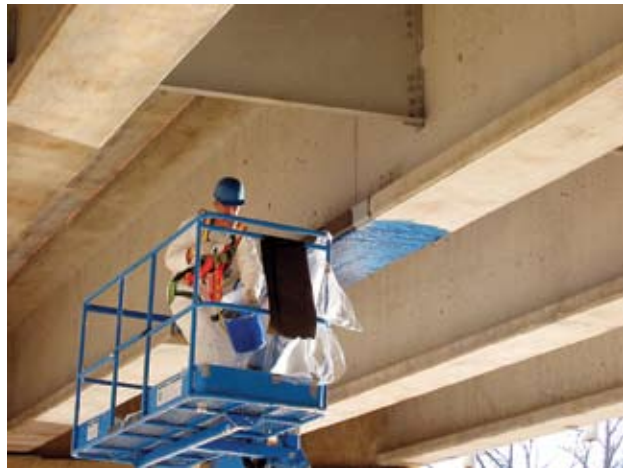
Application of second fiber sheet

- **Application of second layer of saturant:** A second layer of saturant is applied and worked into the fibers with a ribbed roller. After this, the second and third fiber sheet can be installed by repeating the described procedure.

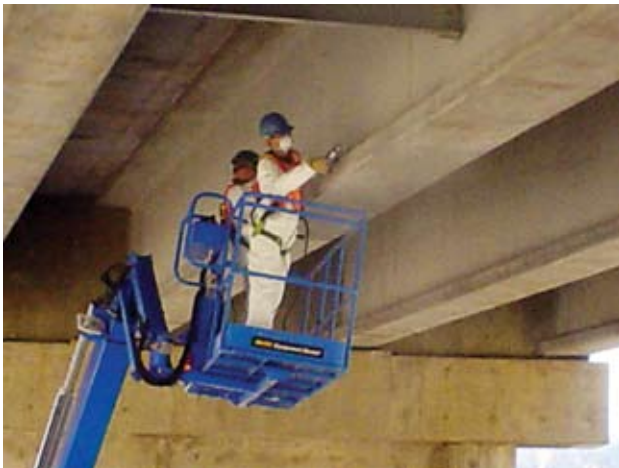
Surface preparation

- **Surface preparation:** The bottom edges of the girder are rounded for proper wrapping and the concrete surface is sandblasted until the aggregate is exposed and the surface of the concrete is free of loose and unsound materials;

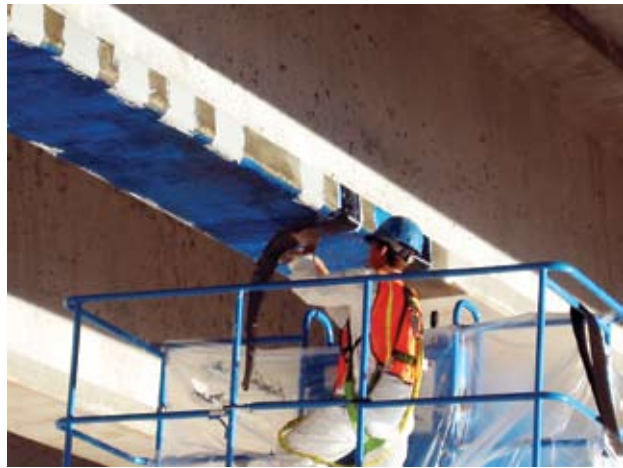
Application of U-wraps

around the bulb of the girder over the previous installation (refer to Fig. 3(b)). The purpose of the U-wrap is to prevent delamination of the FRP plies applied to the bottom surface of the girder.
