# Innovative Corrosion Evaluation System for Unbonded Post-Tensioned Cables

By Garth Fallis, J. Christopher Ball, and Andrew Moad

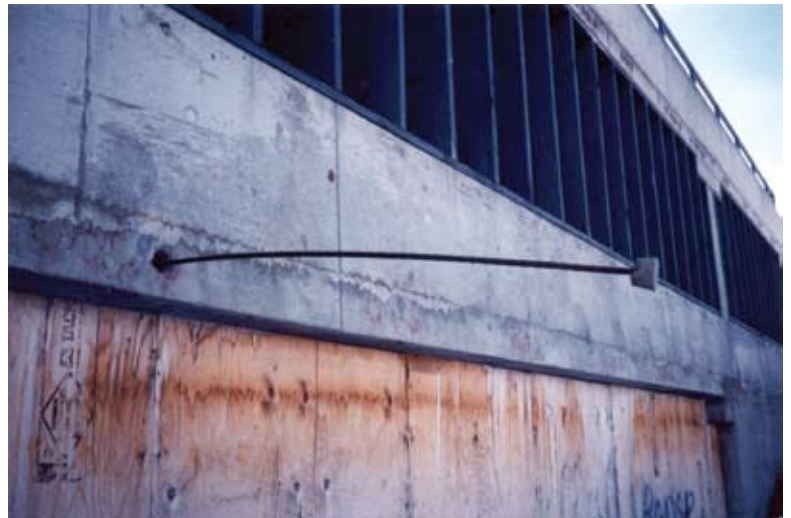
*Post-tensioned tendon anchor and grout pocket protruding from parking garage façade after failure*

Broken strands or entire tendons have been found during the investigation of many of the

older types of unbonded post-tensioned structures. As the tendons are integral structural members, the loss of strands and tendons can significantly affect the structural capacity of the structure.

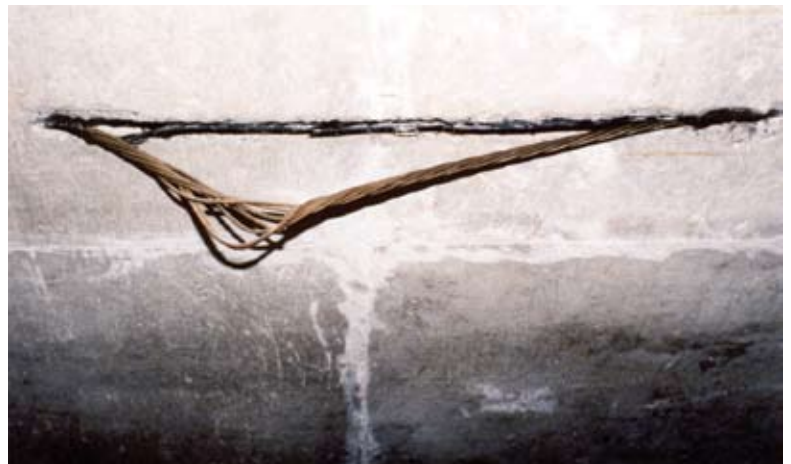
*Failed post-tensioned tendon that erupted from slab soffit*

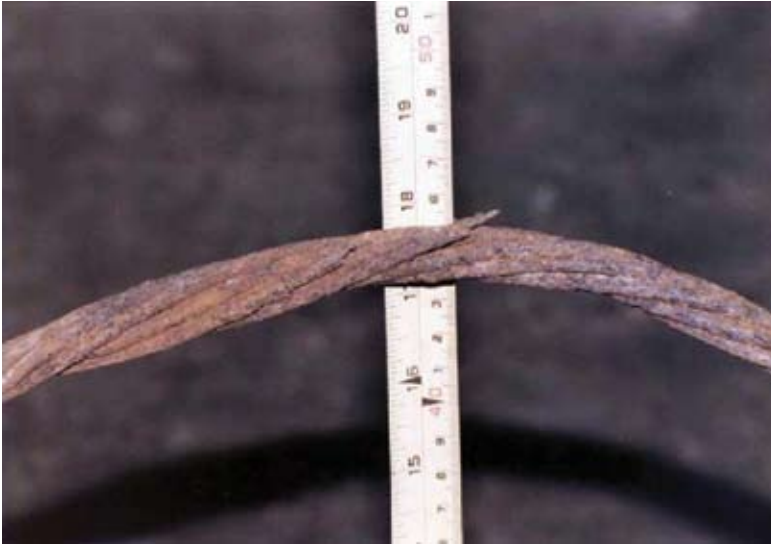
*Failed strand from post-tensioned tendon*

In pitting corrosion of unbonded post-tensioning, the metal does not corrode uniformly, but rather deep pits are produced at distinct locations. This may lead to sudden brittle failure after only negligible overall corrosion. The time from construction to tendon failure may therefore be quite short.

Stress-induced corrosion cracking produces pits at the base where microcracks may originate. Once a crack has started, the stress concentrations result in the formation of larger cracks, which may propagate causing a sudden failure. In some cases, hydrogen embrittlement appears to be involved. In any case, corrosion of a tendon under stress will likely produce a sudden and sometimes volatile failure.

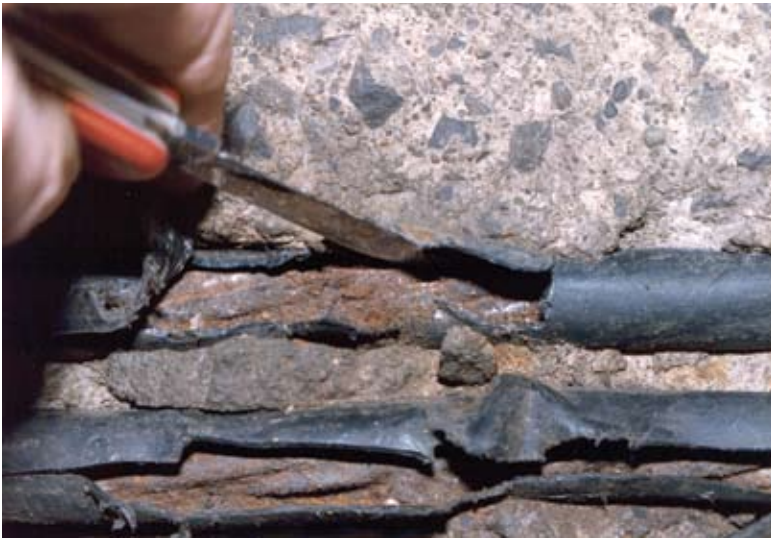
*Void space in greased unbonded push-through, post-tensioned system*

Unbonded post-tensioned tendons may corrode for a number of reasons, even though they are encapsulated by a plastic duct. This is primarily due to voids in the protective grease, which allow moisture to accumulate adjacent to the post-tensioned tendon. Corrosion may go undetected for years until eventually significant structural deterioration, leading to a loss in structural capacity and, eventually, extensive and costly repairs. Increasingly, however, cases have been reported where corroded (failed) cables have erupted from the concrete, thus also posing a risk of damage or injury from ejecting cables, falling concrete, and/or dislodged claddings.

It is accepted that, for corrosion of steel to occur, both water (in liquid or gaseous state) and oxygen must be present. As oxygen is generally always present, moisture is the external factor in promoting corrosion in unbonded post-tension cables. Because of the often poorly greased and loose-fitting nature of push-through and heat-sealed ducts/tendons, the presence of moisture in the voids surrounding and along unbonded cables is fairly common.

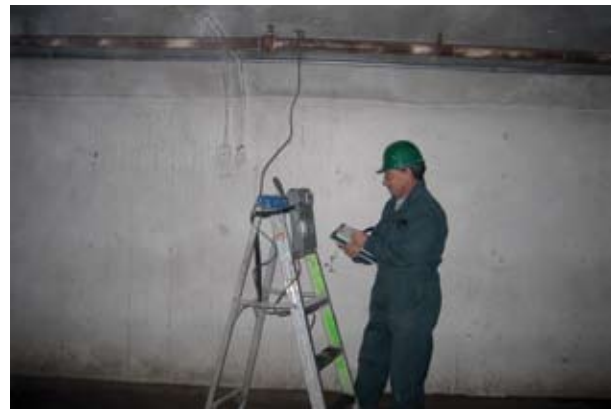
Taking readings for the PT corrosion evaluation

flow into the post-tensioned cable duct at a central location. At an exit port near the end of the cable, the air is directed through the PT corrosion evaluation testing unit, which verifies the flow rate and determines the moisture content of the air within the cable duct. This information is then analyzed and processed to determine the potential for corrosion in that cable. Information is tabulated for all cables tested to provide an overall picture of the condition of the structure.

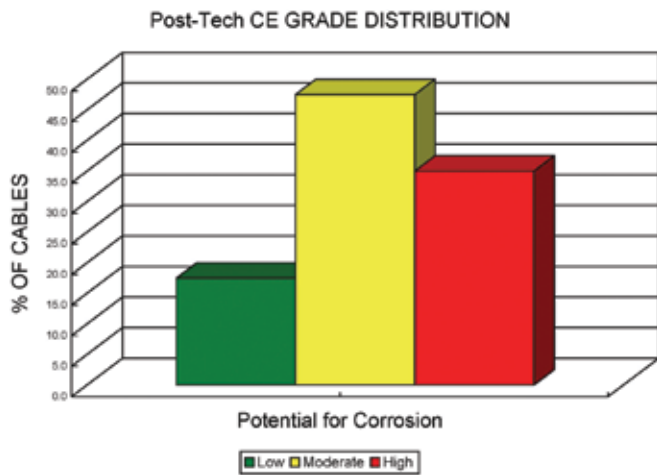
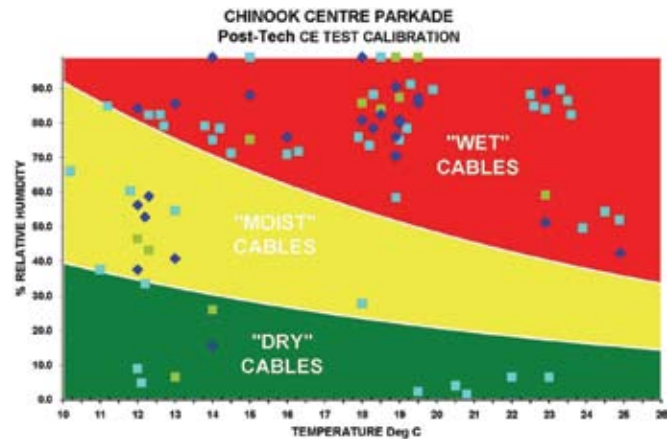
Graphical examples of PT corrosion evaluation test results

Half Cell Corrosion Potential Survey, (ASTM 876) where the potential difference between reinforcing steel and a copper-copper sulphate half cell is measured and related to the probability for corrosion. In both cases, there is a range of measurements that indicates a lower probability of corrosion (less than -200 mV for corrosion potential measurement and less than a moisture content of .003 kg/kg with the PT corrosion evaluation process). Other comparative levels are shown in Table 1.

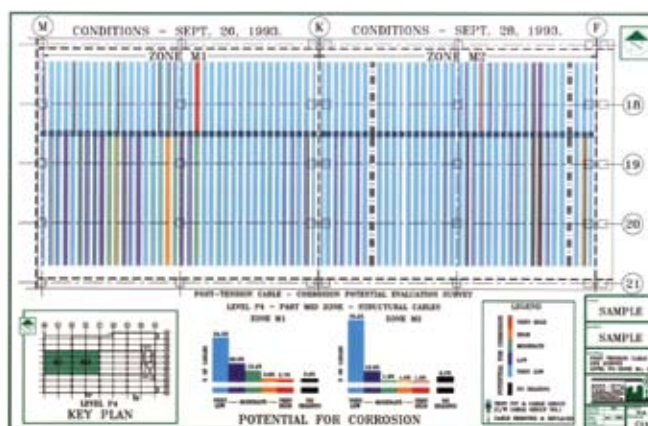
*PT corrosion evaluation readings after drying*

an extended period of time. The extended drying period is required to allow moist air (and any bulk water) to be removed from voids, between the wires of the cable, and from emulsified grease. This process may take 4 to 6 weeks, and is determined by taking corrosion-evaluation measurements before, during, and after the drying is complete.
