# Baltimore Hyatt Garage Deck Concrete Repairs and Coatings

## **Baltimore Hyatt Garage Deck**

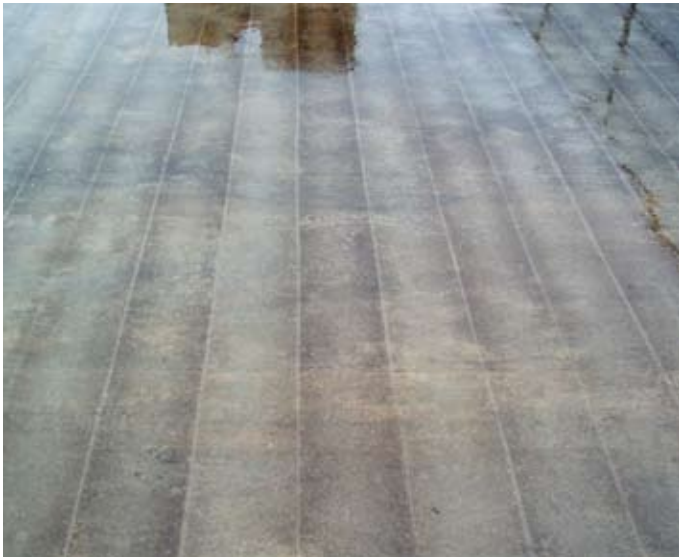
*Concrete surface after shotblasting*

With the exposed surface of the courts and pool deck now bare concrete, the contractor brought a specialty shot-blasting subcontractor onto the job to prepare the area for coating application. Because there was no way to drive any ride-on shotblasters to the roof deck level, walk-behind equipment had to be hoisted by crane.

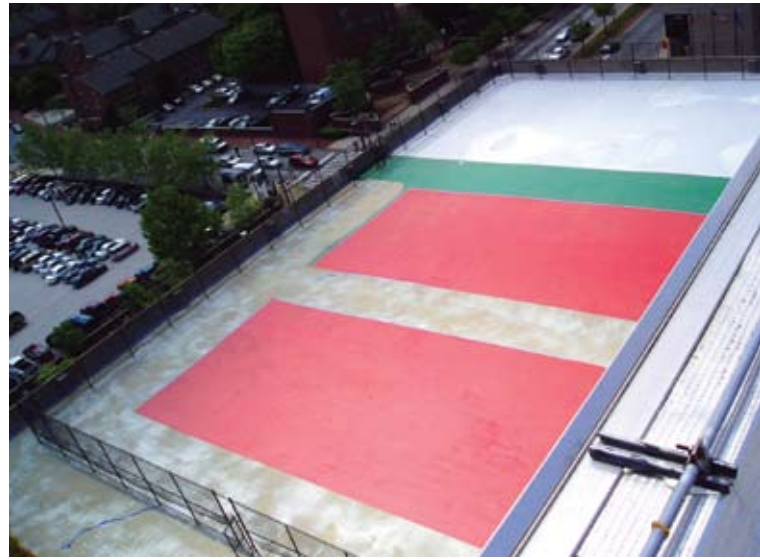
*Tennis court coating*

The playing courts, when finished, consisted of two tennis courts, as had previously existed, plus a basketball court in place of the putting green. The coating application for the tennis courts proceeded without great disruption. The entire area was base-coated; the intermediate coat was then placed for the tennis courts areas, and sand was seeded in the coat to excess. When that coating had cured, the excess sand was vacuumed and swept off the deck. The clay-red color topcoat for the tennis court playing surfaces was then applied, capturing the seed coat and providing UV protection for the waterproofing layers beneath. A

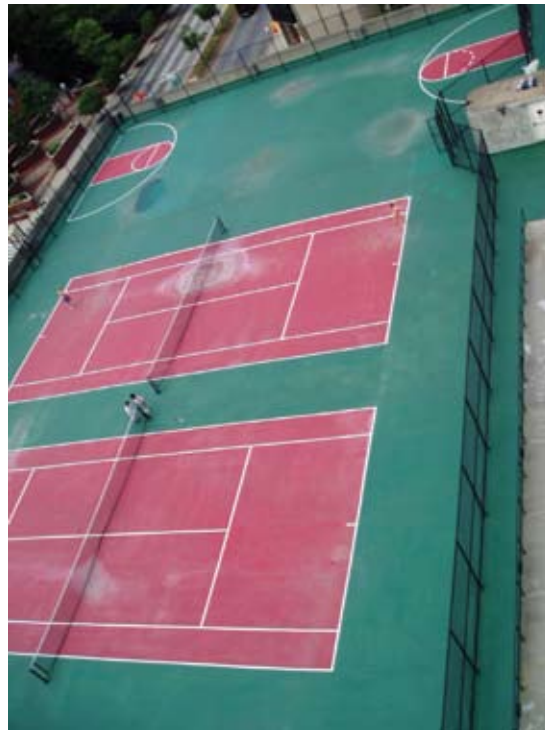
*Finished tennis courts*

similar process was repeated for the basketball court. The only complication experienced during the coating of the courts areas was that heavy springtime pollen resulted in heavy pollen buildup on the deck each morning, requiring power-washing to clean off so the pollen did not become a bond-breaker, and delaying coating work each day until the power-washer water could be blown off using leaf blowers.

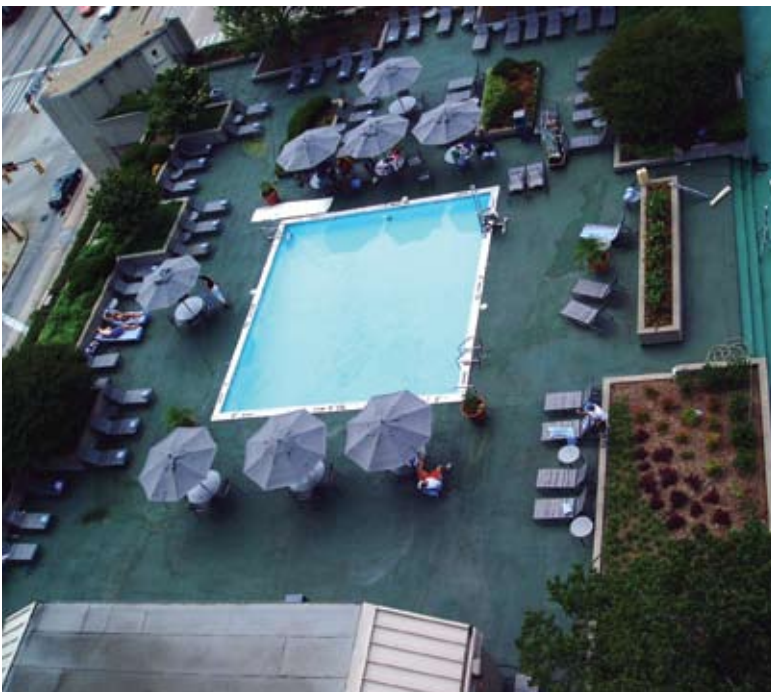
*Finished pool deck*

The contractor's solution to the dilemma was to mix a much larger quantity of green rubber granules, matching the color of the background coating color into the even quantities of red and blue granules. Immediately after another application of the green color intermediate coat was applied, the entire mixture of green, red, and blue rubber granules could then be seeded to excess into it. Even if most of the urethane coat's color was blocked by seeded rubber granules, the majority volume of green rubber granules created the intended appearance of a green background with mixed red and blue highlight dots. The process worked perfectly this time, resulting in a finished intermediate coat consistent across the entire pool deck area whose appearance was a virtual duplicate of the factory-prepared sample. After loose rubber granules were vacuumed off, the entire pool deck area was topcoated with UV-resistant clear topcoat, which captured the granules and locked them into the coating system.
