Parking Structures Category

Auditorium Plaza Garage Repairs and Improvements

Kansas City, Missouri

Submitted by Structural Engineering Associates

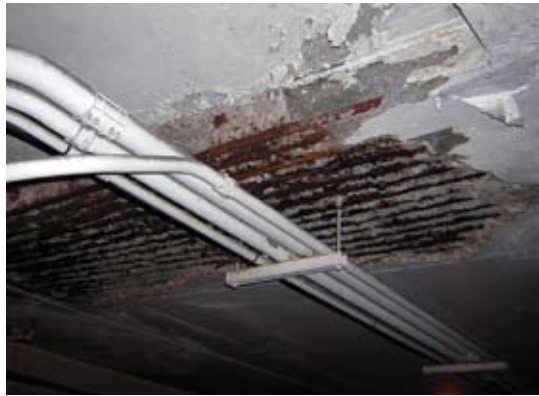
Existing soffit corrosion (note the electrical conflicts/challenges)

The engineer determined that a number of repair procedures were required, including conventional “chip-and-patch” concrete repairs for horizontal and vertical surfaces and the installation of galvanic anodes in the repaired soffit areas. Over 13,500 galvanic anodes, or “hockey pucks,” were installed in the three soffit levels to minimize the high corrosion rates and anodic ring effect in the 20,450 ft² (1900 m²) of delaminated soffit repairs. It is estimated that this passive form of cathodic protection will protect the repaired areas for 15 to 20 years.

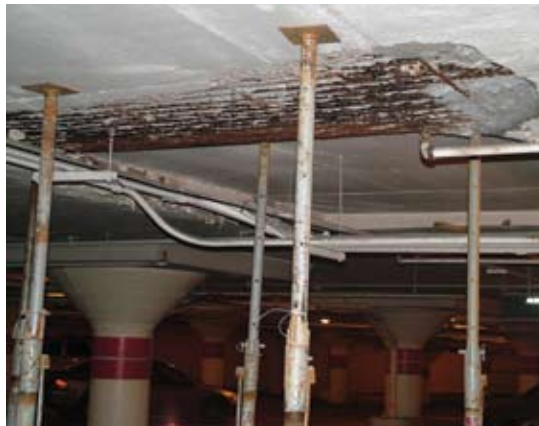
Delaminated soffit repairs

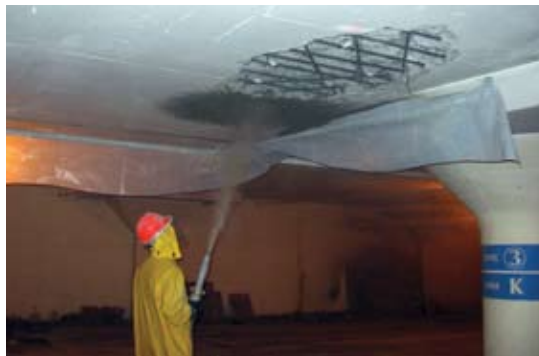
Shotcreting a soffit

The APG repairs and improvements project was bid in May 2005, and was initially budgeted at \$4.1 million. Work commenced in June 2005, and the general contractor and the repair contractors soon realized the many challenges of phasing extensive soffit and slab repairs with a mandatory operational parking garage. Each of the three parking levels was broken into smaller, more manageable repair sub-areas to facilitate vehicular and pedestrian traffic in the garage, while managing the constant, large amounts of dust and poor air quality during the hydrodemolition surface preparation (on both slab and soffit) and dry-process shotcreting work.

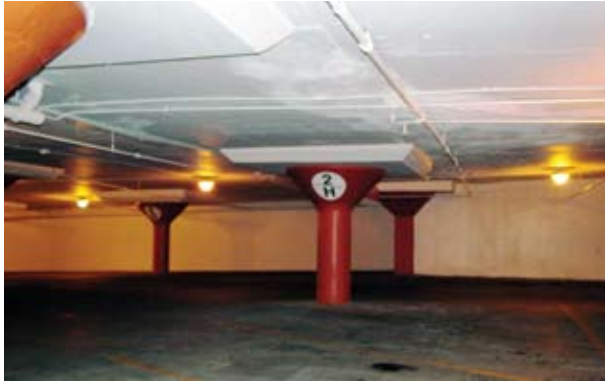
Garage, Level 2, following concrete repairs and painting

Following completion of all repairs to each of the three levels, all columns, walls, and soffits were painted and new signage was added.

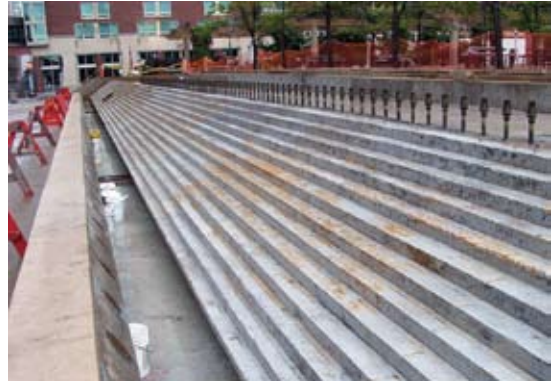
Water feature repairs underway

An existing reflecting pool and cascading water feature bounds the north side of the plaza above, and is completely over the garage below. The pools were drained and the deteriorated waterproofing membrane was milled and scraped off the concrete substrate, while the granite waterfall stones were removed and marked for the new surface-applied waterproofing membrane. Some concrete, plumbing, and lighting repairs were also necessary, and each and every granite stone on the waterfall was cleaned and restored with a cleaning agent, and re-anchored.
