# Restoration of Historic Concrete at Ronald Reagan Washington National Airport

Washington, DC

Submitted by Vector Corrosion Technologies

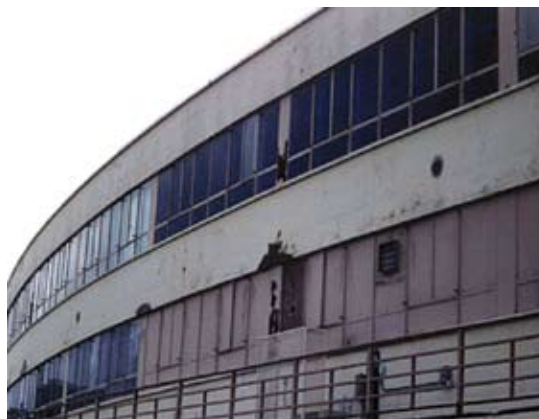
During the exterior façade survey, the most significant concrete conditions observed were pervasive cracking, delamination, and spalling. Almost the entire cornice was spalled. Corrosion of the reinforcing steel was pervasive and apparent from the surface. There had also been a history of

*Damage included cracking, spalling, and reinforcing steel corrosion*

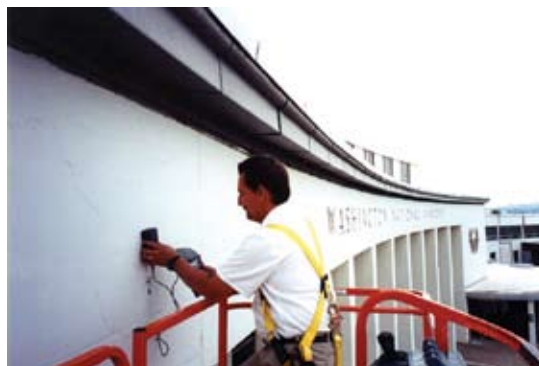
A pachometer survey revealed that the nominal depth of cover was highly variable—sometimes significantly less than 2 in. (50 mm) and many times less than 0.25 in. (0.64 cm) from the surface. The nominal concrete cover over the reinforcing steel was under 0.75 in. (19 mm) in many areas of the structure.

*Nondestructive testing was performed including pachometer readings*

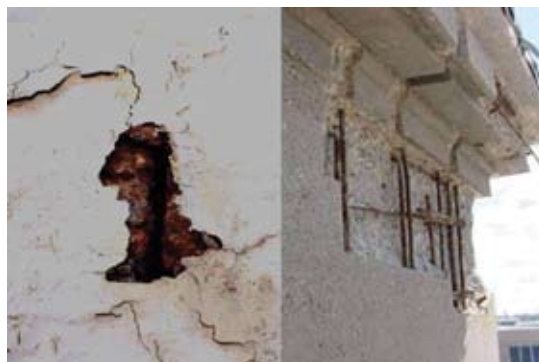
*Typical corrosion condition before and after concrete removal*

After the spalled and cracked concrete was repaired, the electrochemical treatment system was installed as follows:

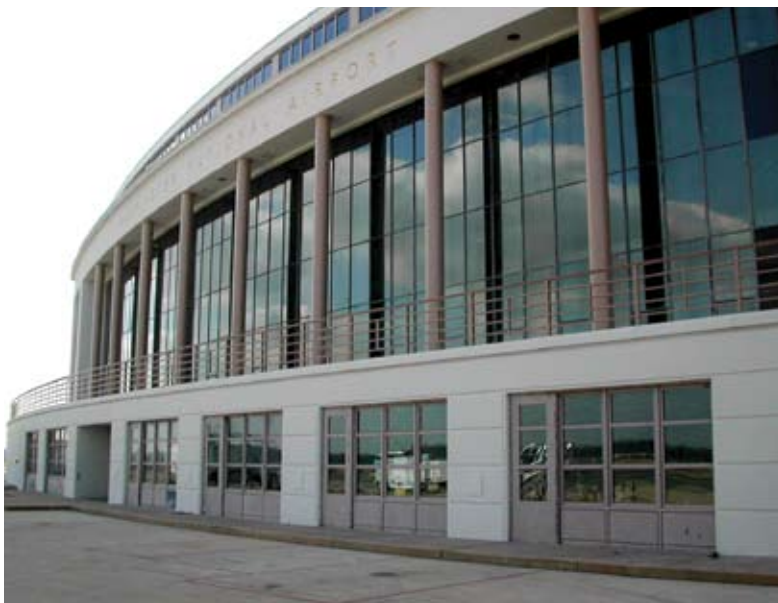
Completion of airside façade

- The system was removed from the surface. All core holes and reinforcing bar connections were patched; and
- After the system was removed and repairs completed, an architecturally acceptable decorative coating was applied.
