Kawaihae Harbor Mooring Structure Cathodic Protection

Kawaihae Harbor, Hawaii
Submitted by Electro Tech CP

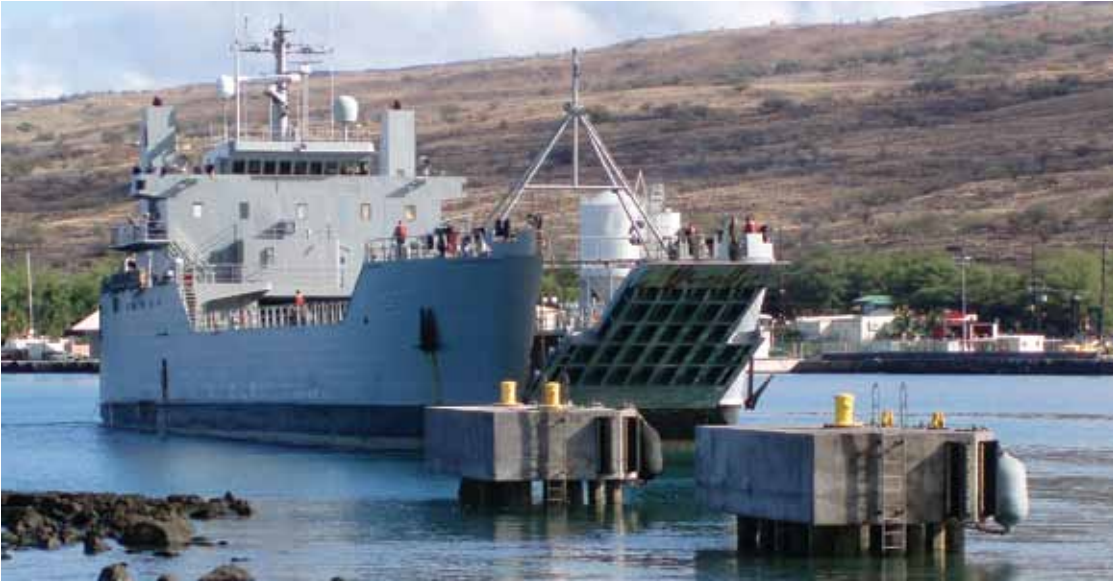
Mooring dolphins, built in 2001, are supported by prestressed, octagonal piles. The piles are driven directly into the bottom of the harbor sea floor

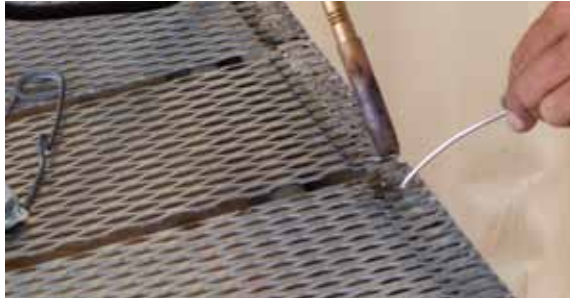
Zinc mesh panels were cut to fit each face of the octagonal pile and connected by soldering a zinc strap at the top of the panels prior to placement on the piles

Installation of the zinc mesh and compression panels required the use of temporary work platforms to position and secure the panels at the required elevation. The zinc mesh sheets were fabricated in a group of eight to permit alignment with one sheet for each pile face. The sheets were attached by soldering a strip of anode grade zinc around the top of all sheets, with a "tag" end remaining for attachment to an anode cable. The zinc mesh assembly was positioned on the temporary work platform so the pile was surrounded completely. The assembly is held in place using plastic ties to connect the open ends. The compression panels were then positioned on each pile face, using elastic cords or rope to temporarily hold the panels in place. The compression panels were permanently secured by stainless steel banding affixed at 1 ft (0.3048 m) increments from top to bottom. Upon completion of the zinc mesh/compression panel installation, the temporary work platforms were removed.

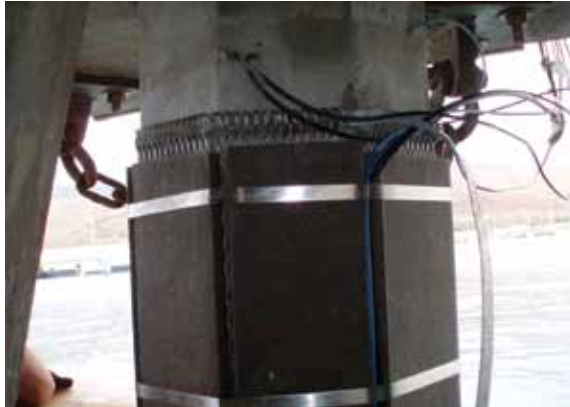
Zinc and compression panels installed and held in place with bands

In addition to cathodic protection, a compression panel made of a wood/plastic composite material was used for each face of the piles to secure the expanded zinc mesh anode sheet to the concrete surface. The contact face of each panel was cut with 1/4 in. (6 mm) longitudinal grooves to allow for wicking action of seawater between the panel and pile surface. A composite wrapping material covers the zinc mesh and compression panel cathodic protection system.

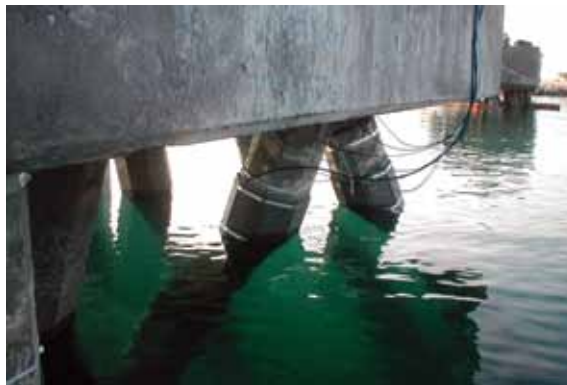
Wiring has been connected to the anodes, testing instruments, and reinforcing and awaits placement in conduits and termination at control boxes

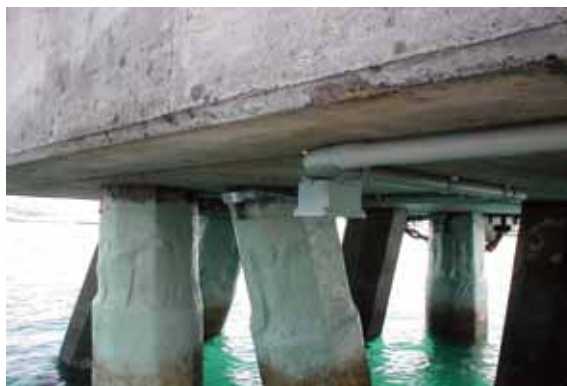
Completed jackets and conduit for wiring

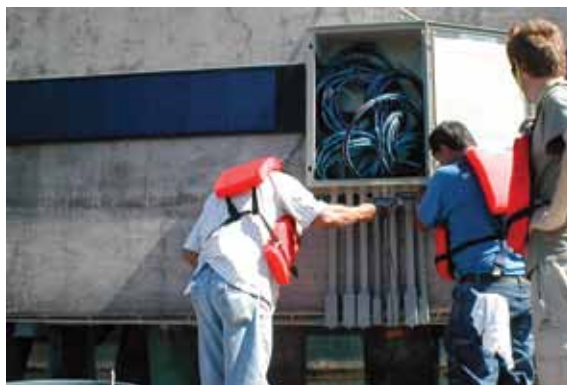
Installation of remote monitoring system on dolphin platform face. Note the solar panel used to provide energy needed to run wireless communications

The remote monitoring unit provides the ability to collect test data from the monitored piles, store it, and download it to the designated main control unit. The remote monitoring units and the main control unit communicate by a wireless connection that is completely powered by solar energy.
