# Galvanic Cathodic Protection of La Unidad Bridge

Col. San Rafael, CP, Mexico

Submitted by Electro Tech CP

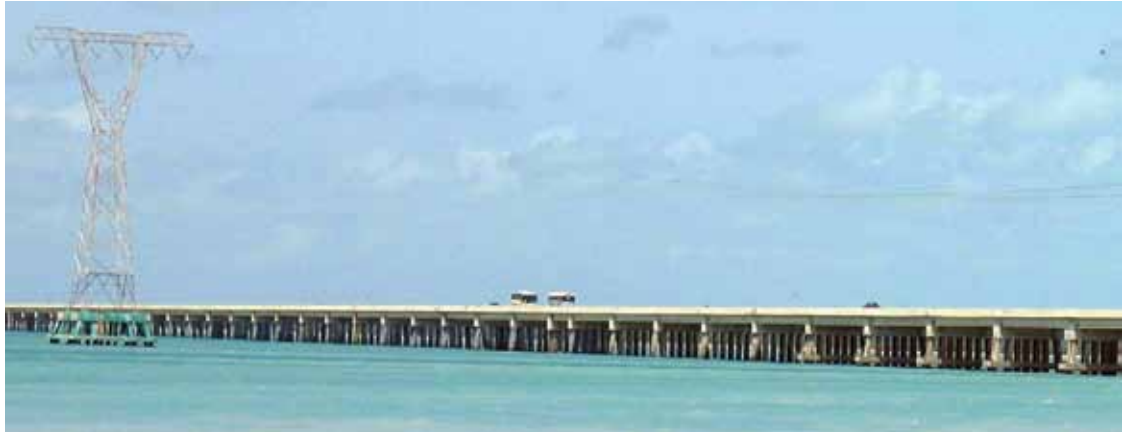
Overall view of the bridge structure

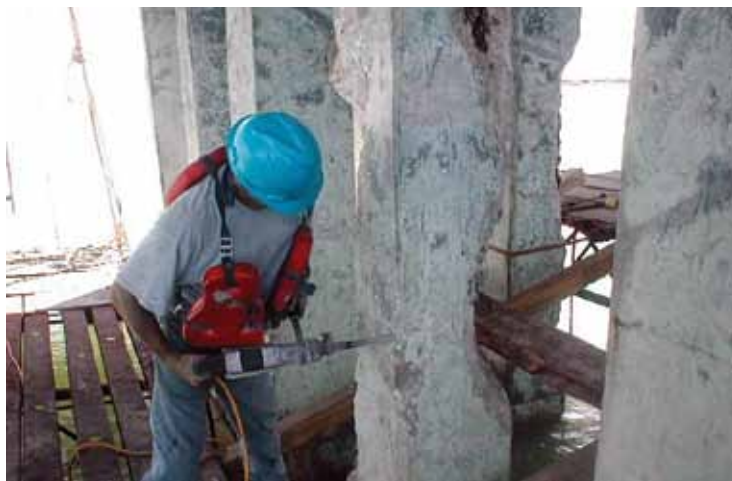
Cracks had penetrated the concrete matrix, which exposed the reinforcement. Located near an aggressive marine environment, the salt in the air caused corrosion of the reinforcement. In addition, a lack of concrete cover over the reinforcing steel in the bent caps permitted the chloride intrusion to the depth of the steel to be accelerated.

*Removal of deteriorated concrete*

Prior to installing the system, the old fiberglass and epoxy jackets were removed. At this point, crews noticed that several piles would need to be recast because of the severity of damage. For the piles that did not need to be recast, all loose or spalled concrete was removed to the depth of the reinforcement. Crews then began to check and establish electrical continuity within the steel. After the continuity work was completed, negative connections were attached to the reinforcing steel using wire with a brazed connection for the piles and a stainless steel threaded rod welded connection for the bent cap.

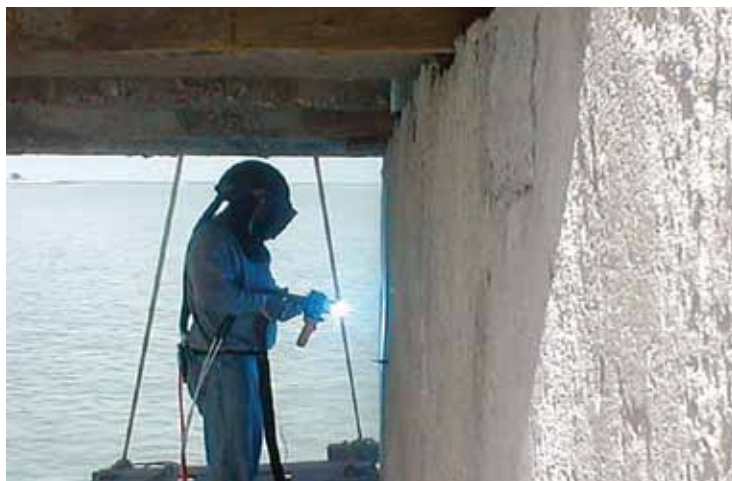
*Metalizing bent caps*

For the application of the metalized zinc anode on the bent caps, an electric arc metalizing unit was employed.

Immediately after surface preparation, the metalized zinc anode was applied on the surface of the bent caps. To ensure uniformity, thickness measurements were taken for every 25 ft<sup>2</sup> (2.3 m<sup>2</sup>) of surface area. Adhesion tests confirmed the ability of the metalized zinc to properly function as an anode.

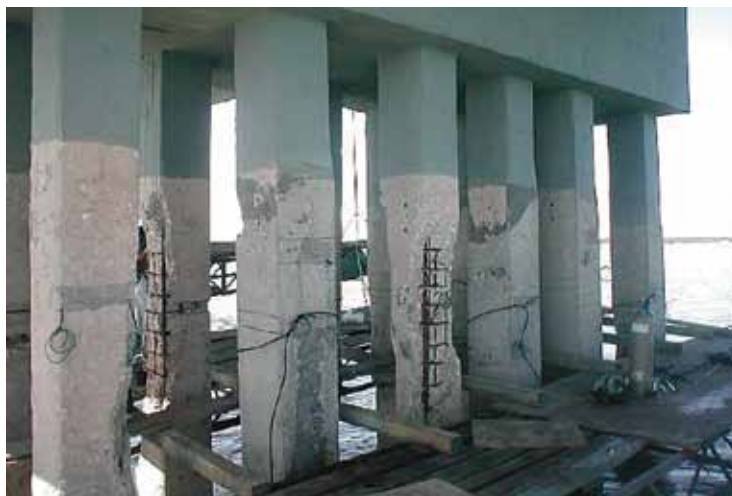
*Bent cap with metalized cathodic protection system installed and pilings prepared for Lifejacket System*

Surface preparation for both the piles and bent cap was accomplished by abrasive blasting. On the bent caps, care was taken to avoid exposing too much aggregate, which would affect the adhesion of the metalized zinc anode.

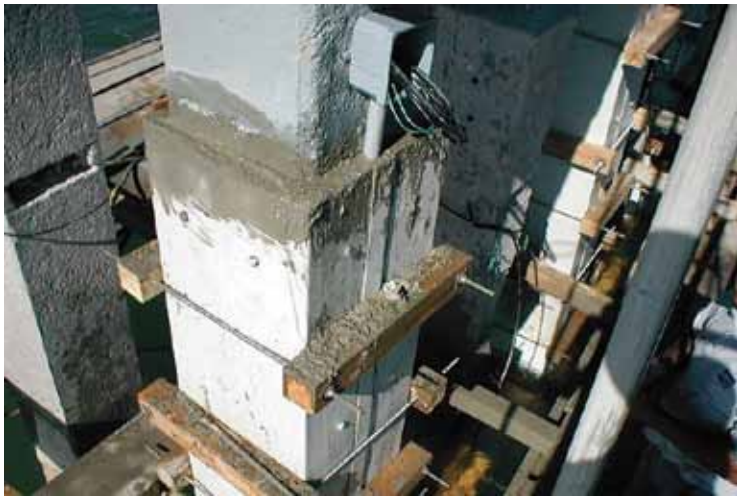
*Lifejackets filled with concrete*

Because of the unavailability of a properly sized concrete pumping machine, it was decided that manual placement of the concrete mortar from above would be used. This resulted in extra attention being concentrated on vibrating methods to consolidate the mixture in the jacket.

For the bridge in Campeche, the jackets were placed around the piles after electric continuity was confirmed or established among all the reinforcing steel within the pile. The contractor assembled the jackets around the pile and poured a mortar mixture into the annular space. The anode grade zinc mesh, preinstalled at the factory, is on the inside face of the pile. The anode is connected to the steel reinforcing at a small junction box above the jacket.

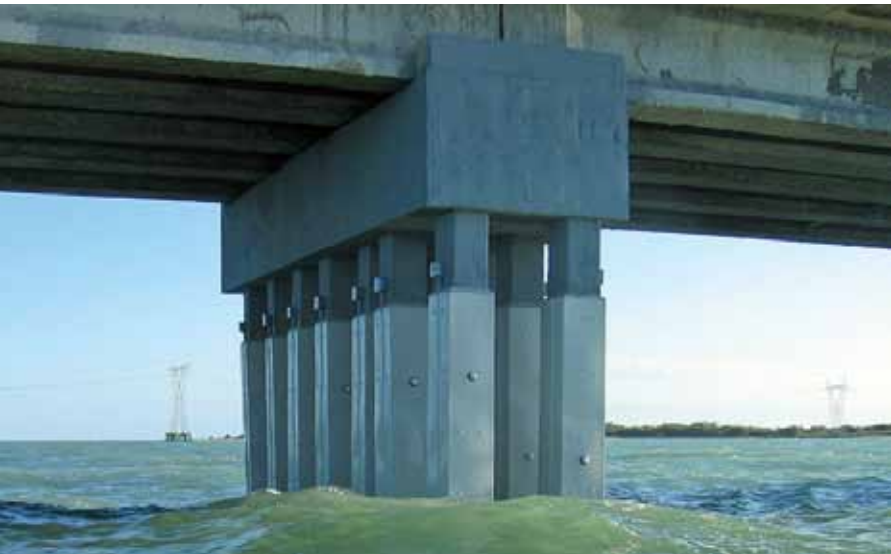
*Completed cathodic protection system on bridge piles and bent cap*

The jacket comes with a preinstalled copper wire and a similar wire is connected to the steel in the field. The connection is completed at the junction box. Reference electrodes were placed at strategic locations on several piles to provide information about the system's performance. In addition, the amount of electrical current that is leaving the jacket is monitored using shunts installed at the junction box. This allows the team to determine the efficiency of the system and estimate the serviceable life of the system.

Based on the readings, the system is working well and will be in place for a minimum of 25 years, providing the long-term solution that the owner desired. More than 1400 piles are scheduled to be repaired and protected using this technology. To date, 240 jackets have been installed during the first two phases of this project.
