# Conde McCullough Bridge Repair—South End

Coos Bay, OR

Submitted by BASF Corporation

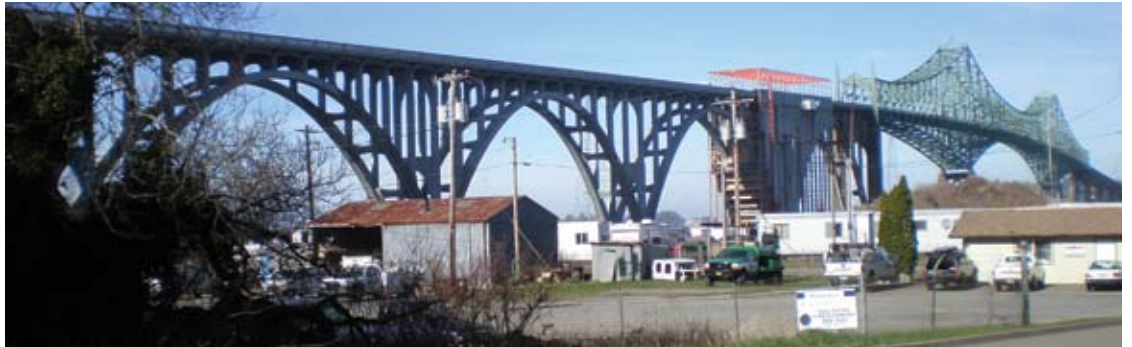
South end of the bridge. Enclosure is visible right before the steel midspan. Scope of work was to repair the South end, a 4-year project

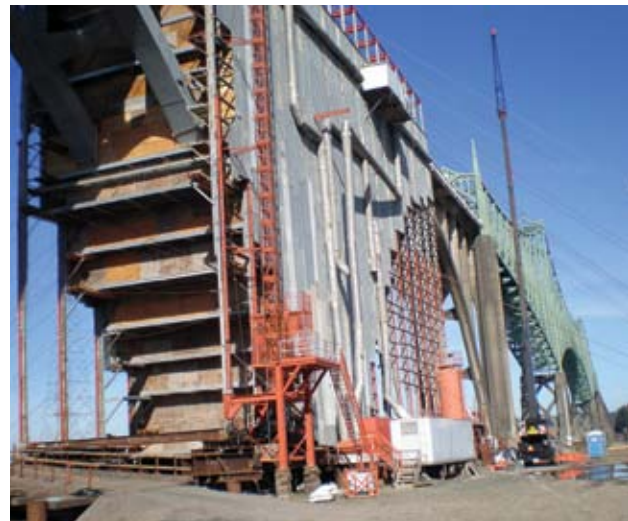
Up-close image of the enclosure showing a perspective of the size of the bridge and complexity of the project. The enclosure is roughly 100 ft (30.5 m) by 120 ft (36.5 m) long. Once the work inside is complete, the enclosure is dismantled and then moved down the line. At the end of the enclosure, you can see a stepping pattern as you follow from top to bottom. Each step represents a repair level—near the top there are “split levels”—16 total to address the complete structure

To address the severe weather conditions, a resilient, movable enclosure was built to create work platforms with multiple levels. Once the work was completed in the section covered by the enclosure, it was disassembled, moved, and reassembled to address the next section of the bridge to be restored. The unique enclosure, which is approximately 100 ft (30.5 m) tall and over 100 ft (30.5 m) long, operates on hydraulics to adjust for the varying height of the bridge. When the section repair was completed, it took approximately 1 month to move the complete enclosure forward to the next repair section.

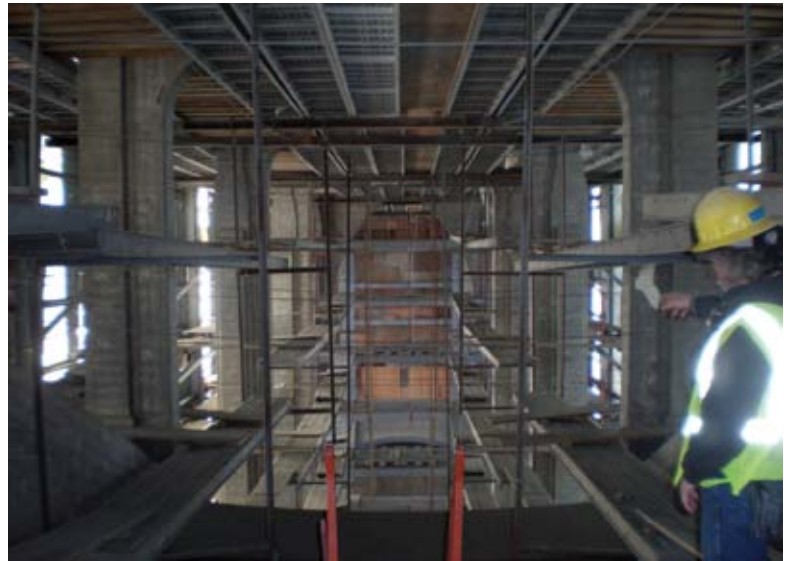
*Inside the enclosure, showing the various levels and work platforms*

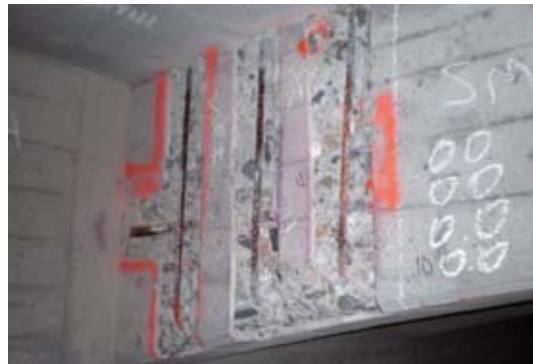
*The repair has been prepared. Rather than cutting out reinforcing bar, the surrounding concrete is prepared and a box form will be built around it*

While earlier projects in this series of bridges used a continuous mixer and rotor/stator pump to place the repair mortar, this bridge required a different solution. The multi-level enclosure called for a pump that was lightweight and mobile, allowing access on each level and on narrow scaffold planks. A Kenrich, diaphragm-type, hand-operated grout pump was used. After placing these portable pumps on tight scaffold areas, the material was pumped full depth both vertical and overhead, where complex forms could be assembled to recreate the original Art Deco design of the bridge. The ability to form these repairs and pump the repair mortar inside the forms proved to be one of the main keys to success. Earlier attempts to address the repairs using shotcrete yielded a great deal of waste due to “rebound” of the pneumatically applied mortar, as well as problems with delamination. In contrast, using the form-and-pump method relies on the form to help hold the repair mortar in place while it gains strength and cures. In addition, the impermeable form creates an ideal curing environment in that the moisture is better retained within the repair mortar, such that shrinkage cracking is greatly minimized versus the shotcrete method of repair.

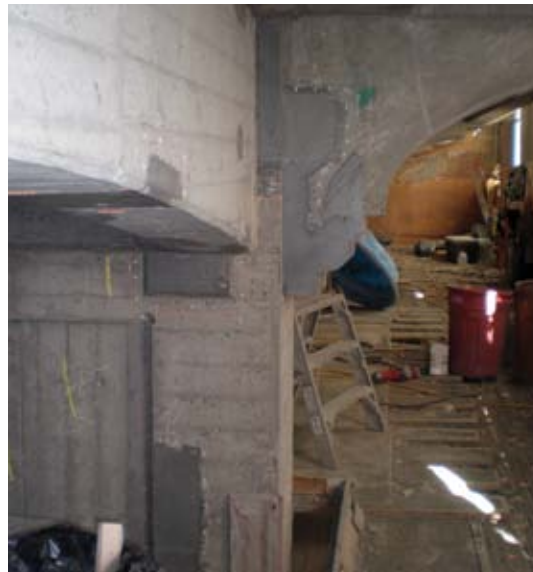
*More complex, three-dimensional repairs can also be completed with the solution created by the team. Forming and pumping does not limit the repair to flat surfaces. Note the architectural corbel formed just right of center. Remnants of the white plastic tapit shells are still in the wall, used to hold the form in place*

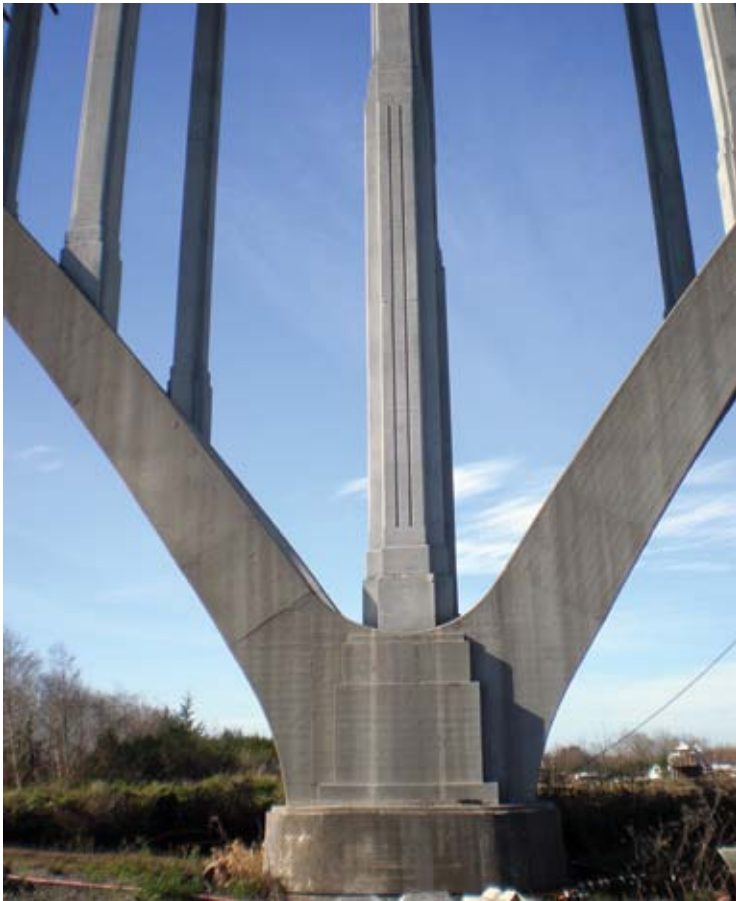
*Inside the enclosure you could see the series of platforms that reached out to the center of the enclosure, which was currently erected around one of the main support columns. This photo shows the graceful sweeping nature of the design of this bridge. Note how the arches come together from either side to meet the column. The surface of the repairs has been sandblasted and coated with zinc as a part of the cathodic protection system*

The method of repair, using the work platform enclosure, required the team to take into consideration cure time and strength gain. The less time spent waiting for the product to cure, the sooner the team could sandblast the repaired surface and apply the zinc coating used as the sacrificial component of the impressed current, cathodic protection system. Through evaluation of the repair mortar, it was determined by the contractor and Oregon DOT that they could keep the forms in place for 3 days, and upon removal at that time, the concrete and repaired surfaces were ready to be sandblasted in preparation for the coating.

The object of the cathodic protection system is to redirect the corrosion activity, which normally would occur in the structural steel reinforcement (reinforcing bar) out to the surface of the structure. To do so, the concrete must be uniformly and electrochemically conductive. The addition of the salt to the repair mortar enhanced the conductivity of the structure, whereas a low-voltage electrical current is used to help drive the corrosion to the zinc coating—sacrificing the zinc coating before the reinforcing bar—protecting the stability and life of the bridge.
