St. Charles Municipal Center River Wall and Plaza Restoration

St. Charles, IL

Submitted by Wiss, Janney, Elstner Associates, Inc.

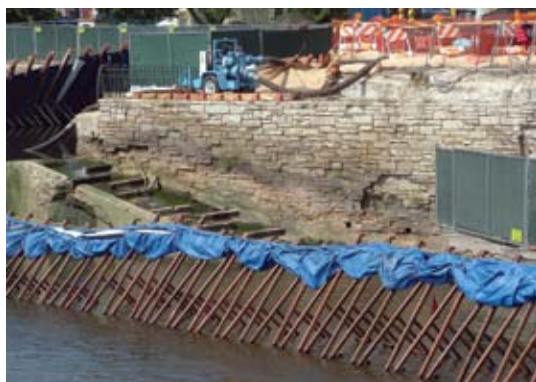
Extensive deterioration to the Lannon limestone cladding and underlying concrete wall at the north end of the river wall. Installation of the portable dam system for the contractor to perform repairs within the river is shown in the foreground

The investigation revealed significant deterioration of the original Lannon limestone cladding on the river wall due to weathering and the Indiana limestone parapet wall due to corrosion of embedded steel bars and plates. The combination of exposure and incorporation of corrodible metal anchors resulted in an advanced state of deterioration of the limestone and mortar. Observed distress included spalls, incipient spalls, cracks, deteriorated mortar joints, exfoliating/scaling of the limestone surfaces, and displacement of the cladding.

- Extensive deterioration of the northern portion of the concrete river wall, directly adjacent to the dam, required that it be removed and rebuilt. The rebuilt wall consisted of an 8 in. (203 mm) thick conventionally air-entrained concrete wall reinforced with epoxy-coated steel reinforcement. The new wall was anchored to the existing dam abutment structure with rock anchors embedded 3 to 5 ft (0.9 to 1.5 m) into the existing structure.

Additional concrete patching was required throughout the remainder of the wall. The concrete repairs were typically 4 in. (102 mm) deep, requiring that the concrete repair materials be placed into the formwork. The patches were anchored to the original base mix concrete with embedded epoxy-coated steel dowels.

- Each piece of the existing Lannon limestone cladding was digitally identified and documented prior to disassembly. Salvageable units were retained and reinstalled in their original position. New matching Lannon limestone units were used to replace deteriorated units. The new wall cladding was anchored to the repaired concrete backup wall with regularly spaced stainless steel anchors.

The work site presented the contractor with many challenges, including a small site with difficult access for delivering, storing, and setting new materials; placing large volumes of concrete; maintaining egress for the functioning municipal building; and the need to perform extensive repairs from the Fox River. To accomplish the work from within the river, the contractor used a portable dam system, creating a semi-dry condition around the repair areas. The dam system was in place for approximately 4 months during the reconstruction.

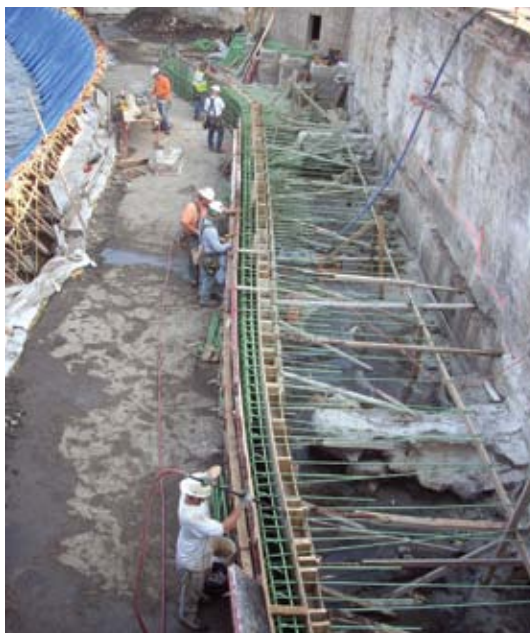
Rebuilding the concrete fishing platform using epoxy-coated steel reinforcement

wall to the north. As such, the fishing and viewing platforms were restored with special attention paid to incorporating details correlating with the original designer's intent and expression. The extent of deterioration of the original concrete structures of the fishing and viewing platforms required that they be completely removed and rebuilt.

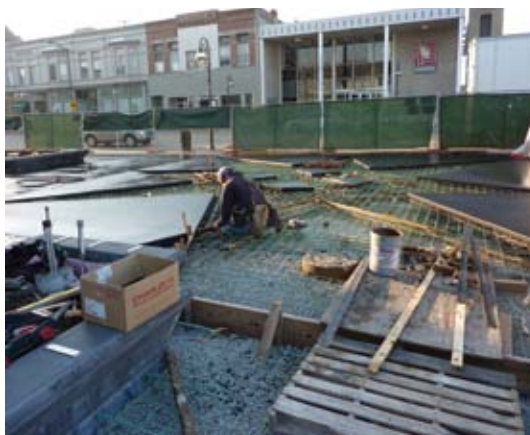
Installation of epoxy-coated reinforcement and intricacy of forming the integrated design features in the color concrete plaza slab

Based on the original design drawings, it appeared that the plaza was to be paved with materials and patterns similar to the interior floor surfaces; however, these materials are not durable in Midwestern climates. The new plaza paving was designed to replicate the original design intent with paving materials selected to be durable with a color palette consistent with the building floor. Based on these criteria, a 6 in. (152 mm) thick reinforced conventional air-entrained concrete slab-on-ground was selected with an integral color pigment to achieve the desired colors. Approximately 200 yd³ (153 m³) of the integrally colored concrete, placed in more than a dozen pours, was required to achieve the as-designed pattern of the plaza slab and planters.

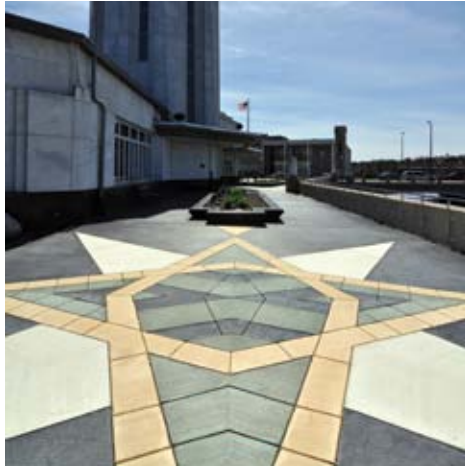
Overall view of completed integrally colored design feature in the concrete plaza slab

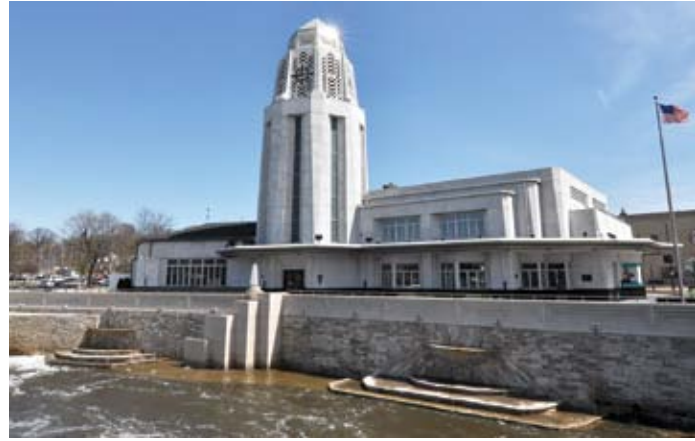
Overall view of completed river wall repairs, including rebuilt fishing platform, fountains, precast concrete stair, and precast concrete parapet walls

- The pieces of the existing cut Indiana limestone parapet that were salvageable were reinstalled along the north side of the plaza. Along the west edge of the plaza, the parapet wall was recreated using precast concrete panels simulating the look, color, and texture of the original cut limestone parapet wall. Numerous mockups and submittals were required by the precast concrete subcontractor to develop and fine-tune the concrete color, finish, and jointing so that the final precast concrete members matched the cut limestone. The use of epoxy-coated steel reinforcement, air-entrained concrete, and stainless steel connections was specified to help increase the durability of the precast concrete members.

- As with the parapet wall along the west side of the plaza, the design team and owner opted to recreate the previously cut limestone cladding of the stair using matching precast concrete. Again, the use of epoxy-coated steel reinforcement, air-entrained concrete, and stainless steel connections was specified to help increase the durability of the precast concrete members.
