Silver Jubilee Bridge Remediation

Widnes, Cheshire, UK

Submitted by Mott MacDonald, Ltd.

2012 Award of Excellence

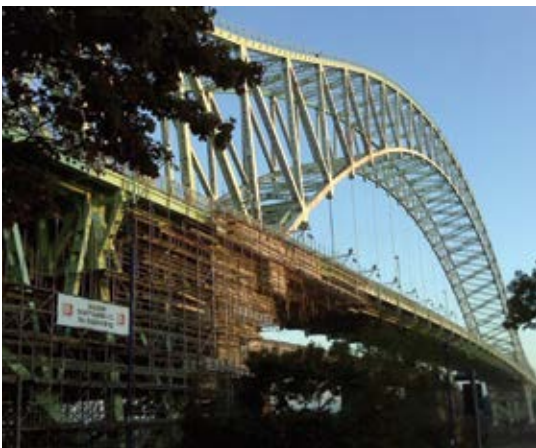
Silver Jubilee Bridge with repair scaffolding in place

The trial section was installed, taking advantage of scaffolding that was already erected for a major painting contract. However, the simplicity of installing the cassettes allowed for a consideration of a roped installation where alternative access was not readily available. This approach was used when the system was installed to the remaining 1700 ft (430 m) of the main suspended deck.

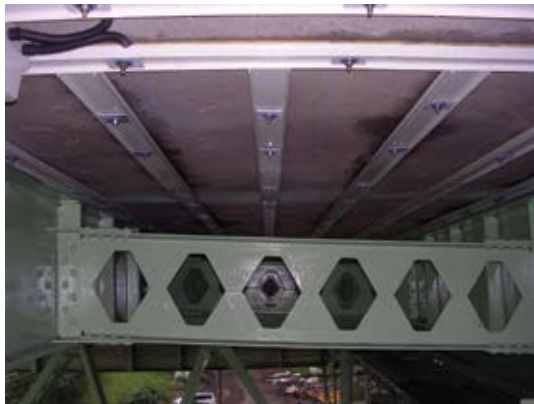
Installed cathodic protection "cassettes"

A lightweight, prefabricated bolt-on "cassette" cathodic protection system was identified as the most suitable solution. The system was originally developed for use on harbor structures in Norway and consisted of mixed-metal oxide-coated titanium (MMOTi) ribbon anodes in a glass-fiber foam-filled fiber-reinforced polymer (FRP) tray that are mounted to the underside of the bridge deck using sleeved bolts.

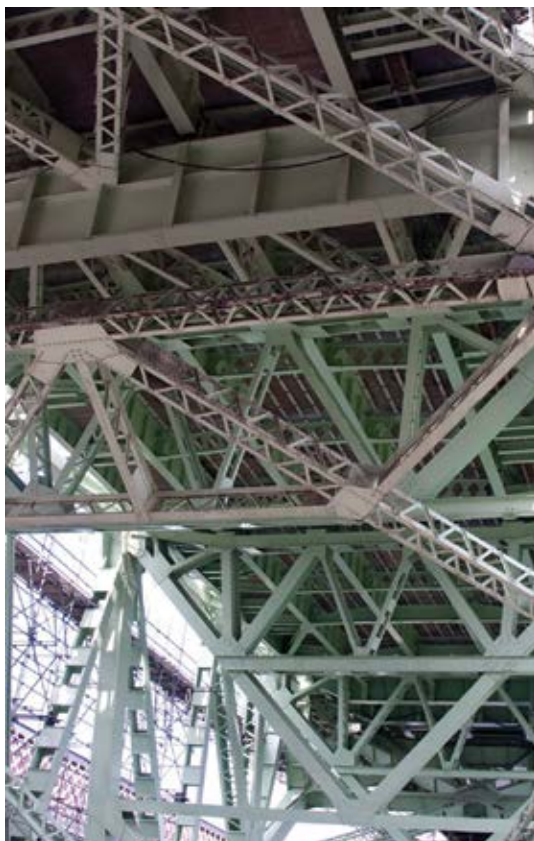
Underside of bridge where "cassettes" were installed
