Construction Savings with Coating Analysis

Reservoir Renovation

Engineer
Simpson Gumpertz & Heger Inc.
Boston, Massachusetts

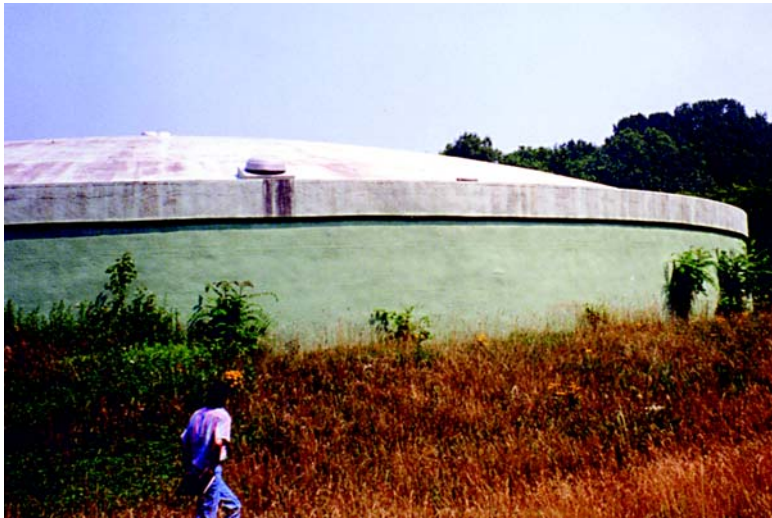
Figure 1: Southside Reservoir before the work

Each tank holds 2.0 million gallons with a diameter of 130 ft. The original dome waterproofing and coating systems on both tanks were no longer effective. The coating systems on the walls, however, were in relatively good condition, even though they were probably applied when the tanks were originally constructed (Eastside in 1996 and Southside in 1973). Unfortunately, the color of the coating systems was a dark green, and Ridgewood Water wanted a lighter, more neutral color (Fig. 1 and 2).

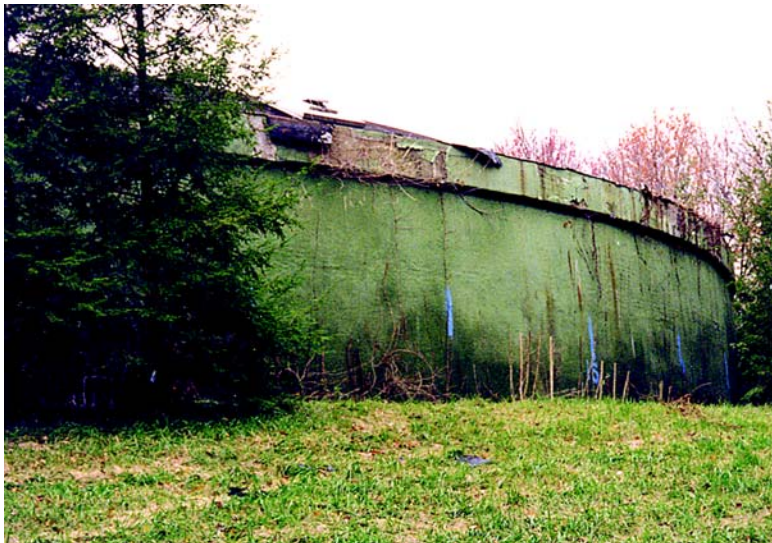
Figure 2: Eastside Reservoir before the work

The coating work at Eastside was performed in the spring of 2000. The contractor, in accordance with the recommendations of the coating system manufacturer, completely removed the existing coating on the walls so the new, cement-based coating system could be applied directly to the shotcrete wall.

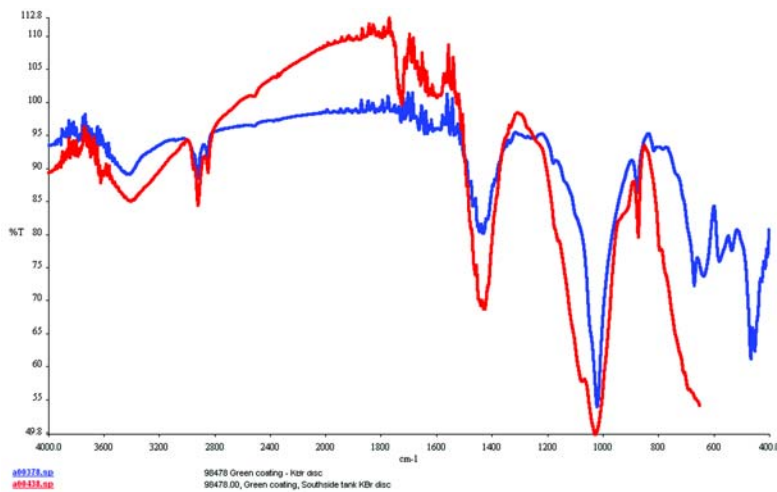
of the coating using the ATR technique. Figure 3 shows the spectra for the sample and for two reference coating systems. Based on the analysis, we were able to determine that the coating was a polymer-modified, cement-based coating. It also concluded that the thickness of the existing coating was not an issue.

Figure 3: Polymer spectrum for coating sample and two reference coatings

The coating on the exterior wall surfaces appeared to be cement-based, so Ridgewood Water provided us with samples of shotcrete with the coating for analysis. The coating analysis used a Fourier Transform Infrared (FTIR) spectrophotometer. The analysis began by removing the coating from the shotcrete. Then, spectra for the coating were generated using Attenuated Total Reflectance (ATR) and Transmitted Light techniques. A polymer spectrum was also generated for a solvent extraction

These findings were presented to Ridgewood Water and the coating manufacturer. The coating manufacturer agreed that the existing coating could remain. Surface preparation for the coating work included power-washing to remove any unsound coating and other miscellaneous coatings applied over graffiti. An additional benefit was that this surface preparation was less damaging to the surface of the shotcrete wall.

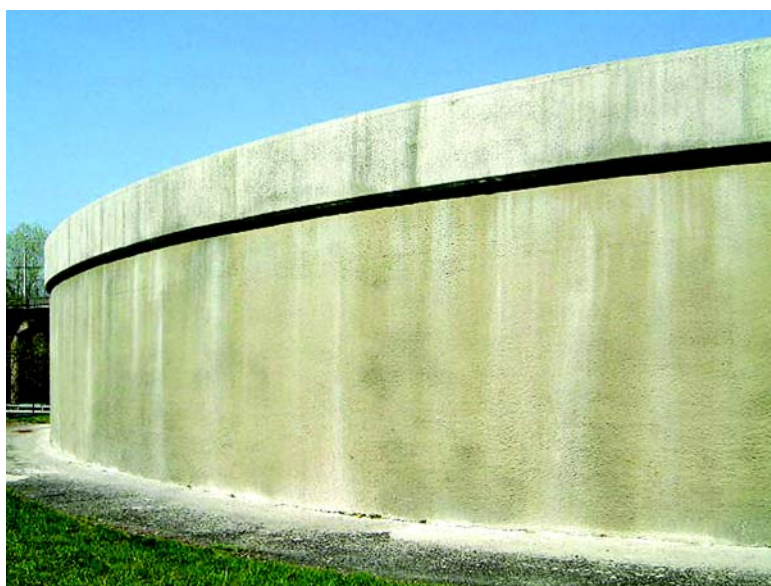
Figure 4: Southside Reservoir after the work

As a result of the thorough coating analysis by our engineering firm, Ridgewood Water saved both time and money in the renovation of Southside Reservoir. Today, both tanks look like new (Fig. 4 and 5).
