Evaluation of Concealed Waterproofing Membranes on Concrete Structures

By Scott B. Harrison, PE

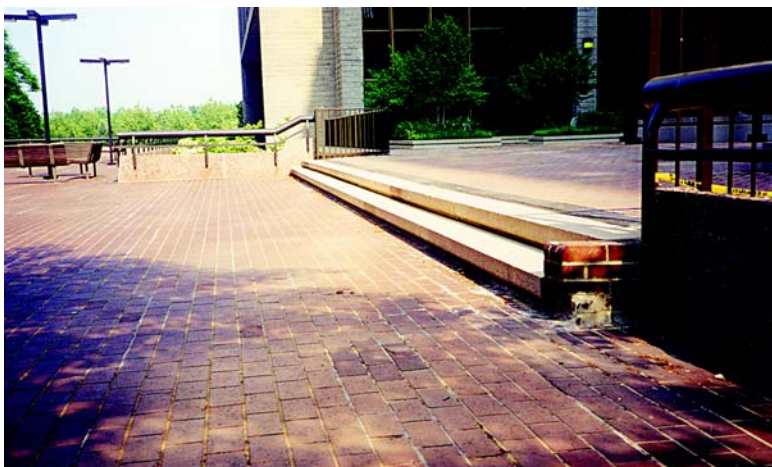
Fig. 1: Waterproofing membranes on concrete structures may be concealed by pavers, steps, masonry walls, planters, and many other coverings

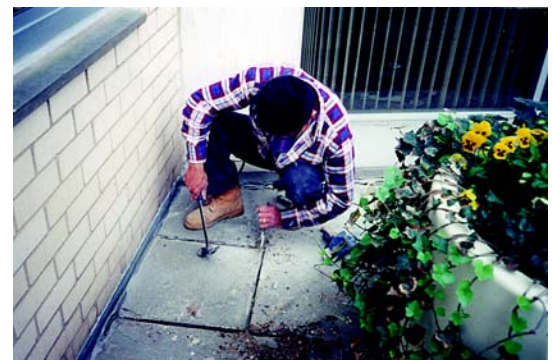
Fig. 2: Test holes should be performed and repaired by a qualified contractor

A sufficient quantity of test holes should be opened to reveal the existing construction and condition of the waterproofing system. This work should be performed by a contractor who is qualified to repair the waterproofing membrane system, as well as the material covering the

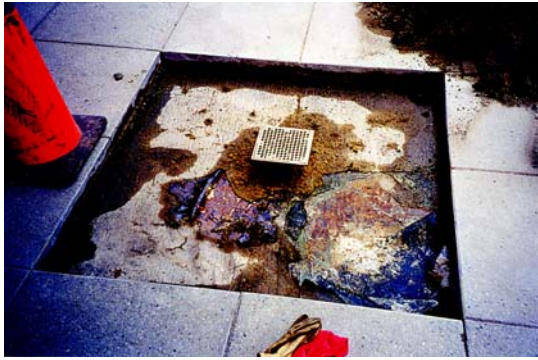
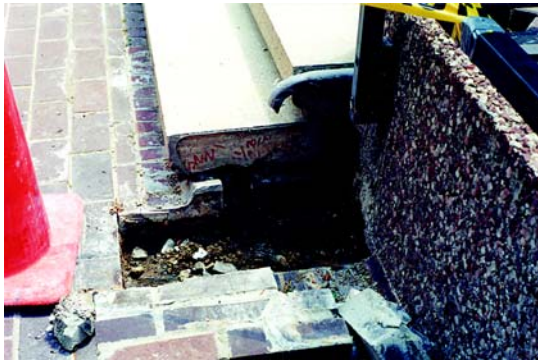
Fig. 3(a) and (b): Test holes should be performed at flashing detail locations, such as deck drains, perimeter walls, and transition areas (steps)

waterproofing. Test holes should be made at a minimum of the following locations:

- Typical field conditions of the membrane: at least one hole at each type of covering (pavers, soil, stone, cast concrete);
- Deck drains;
- Structural expansion joints;
- Perimeter walls;
- Structure penetrations: electrical conduit, duct work, and plumbing lines; and
- Severe leak locations that do not coincide with one of the above.

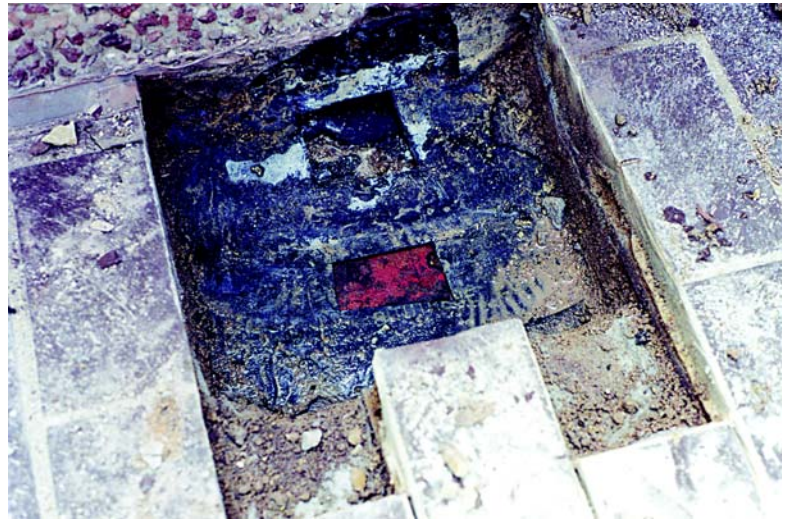
Fig. 4: Test cuts in the membrane assist in determining the existing condition and estimated remaining useful life of the membranes

Typically, the waterproofing membrane is at the bottom of the test holes and lying directly on top of the structure. Cutting and removing sections of the membrane will assist in determining the:

- Condition and estimated useful life of the membrane material;
- Proper/improper installation of the membrane and flashings;
- Quality of adhesion to the substrate;
- Water tightness of the membrane at the test hole location; and
- Localized condition of the underlying structure.

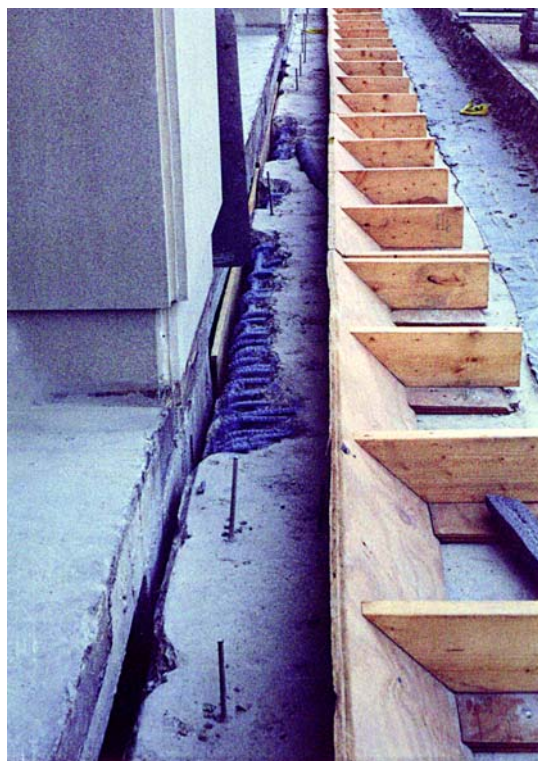
Fig. 5: Exposing the underlying concrete structure can reveal deteriorated concrete conditions

One factor frequently overlooked during the evaluation of concealed waterproofing systems is what is happening to the concrete structure under the membrane. Following the removal of a deficient and leaking membrane on a cast-in-place parking garage, some may be surprised by the extent of deteriorated concrete on the top surface of the slab.

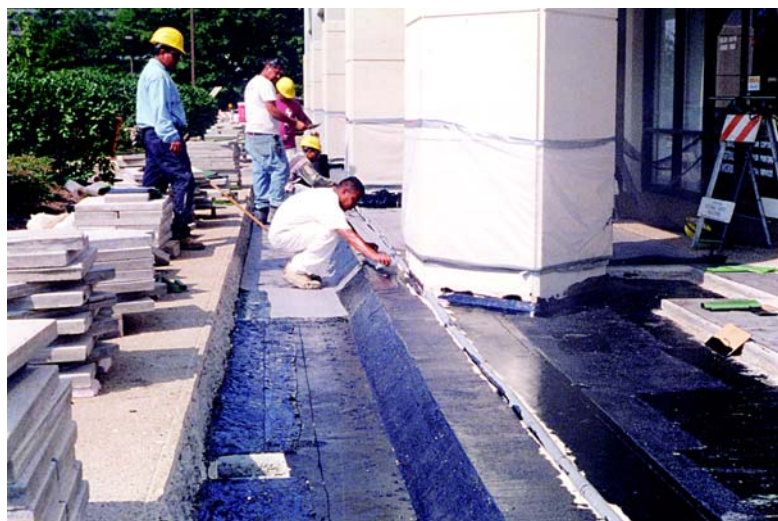
Fig. 6: Ultimately, the building owner may decide to perform spot repairs on the membrane system until the building can be sold or money for complete replacement can be budgeted

existing membrane be effectively and economically repaired at spot locations, or is the existing membrane completely deteriorated and in need of removal and replacement? Ultimately, the owner may decide to do the least expensive fix if that option will take care of the leaks until the building is sold.
