Christ Church Harbor Apartments/University Specialty Hospital Plaza Deck Repair

By Alaric Hergenroeder

Christ Church Harbor Apartments/University Specialty Hospital Plaza Deck

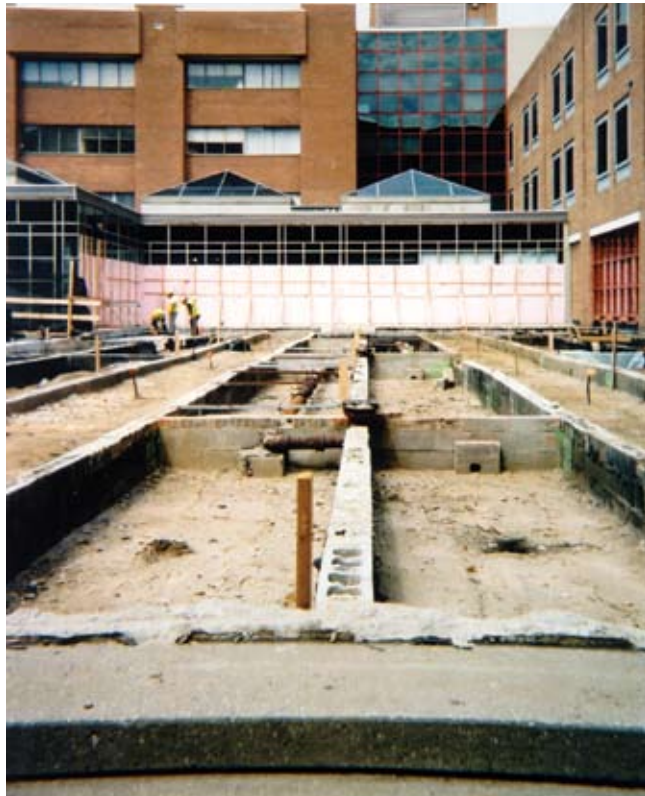
Upper level after demolition of existing exposed aggregate concrete topping and steel pan deck. Notice the 3 ft (0.9 m) CMU block wall cavities that were originally designed to raise the upper level above the other two levels. These block walls were repaired and heights were adjusted to allow for the new composite pan deck slab to slope to new drains slated for installation

The repair contractor removed the existing concrete topping and pan decking down to the cavities located above the structural slab. The 3 ft (0.9 m) CMU cavity block walls were repaired as needed and the engineer changed the specification so that the height of each wall was adjusted to allow the new pan deck slab to slope toward the new drains slated for installation—a change that would allow for better drainage. A new composite pan deck slab was installed, concrete was placed, and a hot-applied waterproofing system was applied.

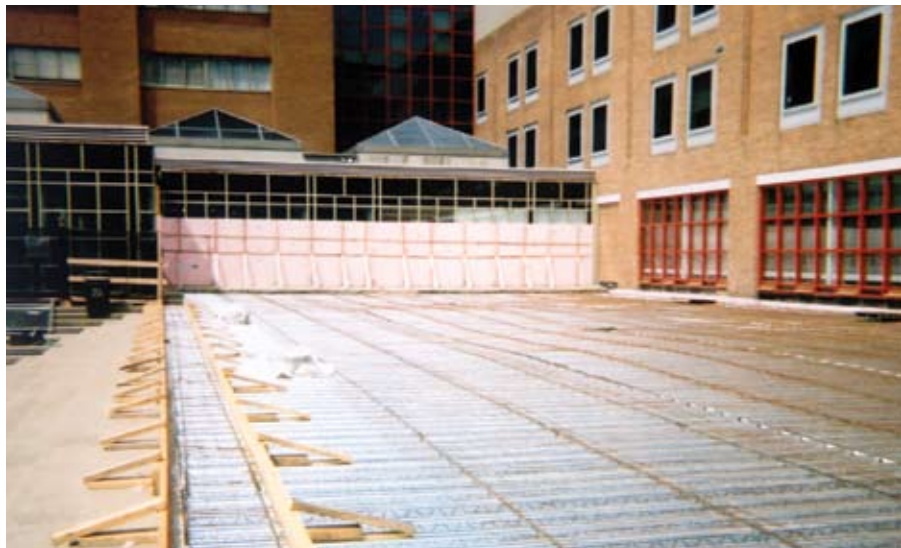
New composite pan deck on upper level prior to concrete placement, waterproofing, and paver placement

The new design called for pavers to be placed on pedestals that would raise the pavers and allow for better drainage. Additionally, the pedestals worked as shims to adjust the height of the pavers to keep a level surface on the top of the plaza while still allowing the pan deck slab below to slope toward the new drains. The existing steps were left in place with repairs completed on an as-needed basis. A urethane protective coating was applied to all steps. New light poles were placed and an

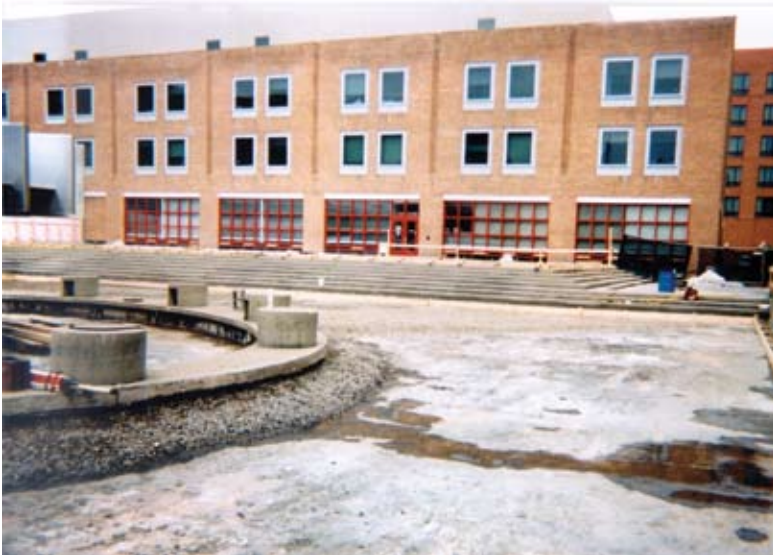
Lower level surrounding the fountain after demolition of existing exposed aggregate topping and removal of the existing gravel

and pool on the waterproofing. As the waterproofing system failed, the water would leak into the occupied garage below. The plan called for removing the exposed aggregate concrete topping, gravel fill material, and waterproofing down to the

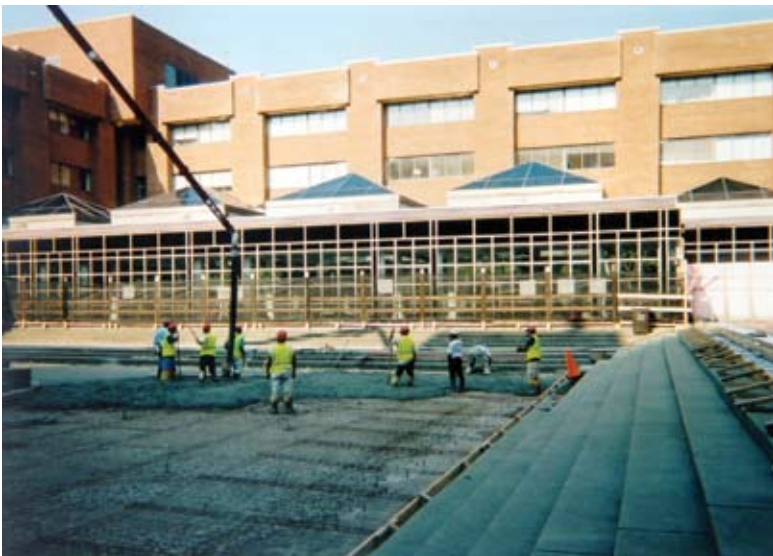
Lower level—placement of lightweight concrete fill

existing structural slab and replacement with a lightweight concrete fill placed directly over the structural slab, which was sloped outward from the center of the plaza toward the perimeter trench drains. A new hot-applied waterproofing system was installed over the sloped lightweight concrete fill with new pavers on pedestals installed to the final grade. Like the upper level, this system would provide for better drainage and be more aesthetically pleasing than the previous exposed aggregate concrete topping.

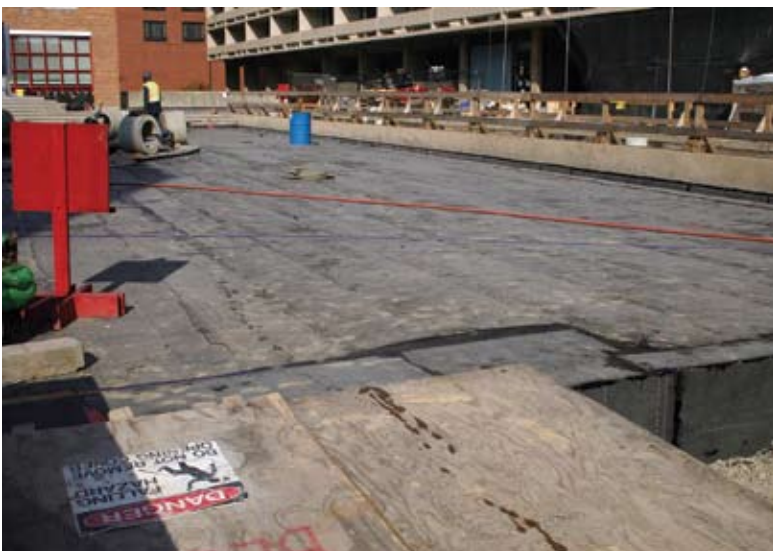
Lower level after new hot-applied waterproofing system was installed

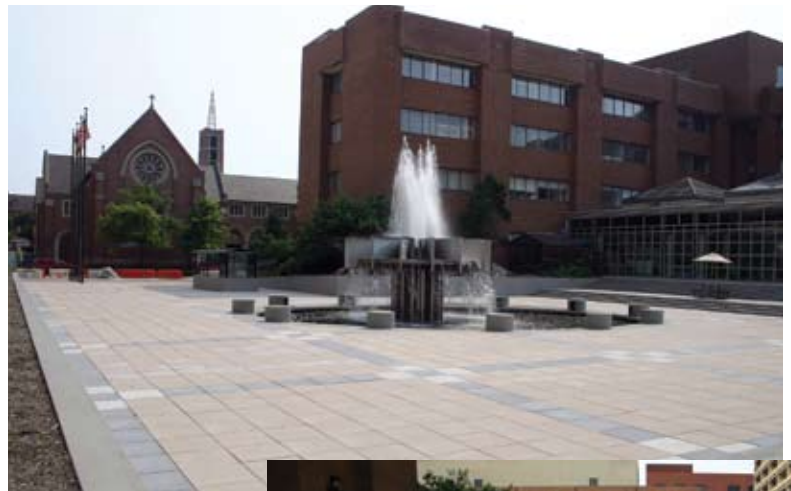
Completed lower level with operational fountain

Probably the most important aesthetic piece to this project was the fountain. Because it leaked, the fountain was not operational at the time of the repair. During the repair, the existing tile, topping slab, and waterproofing were removed and a new concrete and waterproofing system specifically designed for water immersion was installed. New tile was laid in the fountain, along with anti-vortex drains, new scuppers, water level and overflow sensors, and new lighting. The existing concrete perimeter of the fountain was repaired as needed and a urethane coating was applied and tied into the waterproofing systems for the fountain and the lower level deck.

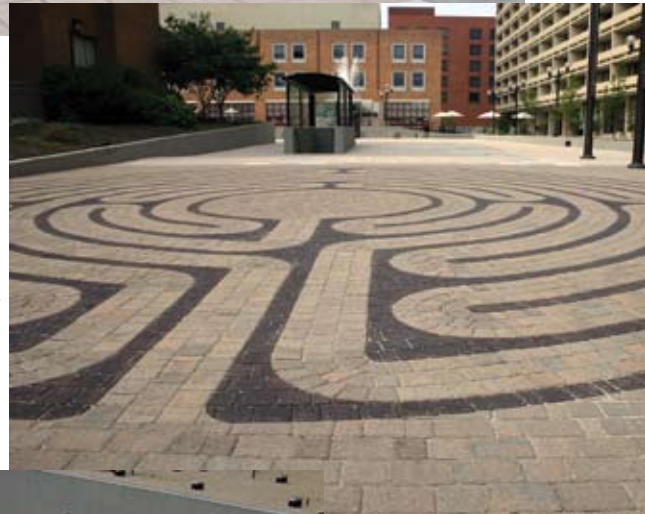
Finished lower level with labyrinth and stairwell enclosure

For the remaining on-grade section of the lower level (approximately 5000 ft² [465 m²]), the repair contractor removed the existing exposed aggregate concrete down to subgrade and excavated the existing sub-base. New compacted gravel fill was placed and sloped to several newly installed drains. The pavers on this section rested on a 1 in. (25 mm) setting bed of sand that was placed on the compacted fill. Another interesting feature of the new plaza was the installation of a labyrinth, or maze, at the end of the lower level. Installed using a 35 x 35 ft (10.7 x 10.7 m) special paver kit, this functional labyrinth added to the visual appeal of the plaza, as well as provided an activity for visitors.

The last water intrusion issue to be tackled was the uncovered stairwell leading from the lower level to the parking garage. Original design specifications called for a glass enclosure; however, the architect working with one of the owners saw the bus stop enclosures used by the City of Baltimore and asked the repair contractor to research the manufacturer and determine if this enclosure was suitable to cover the exposed stairwell opening. After contacting the manufacturer and consulting with the engineer, it was determined to be a suitable alternative. Because it also blended in better with the design of the rest of the plaza, as well as provided sufficient cover for the stairwell opening, this alternate was chosen.

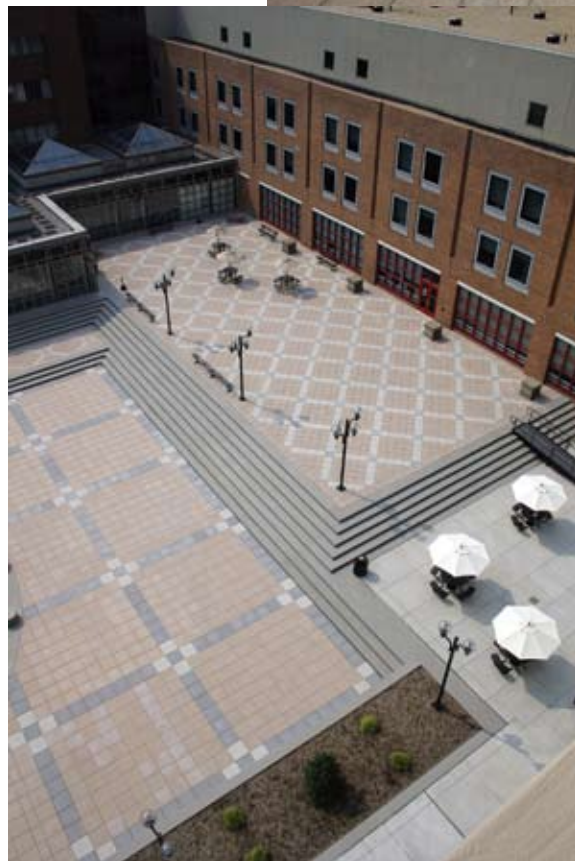
Complete plaza showing all three levels—notice the integration of differing paver designs of the upper and lower levels on the left and concrete slab of the intermediate level on the right

Based on a recommendation from the repair contractor, the specification was changed and a concrete topping slab with a broom finish was installed. Control joints to prevent cracking were tooled in, based on a pattern recommended by an architect working with one of the owners. The pattern blended well with the new paver designs on the other levels as well as the existing steps and concrete perimeter bands.
