# Kauffman Fountain Water Spectacular

By Ralph C. Jones and Kirk Matchell

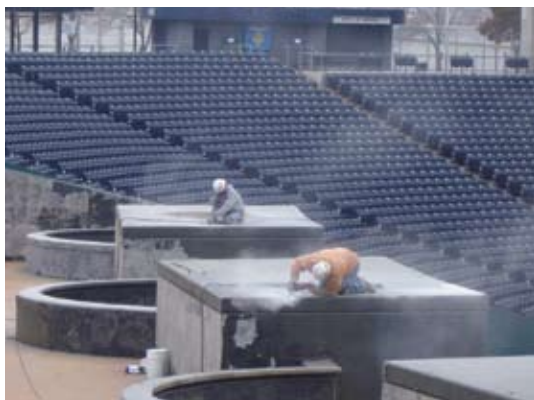
*Removal of existing coatings*

Prior to the concrete repairs, the entire surface area needed to be prepped for the new waterproofing system. This led to the complete removal of all the existing membrane systems. The removal process consisted of sandblasting, hand grinding, and chemical removal.

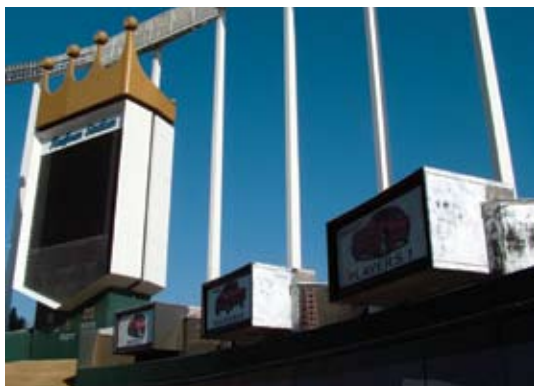
*Removal of existing coatings at the signage boards*

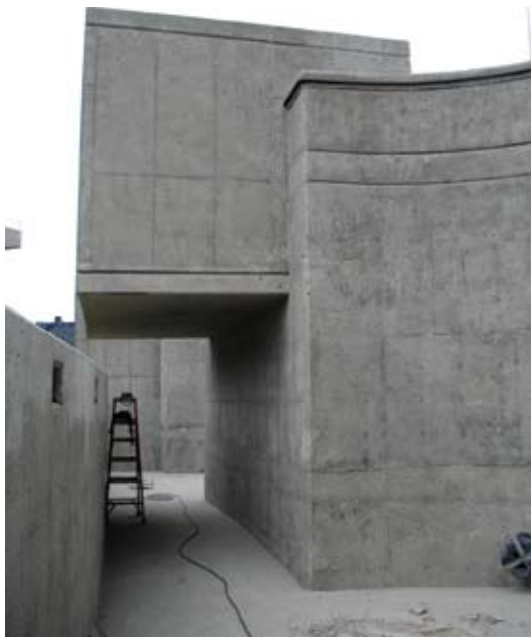
*Lower pool area: main fountain after coating removal*

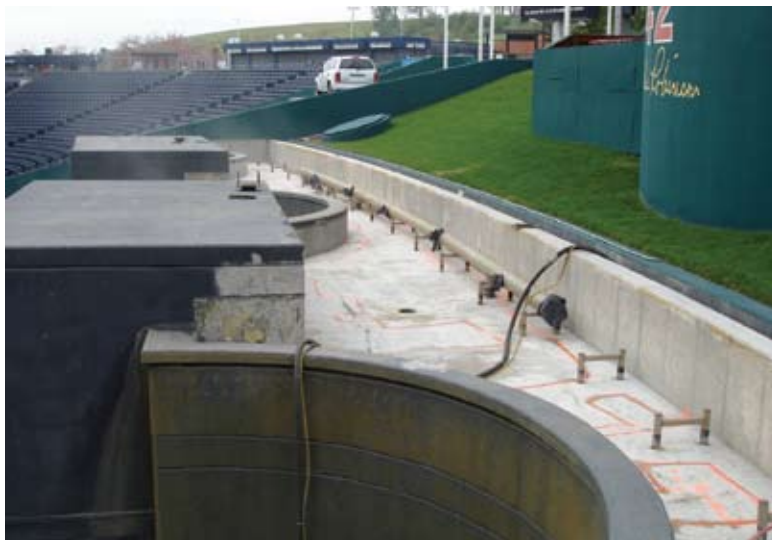
*Secondary fountain: mapped out delamination locations*

In August 2006, the study and evaluation of the Kauffman Fountains began. All areas were sounded

by chain dragging to determine the location and amounts of partial- and full-depth delaminations of the concrete. Site observations were also conducted throughout the site for determining additional deterioration items.

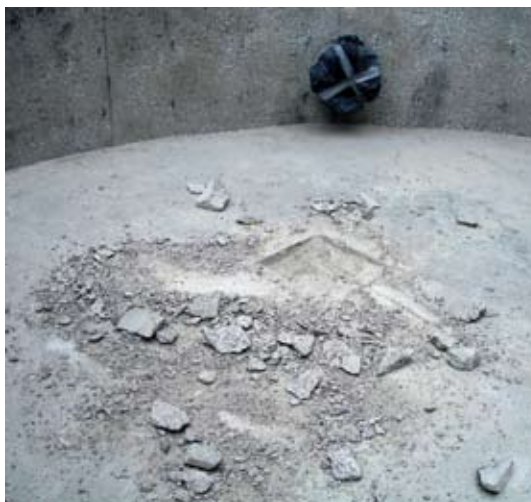
*Concrete slab delamination removal*

All concrete surface repairs required a nonshrink patching material with corrosion inhibitors built into the patch matrix. In addition, if the delamination was deeper than the patch supplier's recommendations for a single layer, pea gravel was added to increase the depth capabilities.

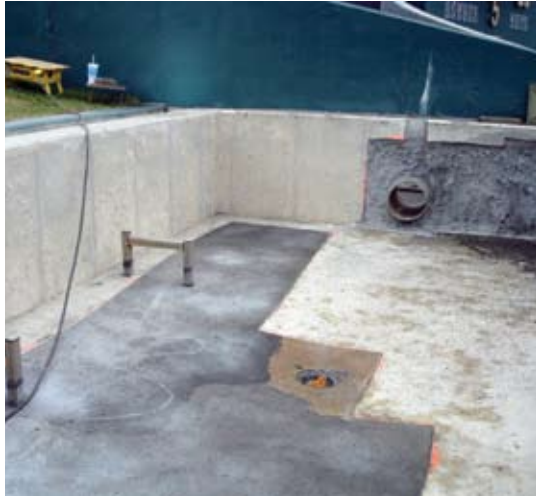
*Completed concrete slab repairs*

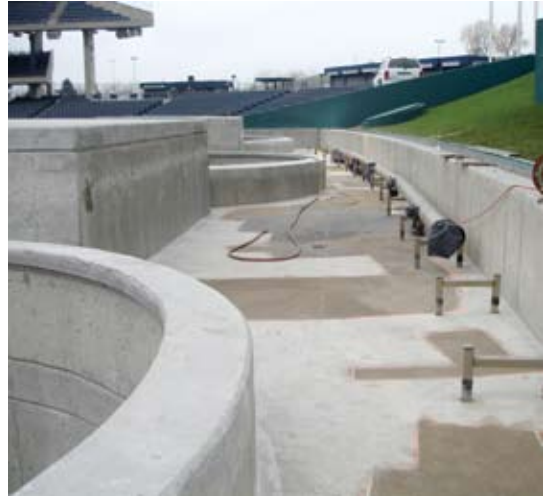
*Secondary fountain: completed concrete slab repairs*

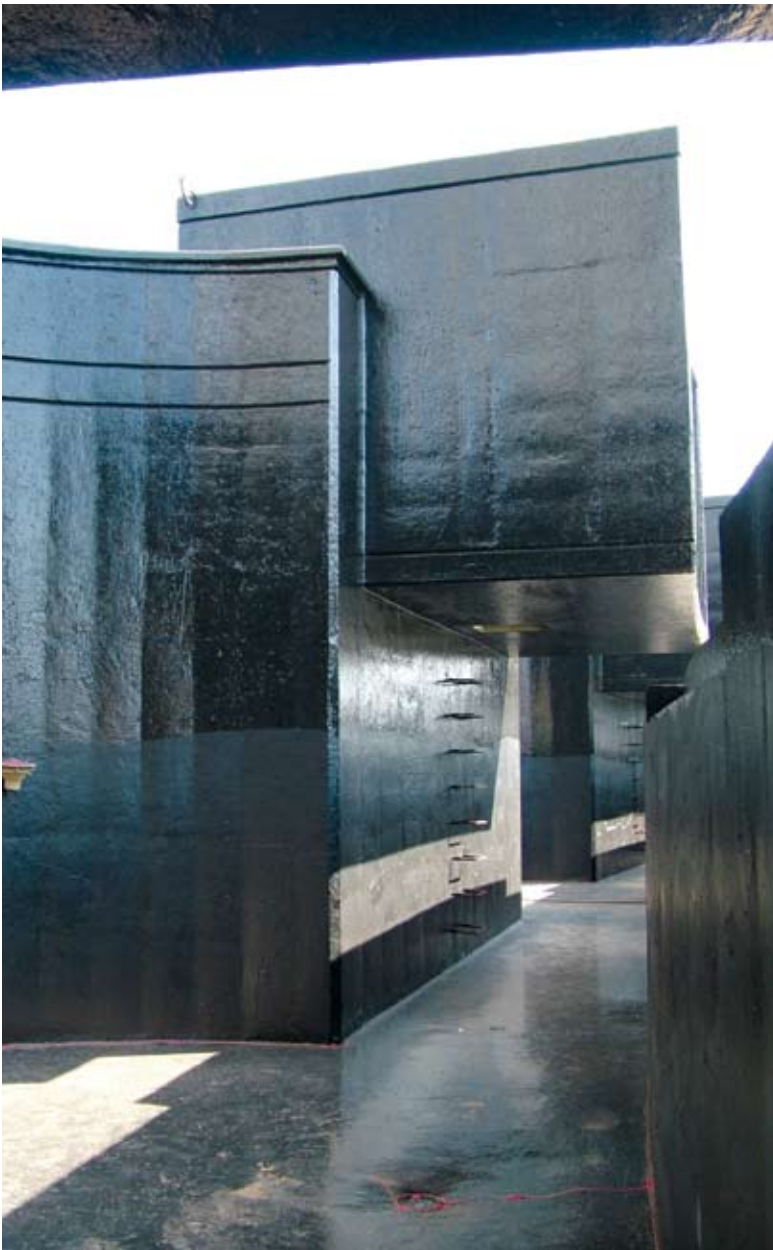
*Main fountain: completed waterproofing membrane system in the lower pool area*

all the surface preparation and repairs were completed, the new membrane system was installed. The membrane was installed with rollers, brushes, and special squeegees.

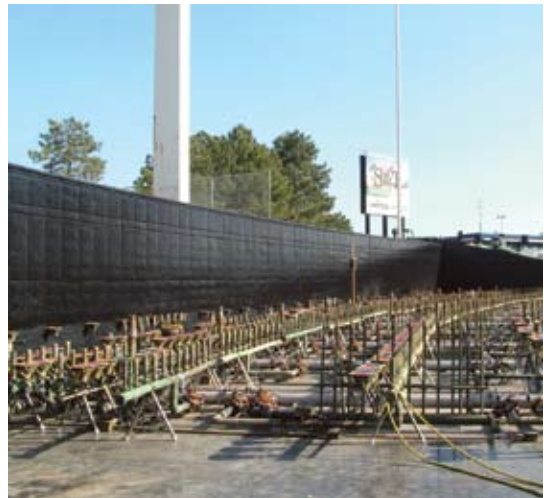
*Main fountain: completed waterproofing membrane system and equipment installation in the upper pool area*
