REHABILITATION OF HISTORIC MASONRY BUILDINGS USING CONTEMPORARY MATERIALS AND DETAILS

EMILY R. HOPPS AND PETER M. BABAIAN

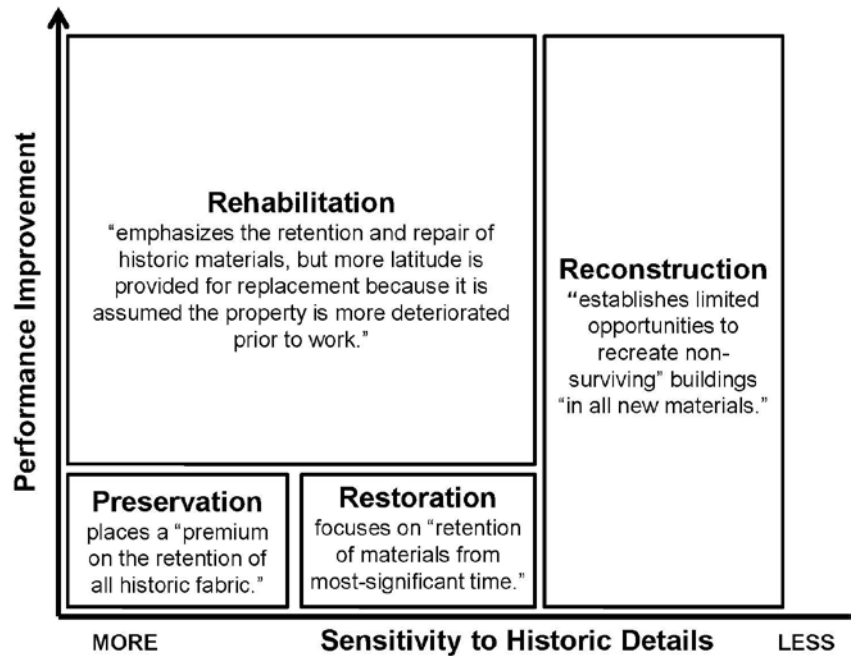
Fig. 1: Performance versus historic sensitivity for preservation standards

Most building envelope preservation work in existing structures is prompted by visible deterioration or interior leakage that typical maintenance or preservation measures cannot remedy. Determining the appropriate materials and details for repairing the deterioration can be difficult; and, in most cases, the decision comes down to two considerations: performance improvement and sensitivity to historic details (Fig. 1).

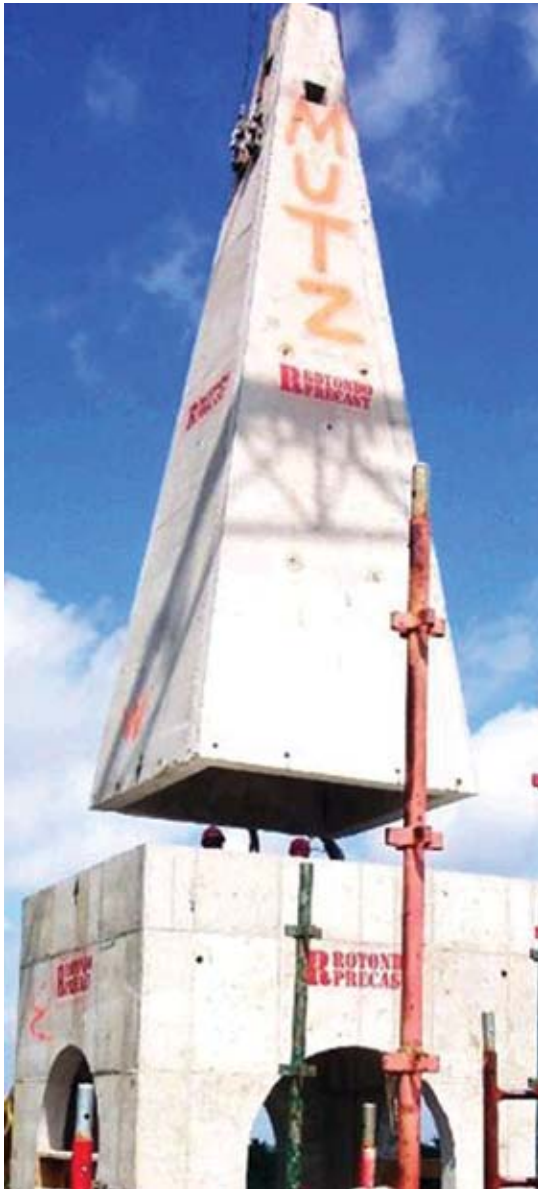
Fig. 3: Precast concrete for bell tower backup wall

to replace the original deteriorated backup wall address seismic issues, provide supplemental support of the sloping cornice, reduce horizontal thrust at the top of the wall, and provide solid attachment and support for the exterior granite (Fig. 3). In this case, the collar joint between the granite and precast concrete was grouted solid with portland-cement-based grout to reduce water penetration. The college and contractor found the original granite quarry located a few miles from the school and sourced all new granite from that quarry.

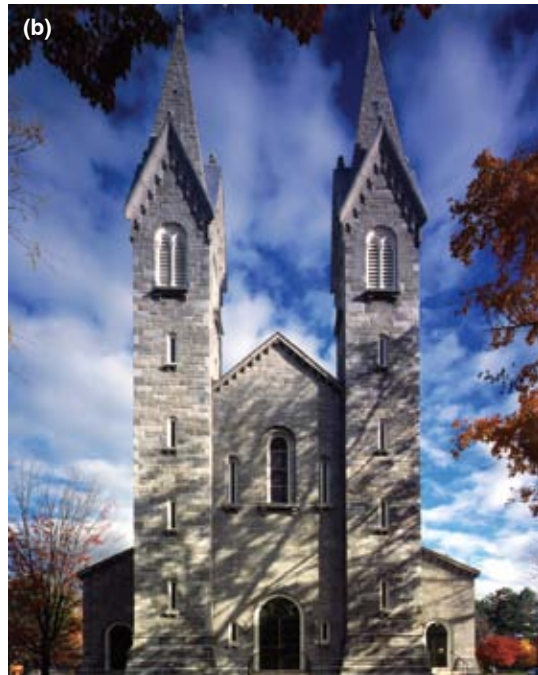
Fig. 4: Images of rehabilitated bell towers: (a) before; and (b) after

The final reconstruction maintained the original building aesthetic despite the introduction of contemporary materials and details (Fig. 4).

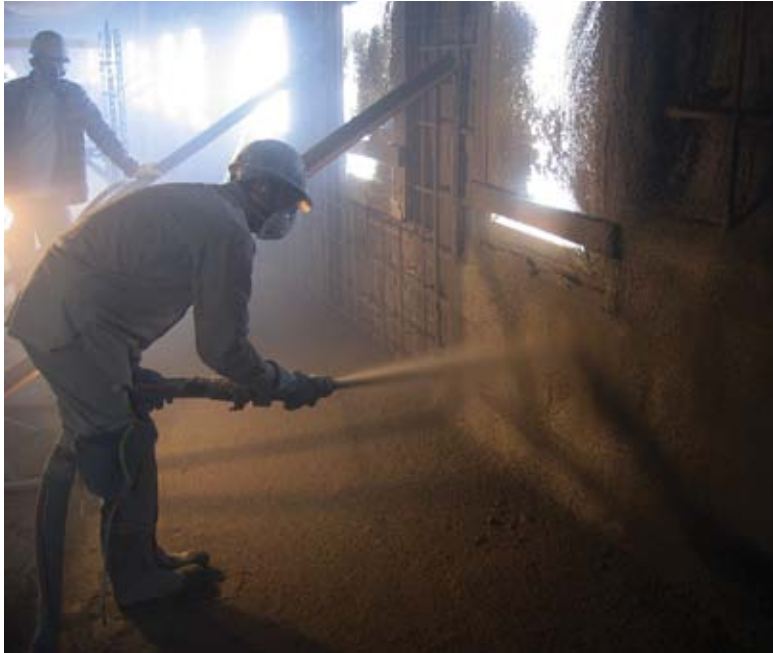
Fig. 5: Shotcrete backup wall fastened to the restored brick masonry veneer

construction. To provide structural stability for the wall and keep the renovation on track, a new shotcrete backup wall was designed that is mechanically fastened to the recently restored brick masonry veneer to provide composite action (Fig. 5). The new shotcrete wall was reinforced and kept to a minimum thickness to prevent significant impact to the interior renovation. The consultant designed the shotcrete wall to function as a fully independent backup wall system capable of resisting all loads on the wall system. This novel approach to the reinforcement of an existing wall system allowed the college to open the renovated dormitory on time without any change in exterior historic appearance.

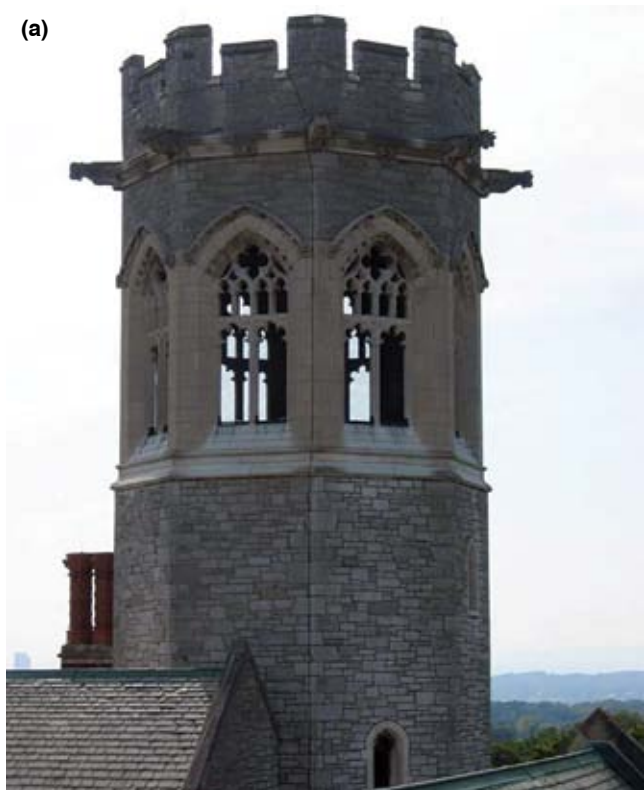
Fig. 7: Images of rehabilitated tower: (a) before; and (b) after

By creating a cavity wall, the water that bypasses the exterior stone veneer is captured, managed, and directed out of the wall at a flashing placed at the base of the cavity wall section. To protect the new reinforced concrete masonry backup wall from water, it was covered with a waterproofing membrane that is integrated with the flashing at the base of the wall section (Fig. 6). Standing-seam copper panels cover the backside of the crenellated parapets and prevent two-sided water absorption. The entire adjacent flat-seam copper roof is wrapped in waterproofing to further prevent water from entering the backup wall or wood-framed roof system. The use of reinforced concrete masonry structure and cavity wall construction increases the service life of the rehabilitated masonry parapets, and the building aesthetic has not changed (Fig. 7).
