# PROTECTING PARKING GARAGES WITH ELEVATED CHLORIDE LEVELS USING SURFACE APPLIED CORROSION INHIBITORS

#### BY PETER DeNICOLA

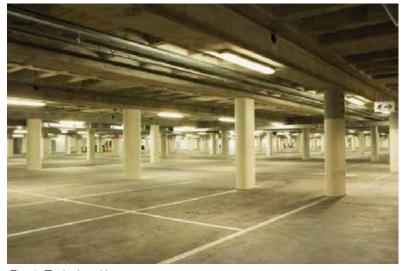
Fig. 1: Typical parking garage

Parking garages (Fig. 1) are exposed to many harsh environments. Whether in the form of deicing salts used during wintertime, or airborne salt from seawater in coastal environments, these two sources of chlorides can make for one of the

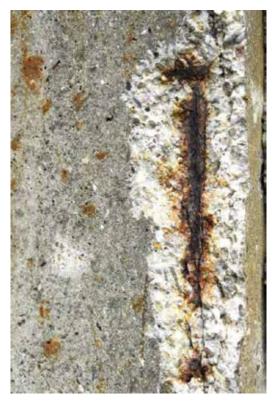
Fig. 2: Spalled concrete due to corrosion of reinforcing steel

Following corrosion initiation and propagation, concrete cracks, delaminations, and concrete spalls can occur (Fig. 2) and need to be repaired. Improperly addressing these issues in a timely manner could have potential long-term consequences. Garage collapse can occur in severe cases of concrete deterioration (Fig. 3).

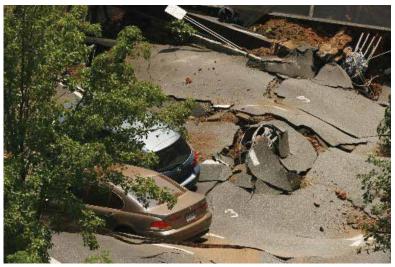
Fig. 3: Garage collapse due to reduced structural capacity
