**Thin SCC Grout
Vertical Repair**
Tainter Gate Side Seals
Auxiliary Spillway
Folsom, CA

Todd Nelson and Stephen Schmitt, Jr.

2017 Fall Convention | November 15-17 | New Orleans, LA

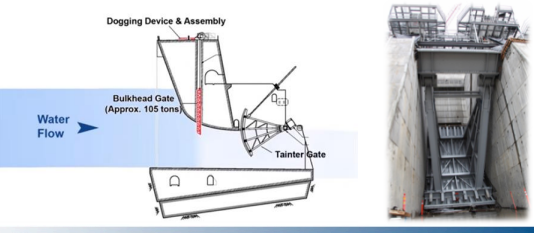
What is a Tainter Gate?

- Also known as a radial gate
- Skin Plate
- Radial Trusses
- Trunnions/pin
- Rubber seals
- Little force to open/close
- Efficient opening/closing

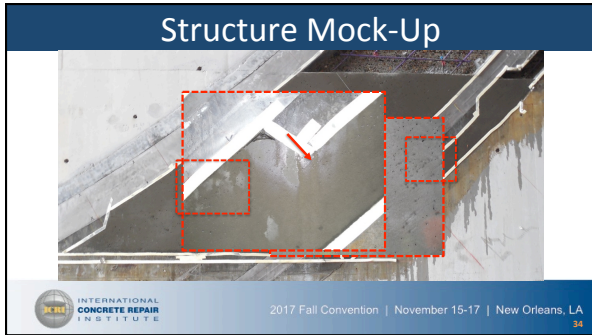
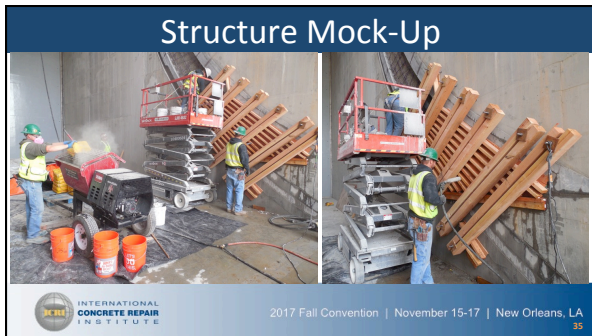
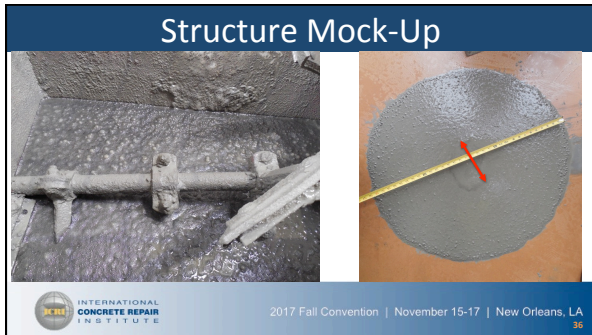
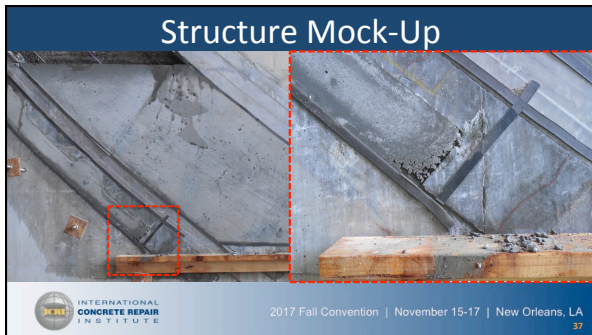
Form Vibration Tests

- Evaluate effect of various external vibration methods on consolidation and surface finish
