MAINTENANCE AND PROTECTION OF CONCRETE FLOOR SLABS IN EXTREMELY HARSH, HEAVY-DUTY ENVIRONMENTS

BY DAVID FLAX

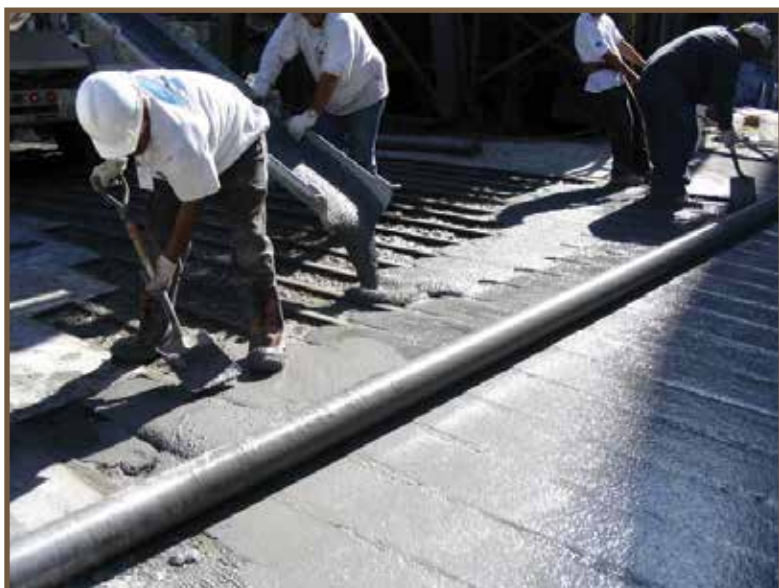
Fig. 1: The problem with railroad rails and the solution with iron aggregate topping

Two systems have commonly been used to address this condition. The first is to put railroad rails in the floor slab upside down so that the flat part is facing up and is flush with the floor slab surface. It sounds like a great idea because it takes a lot to damage a railroad rail. The problem, however, is that the concrete infill between the rails doesn't bond to the rails, which means that for every rail

installed, two joints are created. As a result, chipping and spalling of the concrete infill occurs at the joints from impact and point loads. Figure 1 shows an anode storage area in an Arizona copper mine. The copper anodes weigh hundreds of pounds each and forklifts are continuously placing a dozen or so of them at a time (none too gently) onto the slab. This constant impact causes inches of concrete spalling between the rails as seen at the top of Figure 1. As a side note, steel plates have also been tried instead of the rails, but they come with their own issues. One is that concrete joints around them chip and spall as described above. The other problem is that because they are not bonded on the bottom and the coefficient of thermal expansion for steel is so much higher than concrete, they buckle as temperatures rise. This problem is exacerbated if they are used outdoors. Because of these problems, rails and steel plates are no longer commonly used.

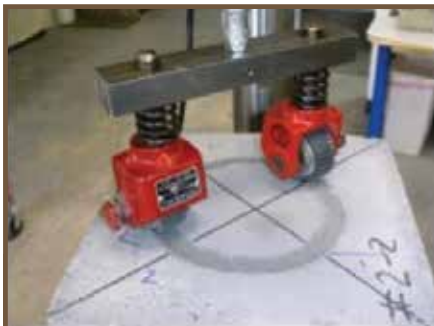
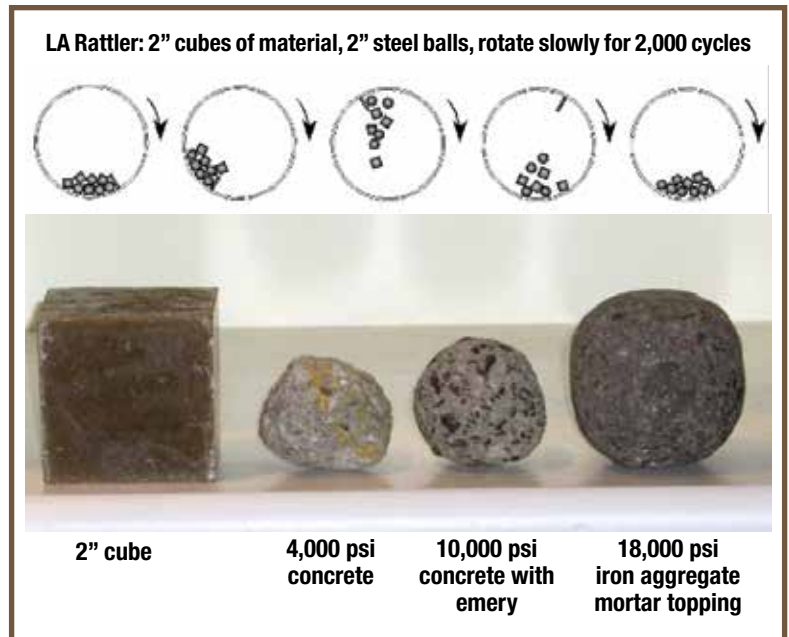
Fig. 2: Iron aggregate dramatically increases impact resistance

The second system to address impact and point loading on floor slabs is to use an iron aggregate topping. Such toppings have been in use for the better part of a century and are primarily comprised of small iron aggregate and chemical admixtures in a cementitious mortar. These toppings have 18,000 psi (124 MPa) compressive strength at 28 days and provide about 6 to 8 times the impact resistance of plain concrete. The LA Rattler test¹ in Figure 2 shows the dramatic improvement in impact resistance with iron aggregate. Figure 1 shows an iron aggregate topping being used to replace the damaged and deteriorated concrete between steel rails. More than a decade later, this repair is still functioning beautifully.

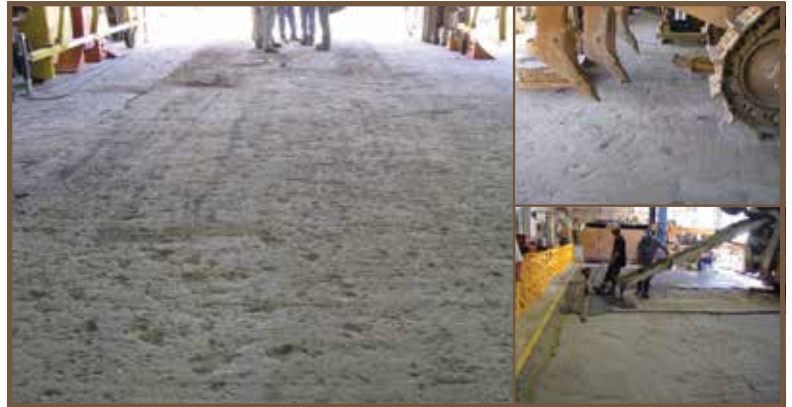
Fig. 3: Tracked vehicle maintenance bay and iron aggregate topping

Figure 3 shows a tracked vehicle maintenance bay. The damage shown on the left in this figure is primarily from impact and point loading, but also

from abrasion, caused by a typical tracked vehicle (upper right in figure). To repair the damage, an iron aggregate topping was placed (lower right in figure) at a minimum 1 in (25 mm) thick, using proper surface preparation and keyed edges at the perimeter of the repair area. This repair was completed over four years ago and it still looks almost like new.

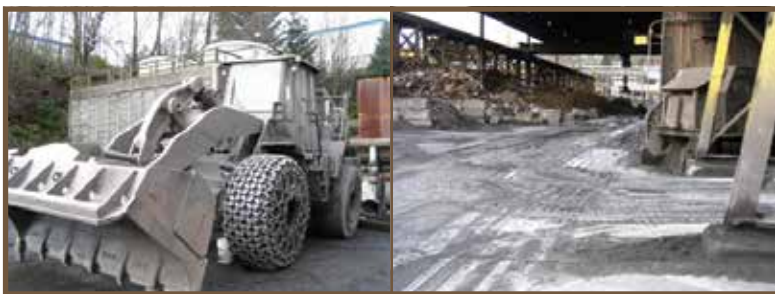
Fig. 5: Iron aggregate topping for thermal shock

A prime example of thermal shock is shown in Figure 5, a steel foundry. The front-end loader carries molten steel to the molds, and along the way it spills some, badly deteriorating the floor slab from the thermal shock. The existing steel rails didn't do much good either. In fact, the rails made the situation worse because as the concrete disintegrated between them, the ride became rougher and more molten steel spilled, causing even more damage. Note that the steel chains on the tires of the front end loader shown in this figure are not for traction, but to prevent the rubber tires from catching fire as they roll through the spilled molten steel. These chains caused the concrete to deteriorate even more quickly. This pavement slab was repaired with an iron aggregate topping that was placed not only between the rails but a couple inches over the rails to bury them completely. This facility has operated for years since this repair and the topping is still doing great. In fact, they have performed the same type of repair at many of their other facilities.

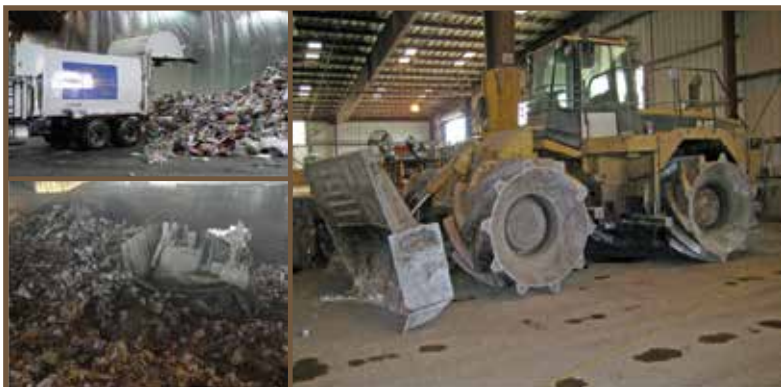
Fig. 6: Solid waste transfer station tipping floor—impact and point loads, abrasion, and chemical attack

Solid waste transfer stations are a good example of the need for chemical resistant floor slabs. Figure 6 shows the process. A garbage truck dumps onto the tipping floor where there is plenty of impact as construction debris, cranks, etc., hit the floor slab (upper left in figure). A steel tracked vehicle drives over the trash (lower left in figure) to break

it up as small as possible so that more can fit into a container that will be hauled to the landfill. Obviously, there is plenty of point loading from this process. The next step is to use the blade to push the broken up garbage to the pit where it falls into a container to be hauled away. Abrasion galore in this process. The photo on the right in Figure 6 shows an even more aggressive piece of equipment. Imagine the damage from those steel wheels as they crush the trash and then push it to the pit. And through all of this, the floor is being bathed in chemicals as the bottles and containers in the trash are crushed and broken, such as restaurant food wastes, sulfuric acid, citric acid, chlorine, paint thinner, cleaning compounds, detergents, solvents, salt, cola, beer, etc.
