# RESTORING THE LANCASTER BUILDING FAÇADE USING PHOTOGRAMMETRY

BY DIEGO ROMERO AND ALFREDO BUSTAMANTE

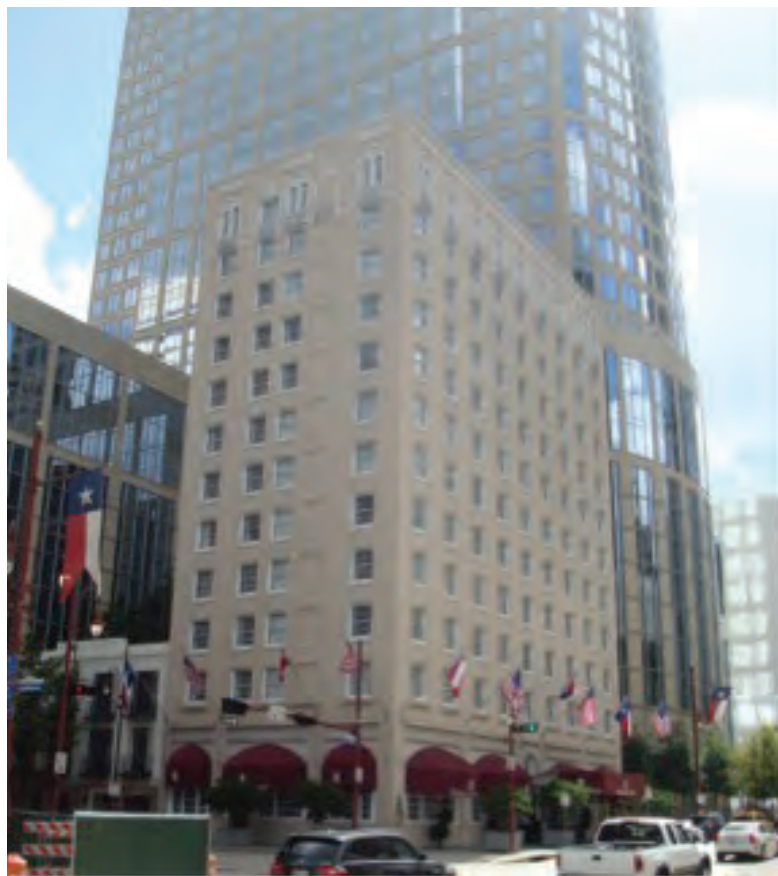
The historic Lancaster Houston Hotel, located in Houston, TX, is a twelve-story structure built in 1926 (Fig.1). Originally known as “The Auditorium Hotel,” the Lancaster was designated a Recorded Texas Historic Landmark by the Texas Historical Commission (THC) in 1984. The hotel was also accepted into the Historic Hotels of America Program of the National Trust for Historic Preservation, representing the Jazz Age, in 2010.

Fig. 1: Overall view of Lancaster Hotel in foreground

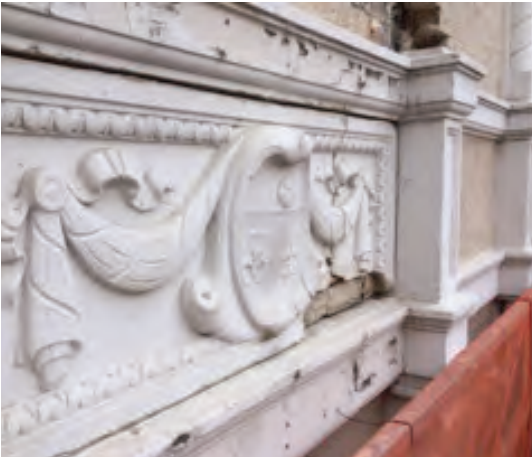
A series of evaluations were performed between 2002 and 2014 to assess the condition of the façade. The evaluations included a binocular survey from the ground and adjacent structures, close-up observation from suspended scaffolding, and laboratory analysis of selected exterior wall materials. The most significant deterioration occurred on the top level of the structure on the south and west elevations. Typical observations included cracks at the spiral columns and mortar joints, localized surface spalling of cast stone trim and spandrel panels (Fig. 2 and 3), and missing ornamental cast stone spiral columns and brackets (Fig. 4).

The deterioration was determined to be a result of the lack of adequate cover of the cast stone reinforcement as well as water infiltration into the exterior wall which resulted in corrosion of the façade anchors. Based on our conclusions, we recommended sealing façade cracks greater than 0.012 in (0.3 mm) in width, repairing localized cast stone and masonry spalls in the facade, and removing deteriorated cast stone units and replacing them in kind. The cast stone replacement encompassed a total of 28 column and bracket units and 14 spandrel panels.

Fig. 2: Typical deteriorated façade spandrel panel

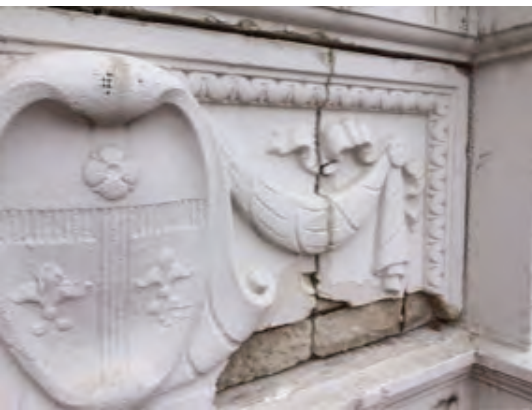
Fig. 3: Cracked and spalled cast stone at façade spandrel panel

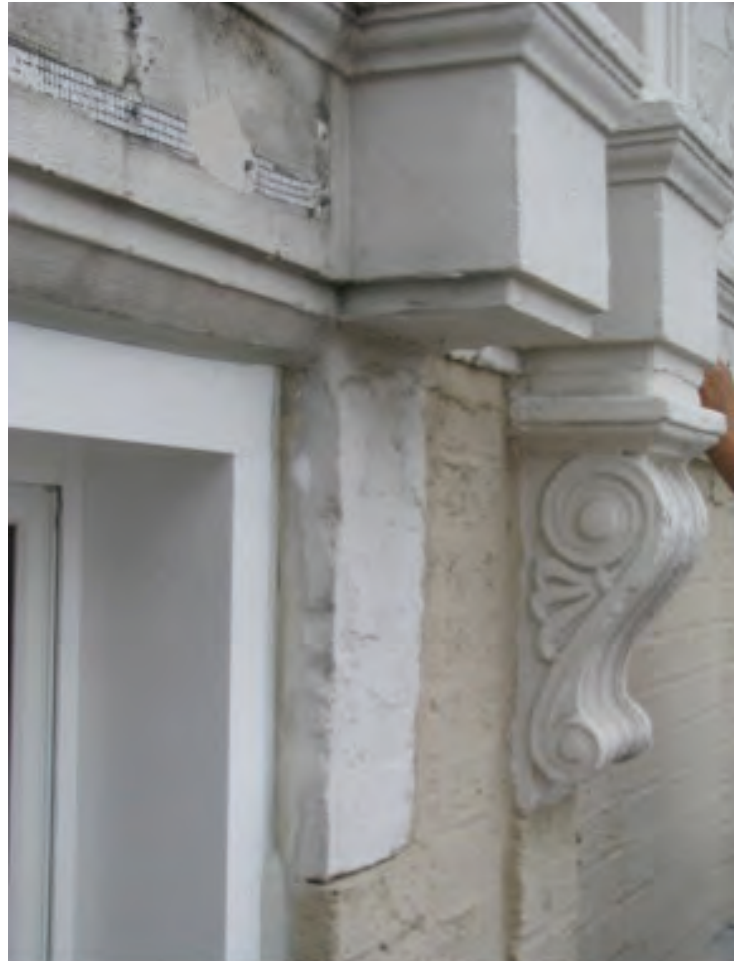
Fig. 4: Missing architectural façade bracket

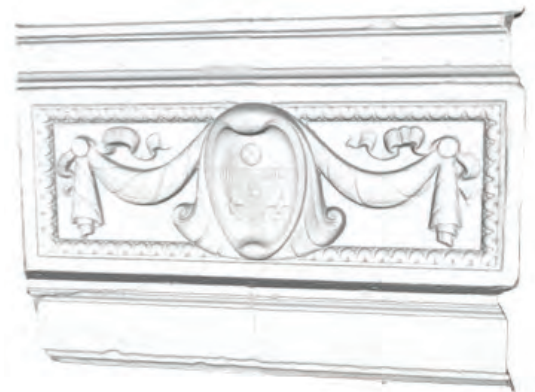
The general procedure was as follows: While on the suspended scaffold, hundreds of photographs were taken of the spandrel panels, columns, and brackets using indicator targets in the objects so the photogrammetry software is able to recognize similarities between photographs. The photographs were then manually sorted to delete photographs that were either blurry or not part of the data set needed. Once sorted, the photographs were uploaded to a commercially available photogrammetry software package to process the point cloud. Once processed, the point cloud was imported to a free and open-source 3D modeling software in order to create a solid surface mesh that connects all of the points in the point cloud (Fig. 5). The time it takes to process a mesh is highly dependent on the complexity of the geometry and the density of the point cloud. For reference, the decorative spandrel took approximately three hours to generate the point cloud, one hour to mesh, and six hours to edit the model and complete the final touches.

Fig. 5: 3D model of spandrel panel developed with photogrammetry

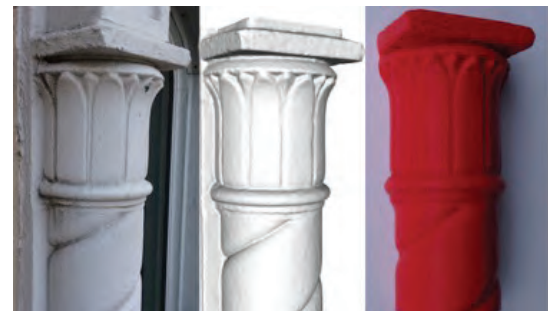
tion. A partial model of the spiral column and capitol was generated, edited, and printed using a MakerBot 3D printer and biodegradable thermoplastic aliphatic polyester filament, commonly known as PLA. The result was a miniature version of the column with all its surface defects and details (Fig. 6). Pleased with the results, it was time to move forward with the full scale replica of the spandrel panel.

Fig. 6: Left - Existing decorative column, Middle - 3D model of column, Right - 3D print of model

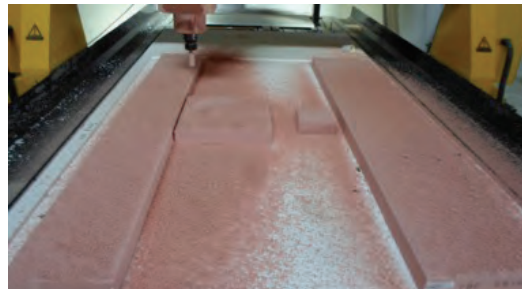
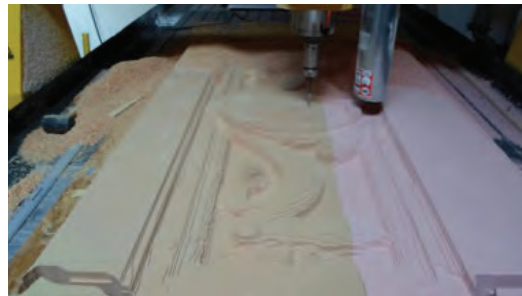
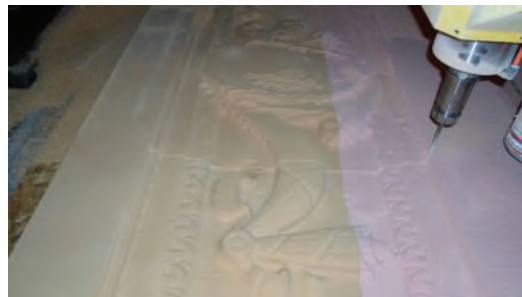
A Stereo Lithography (STL) file was exported and sent to the manufacturer. This file format is widely used for rapid prototyping, 3D printing, and computer-aided manufacturing. Using a three axis CNC machine, a foam master copy of the spandrel panel was milled and sanded (Fig. 8-10). The final master copy coated with polyurethane was delivered to the project site ready for the mold-making process (Fig. 11).

Fig. 8: Beginning of foam milling process

Fig. 9: Fabricating foam panel using CNC mill

Fig. 10: Final detailing process

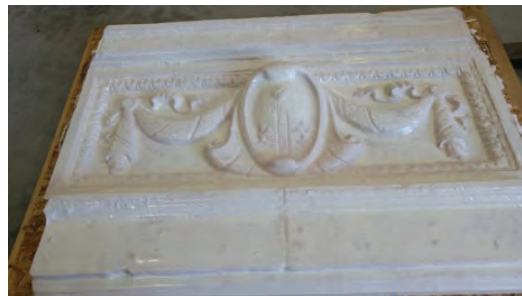
Fig. 11: Foam panel master copy coated with polyurethane

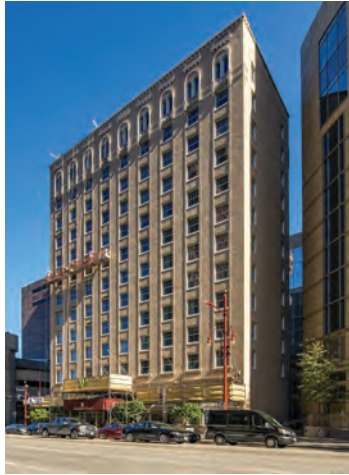
Fig. 12:  
Contractor  
performing  
repairs on  
south elevation  
of the Lan-  
caster Hotel

The spandrel panels are currently being cast using a mold created from the foam panel and will be installed thereafter (Fig. 12). Based on this project experience, we are confident that photogrammetry can be implemented in any project requiring replacement of ornate or historical building features without the risk of damaging the existing conditions of the façade and at the same time, reducing design and construction costs.
