Maintenance with Style Stadium Waterproofing Case Study

David G. Tepke, PE, NACE CS / PCS
SKA Consulting Engineers

Nissan Stadium

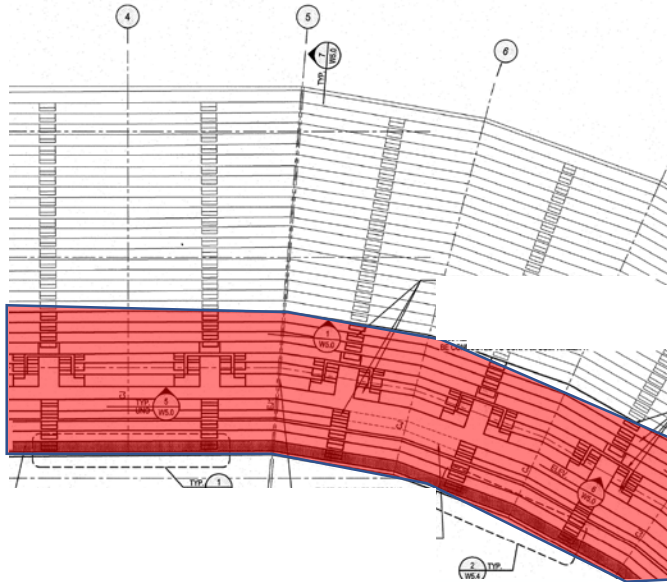
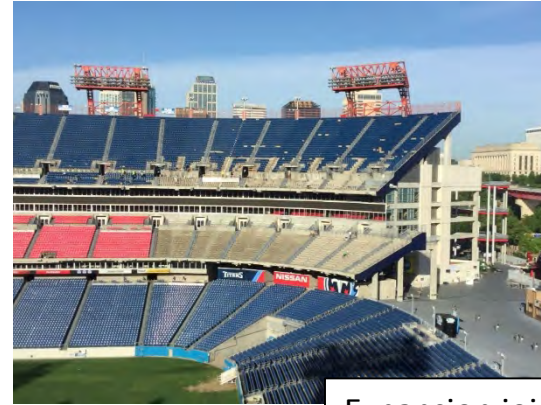
Upper Deck Areas over Suites

Expansion joints
Sealants
Steps and landings
Overlay at Row A
Concrete repairs
Deck coatings
Rails
Connections

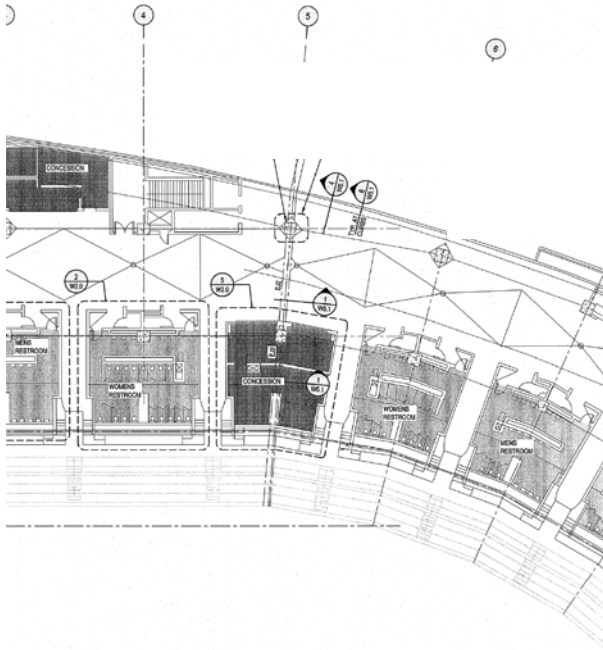
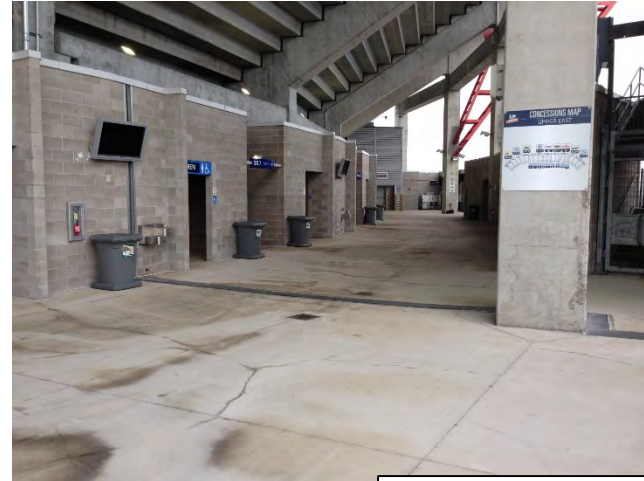
Upper Concourse Areas

Expansion joints
Sealants
Topping slab
Concession stands
and restrooms

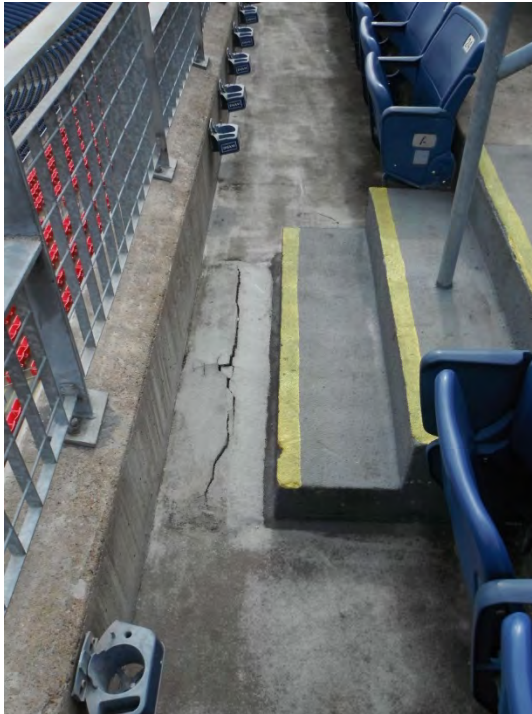
Row A Repairs

- Distress
- Ponding
- Insufficient slope

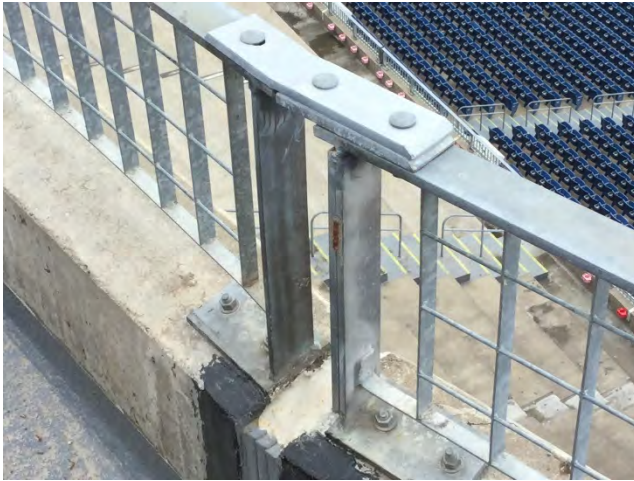
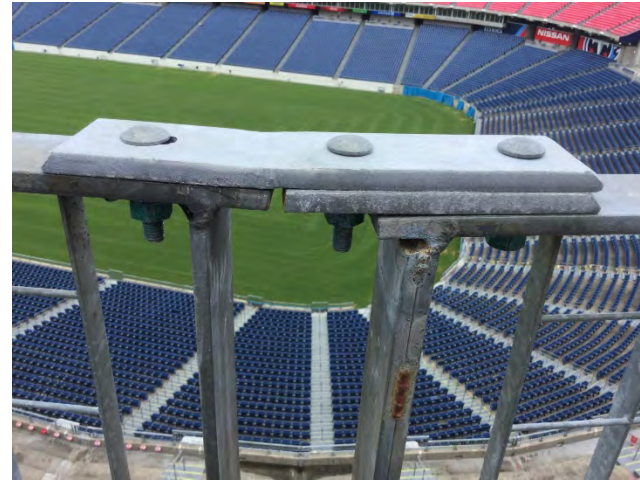
Row A Rail Supplements

- Sloped overlay made landing necessary
- Landing made rail modifications necessary

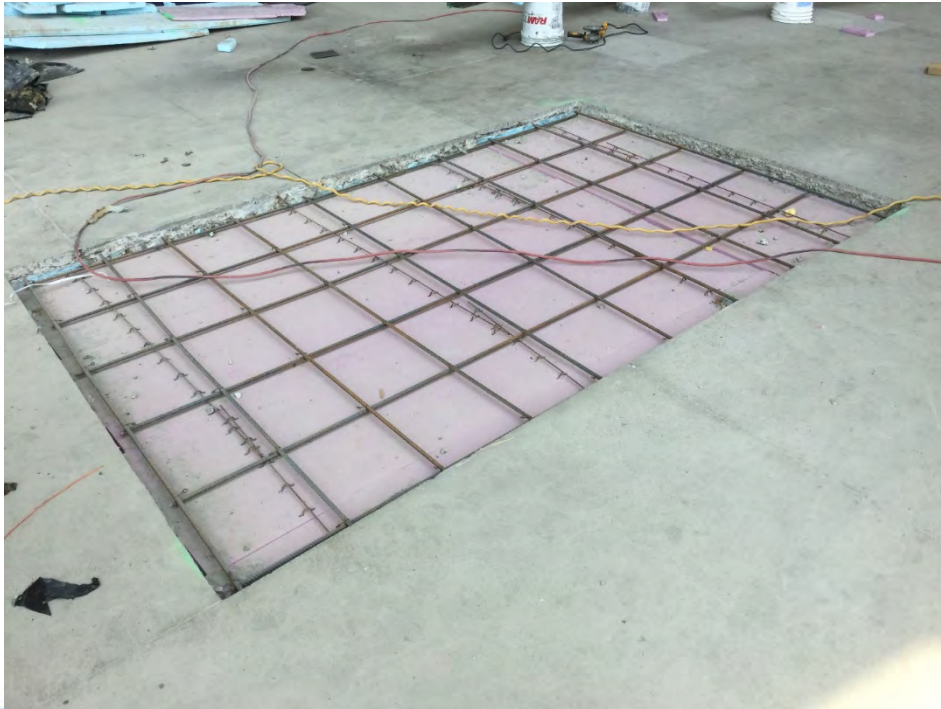
Concourse Topping Slab Repairs

- Very thin / weak
 - More heavily reinforce and make thicker where possible
- Additional load if thicker
 - Lightweight concrete and consideration of substrate
- Insulation / Condensation
 - Analysis to determine if board can be removed
- Loads
 - Stronger insulation board
