## Beyond Chain Dragging – Concrete Bridge and Parking Deck Assessments Impact Echo and Surface Waves Scanning for Bare and Asphalt Overlaid Decks

Larry D. Olson, P.E.

Olson Engineering, Inc.  
Olson Instruments, Inc.

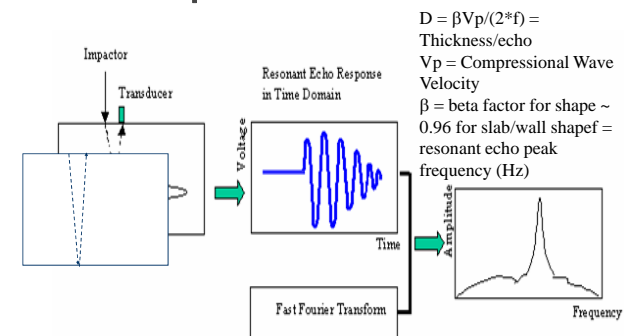
## Impact Echo Test

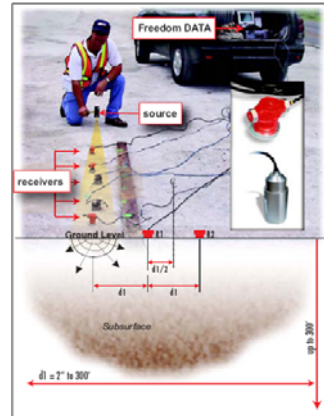
## Spectral Analysis of Surface Waves (SASW)

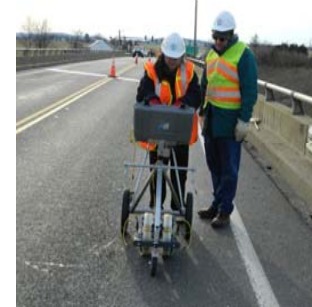
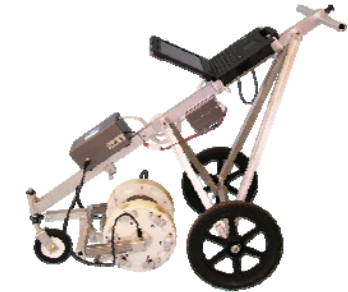
Surface Sonic Scanner S<sup>3</sup> slow-rolling IE/SASW on Cart on Virginia Asphalt Overlaid Deck with tests every 6 inches and latest S<sup>3</sup> on right with bright sunlight viewable screen

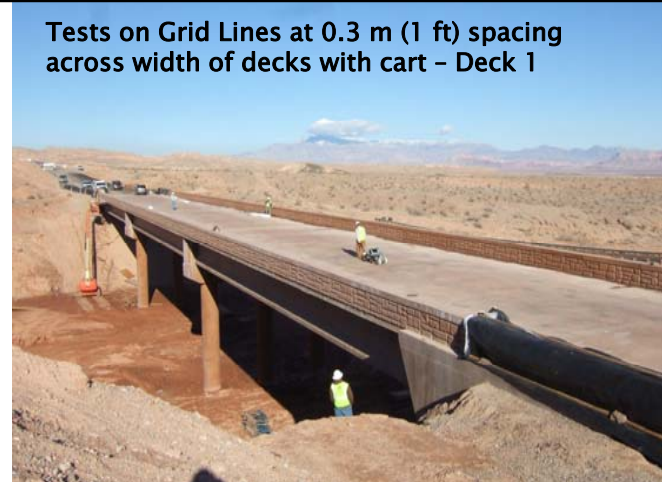
**Tests on Grid Lines at 0.3 m (1 ft) spacing across width of decks with cart – Deck 1**

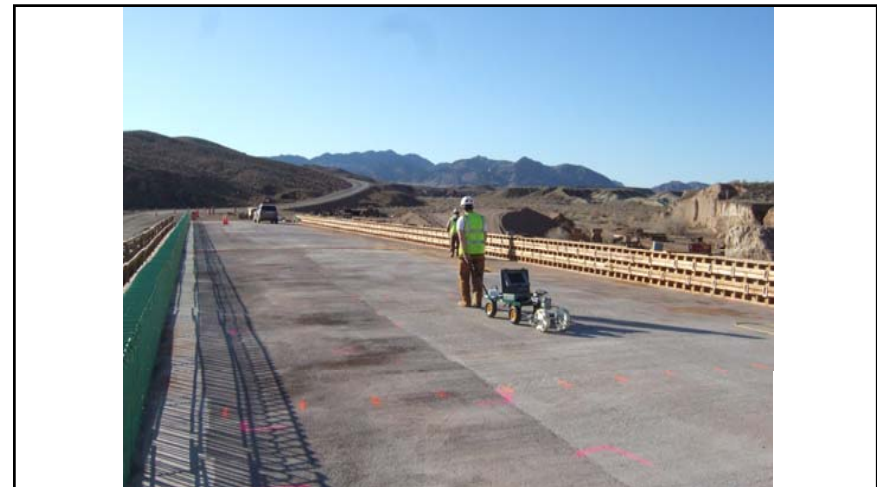
**Bridges supported by concrete I-beams, diaphragms, and piers**

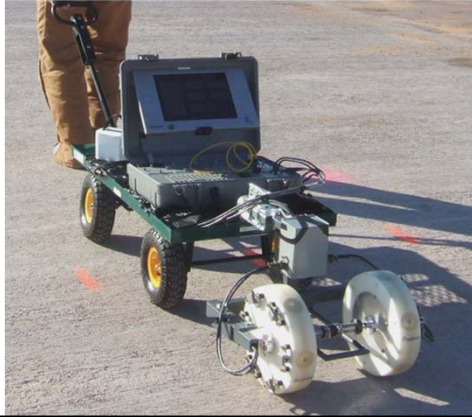
**Bridge Deck Scanner w/ hand-pulled cart for rapid testing - note rough concrete tested well**

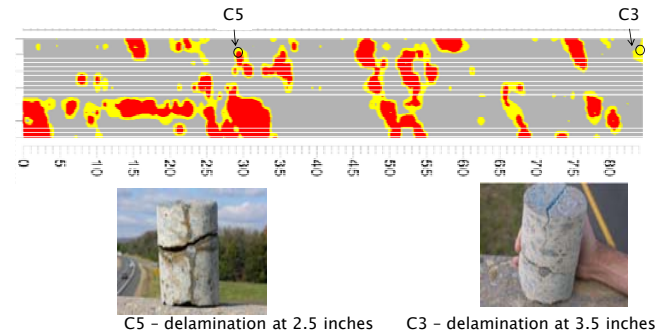
**Comparisons between IE Test Results and Cores**

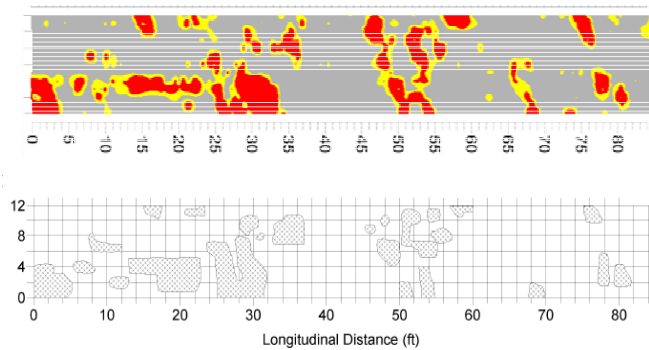
**Top Delamination Test Results from the Surface Sonic Scanner (top) and Chain Dragging Acoustic Sounding Results by Rutgers University (bottom)**

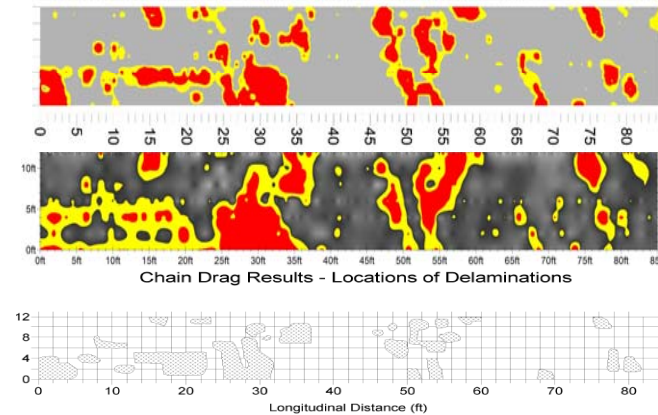
## Top Delamination Test Results from the Impact Echo (top), GPR (middle) and Acoustic Sounding - VA Deck

- ▶ Impact Echo Scanning had the most resolution of Top Delaminations on concrete bridges
- ▶ IE identified bottom delaminations as well as profiling deck thickness echoes. GPR method is not sensitive to bottom delaminations
- ▶ Spectral Analysis of Surface Waves (SASW) for cracking damage due to freeze-thaw, Alkali-Silica/Aggregate Reactions, general condition assessment

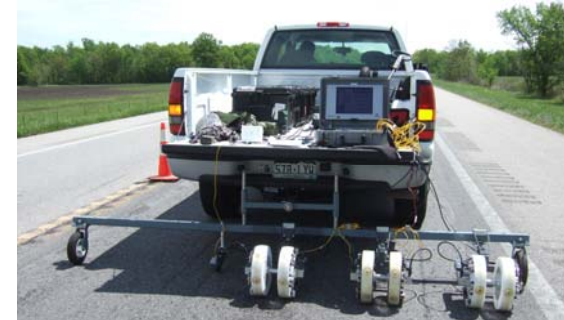
Prototype Pavement Scanner on Kansas Asphalt Pavement site with 3 pairs of wheels spaced 150 mm (0.5 ft) apart for combined Impact Echo and Spectral Analysis of Surface Waves scanning.

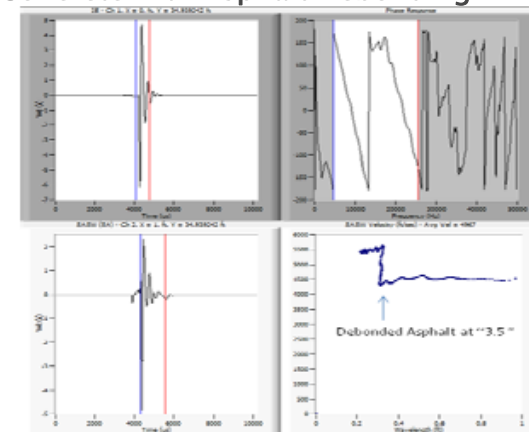
### Sound Concrete with Asphalt Debonding

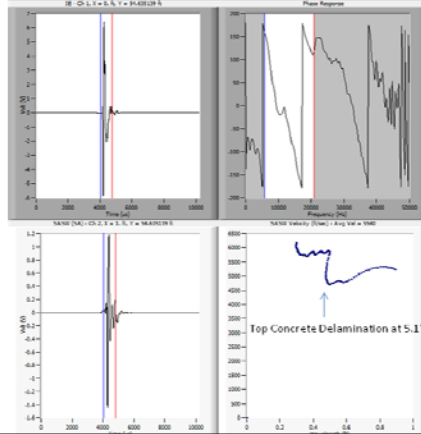
### Bonded Asphalt on Concrete with Top Delamination

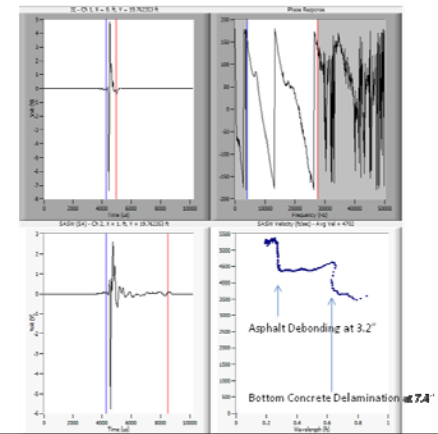
### Debonded Asphalt / Concrete with Bottom Delamination
