October 12, 2021  
ICRI 2021 Fall Convention

# Forensic Structural Engineering and Structural Failure

# Pedestrian Bridge Collapse

Miami, Florida  
March 15, 2018

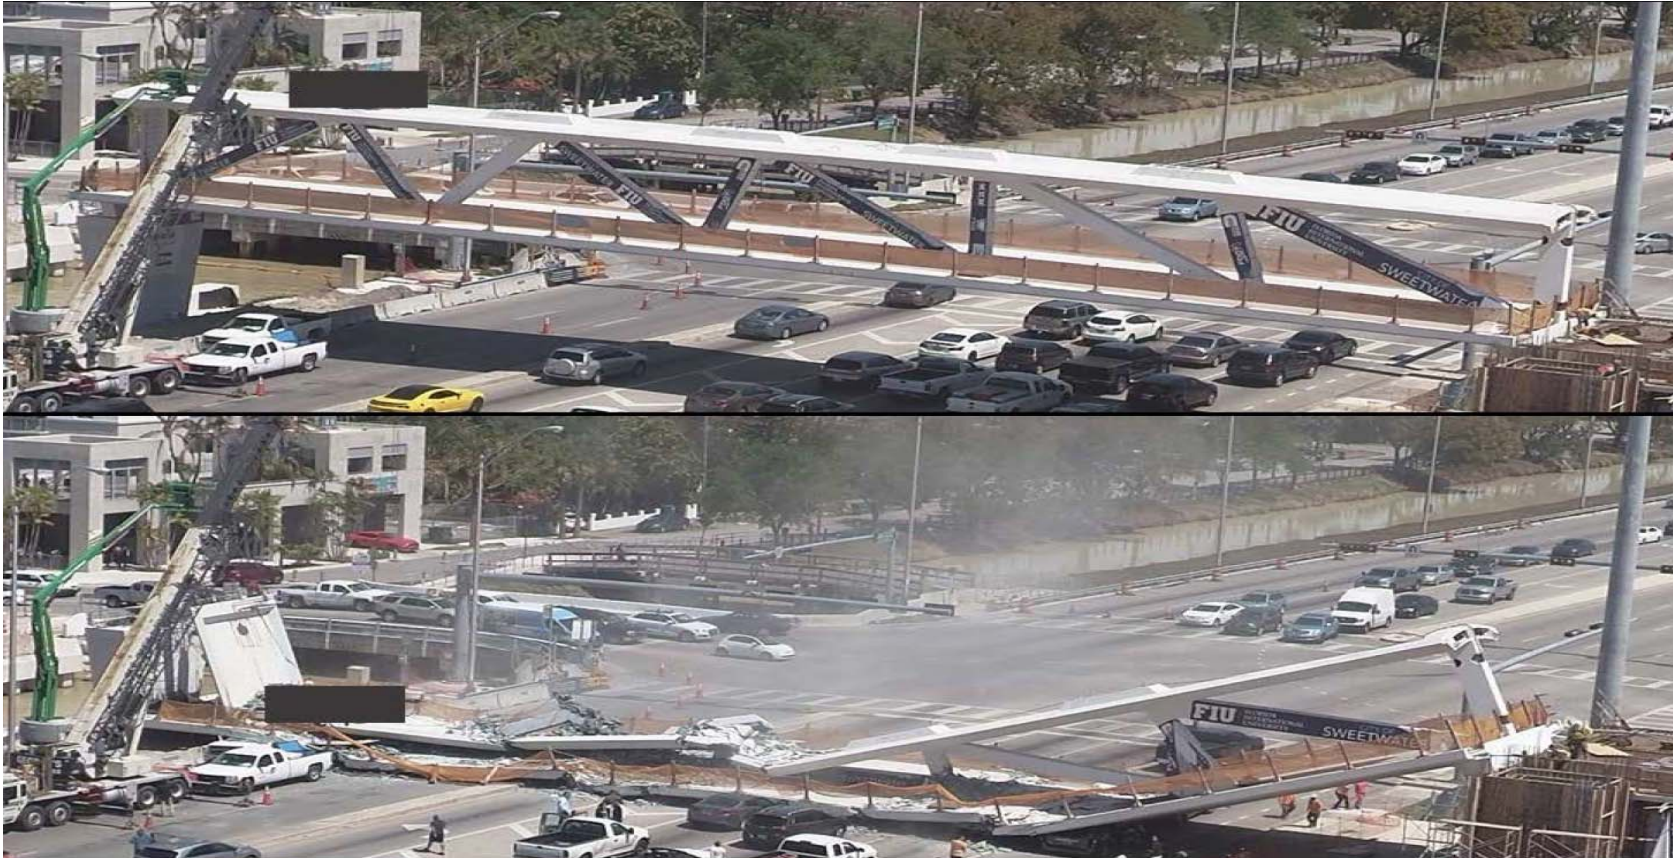
# Scene Diagram Of Vehicles Under Or Proximate To Bridge At Time Of Collapse

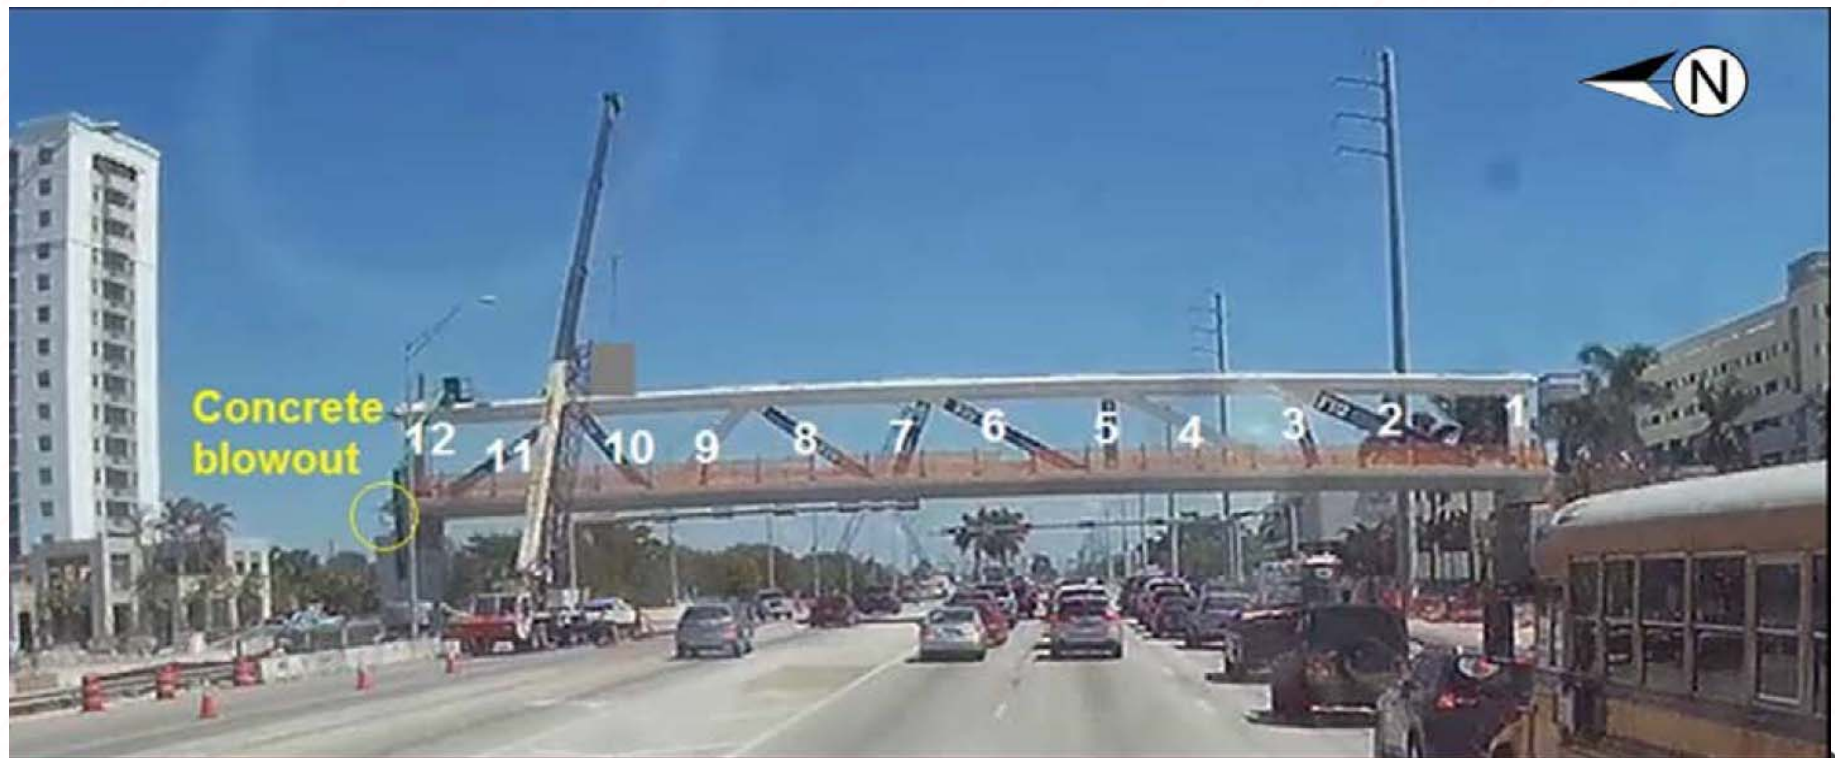
Still image (time stamp 13:46:43:881) from in-vehicle mounted video camera on pickup truck traveling east on SW 8th Street, showing concrete dust and debris blowout at north end (pylon pier), March 15, about 1:46 p.m.

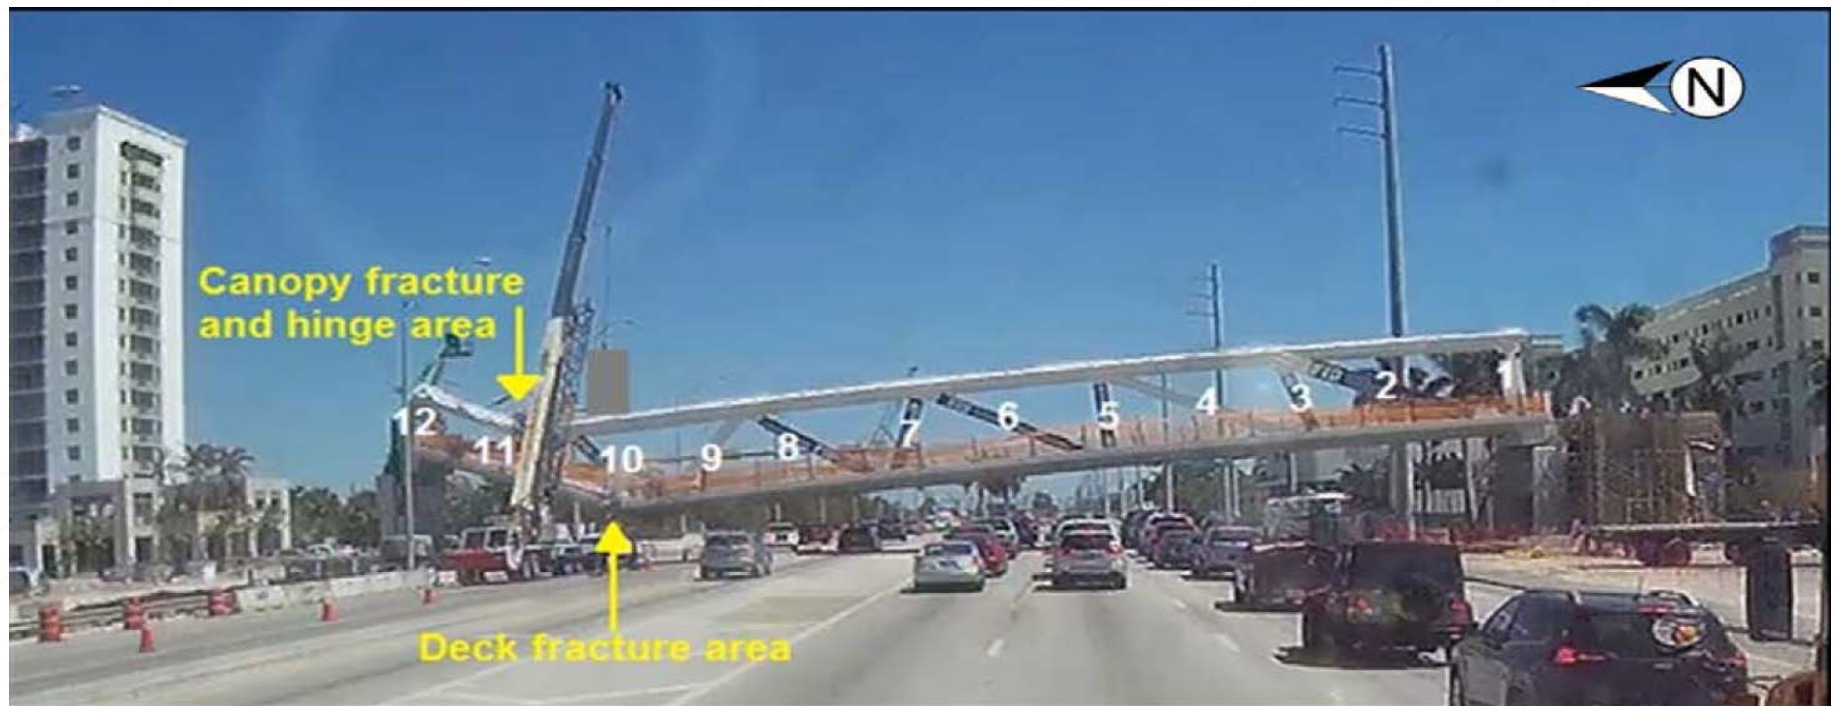
Still image (time stamp 13:46:44:046) from in-vehicle mounted video camera on pickup truck traveling east on SW 8th Street, showing full-width canopy fracture and deck fracture areas at north end (pylon pier), March 15, about 1:46 p.m.

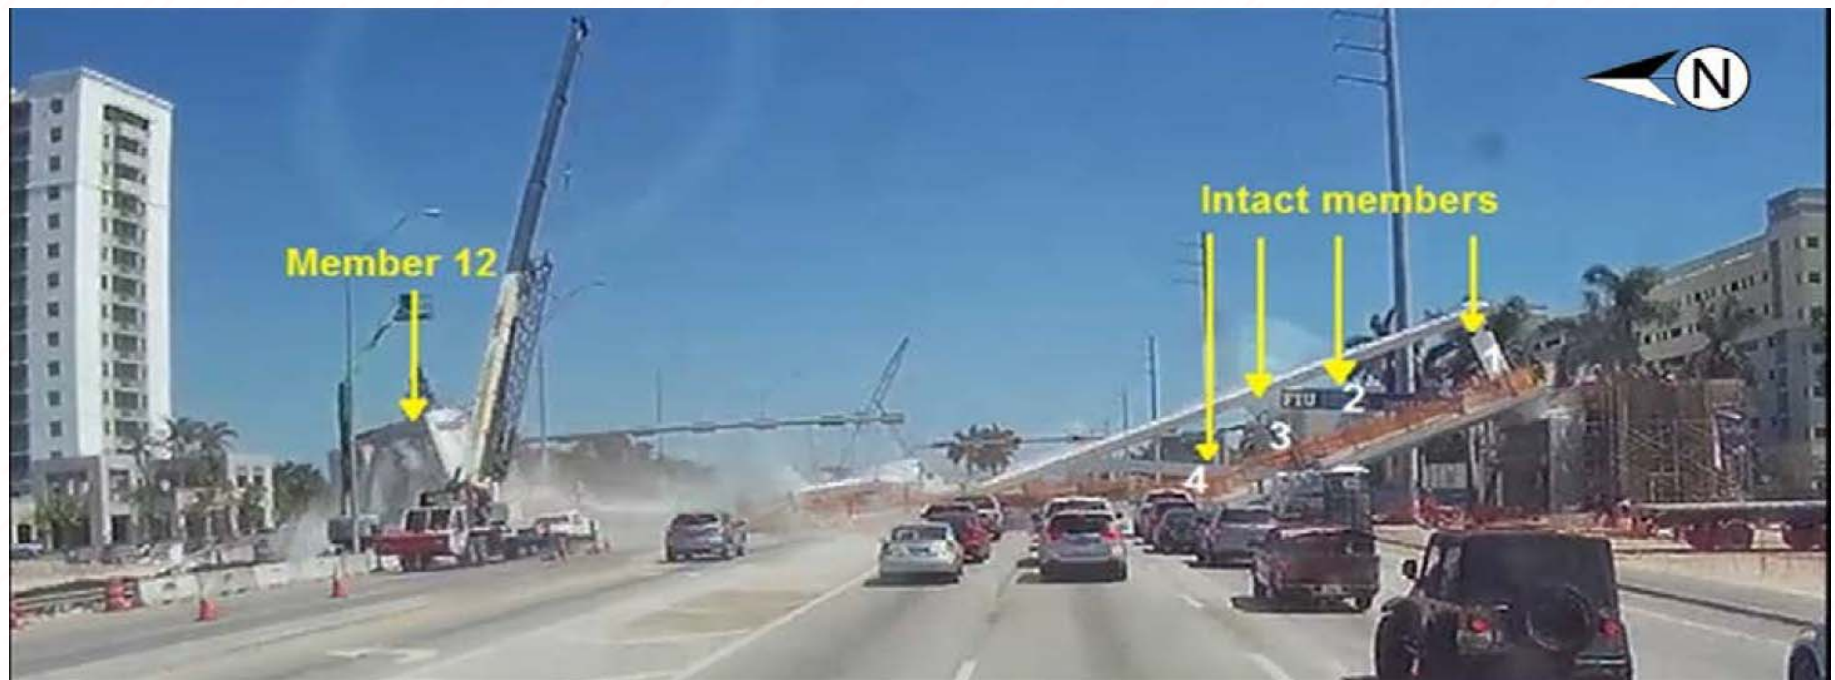
Still image (time stamp 13:46:44:310) from in-vehicle mounted video camera on pickup truck traveling east on SW 8th Street, showing main span completely collapsed, March 15, about 1:46 p.m.

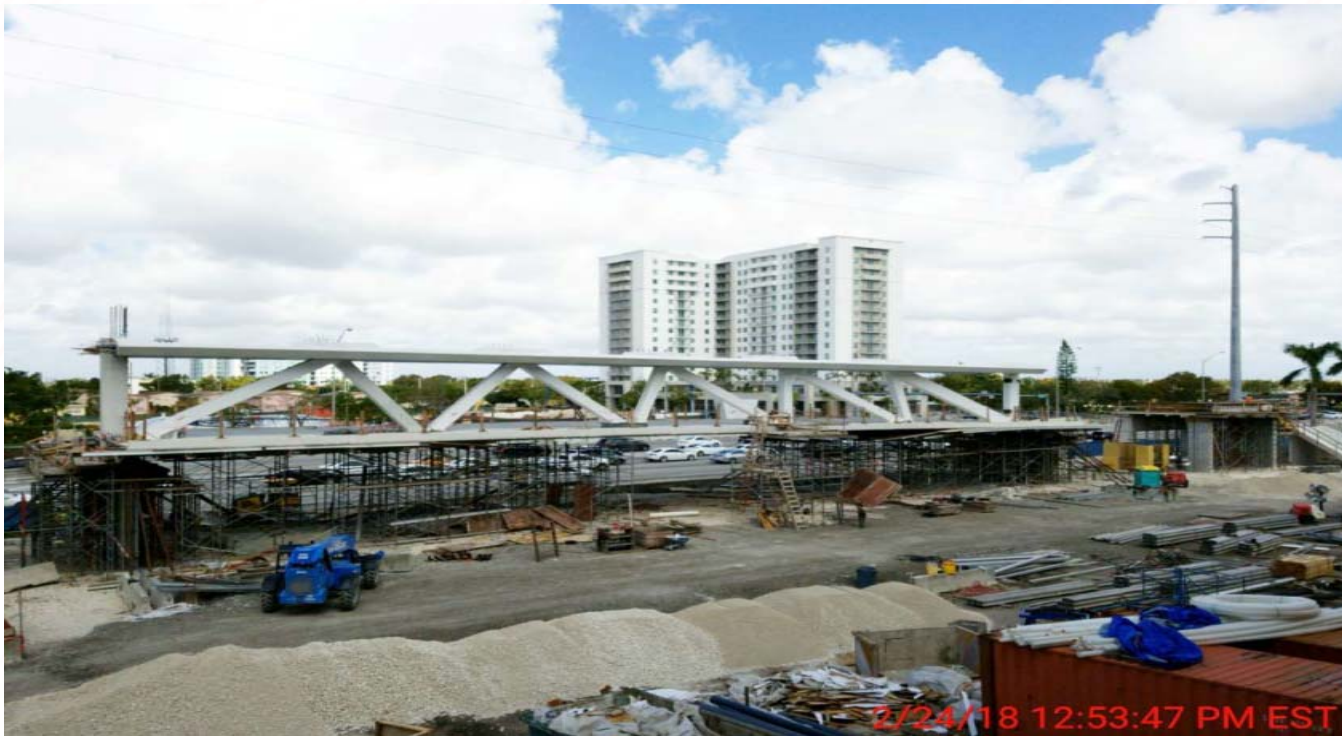
**Temporary falsework supporting the bridge span in the casting yard on February 24, 2018, being sequentially removed from the middle of the span toward the ends of the span**

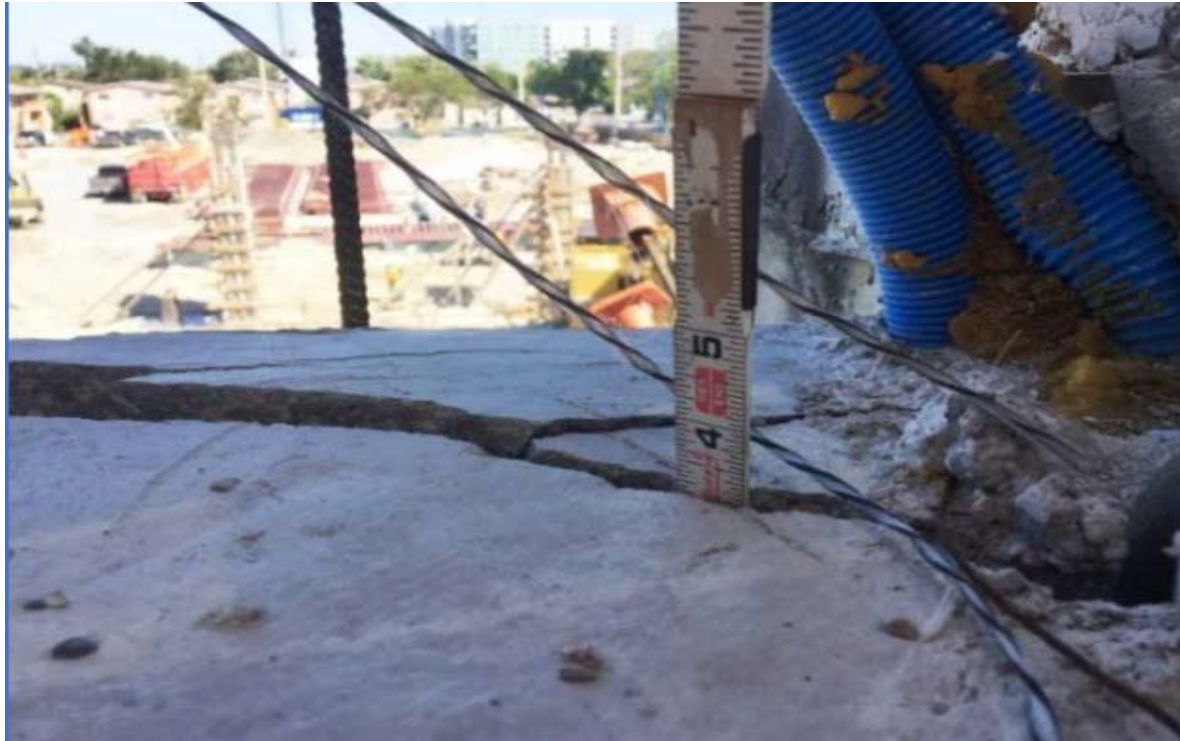
**Cracks of 3–4 inch depth at northern end of precast main span, along west side of diaphragm 2 (north view), March 13, 11:17 am**

- Load and capacity calculation errors in design of the main span truss member 11/12 nodal region and connection to the bridge deck
- Inadequate peer review
- Failure to identify the significance of the structural cracking observed in this node before the collapse and to obtain an independent peer review of the remedial plan to address the cracking
- Fail to cease bridge work when the structure cracking reached unacceptable levels and to take appropriate action to close SW 8th Street as necessary to protect public safety

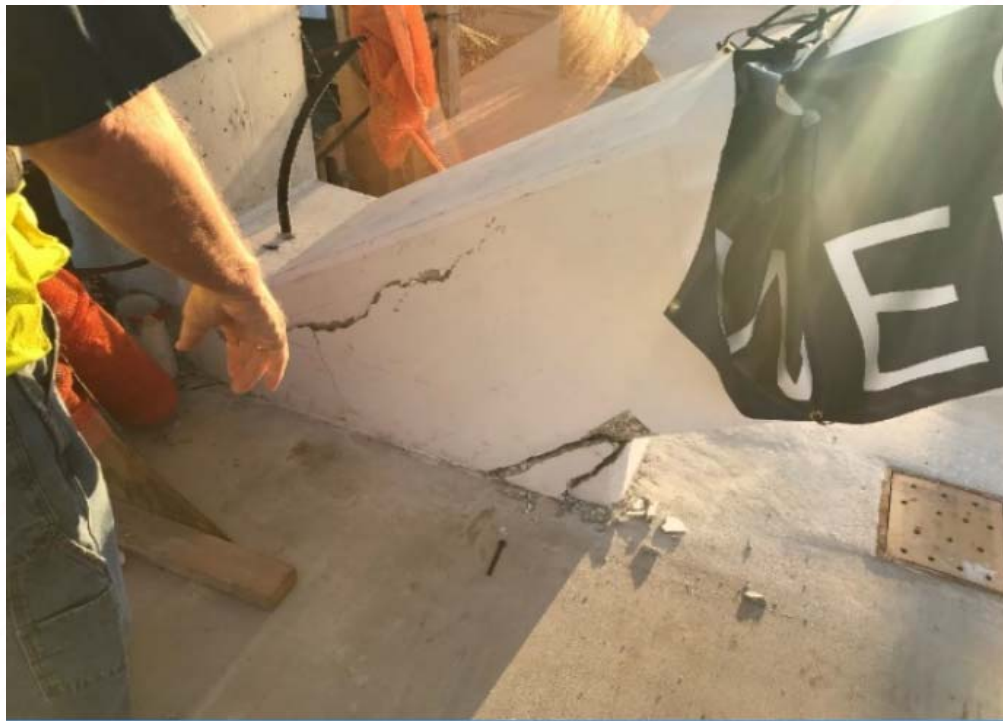
## Cracks at bottom of diagonal member 11 (west view), March 15

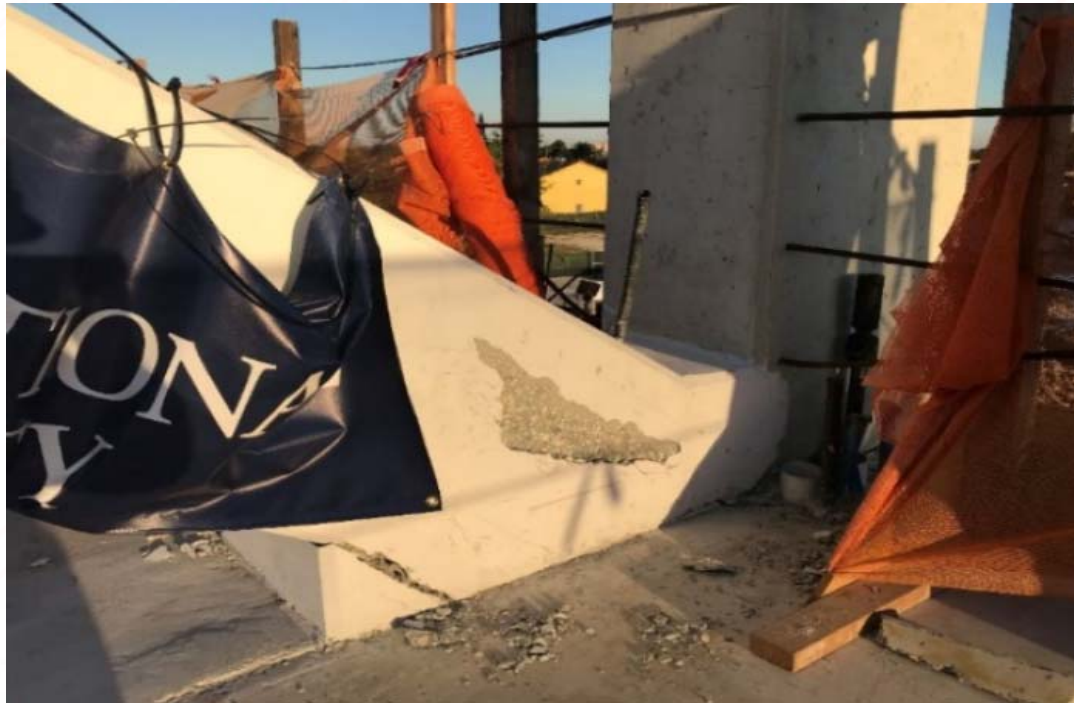
## Cracks at bottom of diagonal member 11 (east view), March 15
