October 13, 2021
ICRI 2021 Fall Convention

A Case Study in Corrosion, ASR, and More: Evaluation and Repair of Reinforced Concrete Flood Channels

Kerry Kreitman
Project Engineer
Pivot Engineers

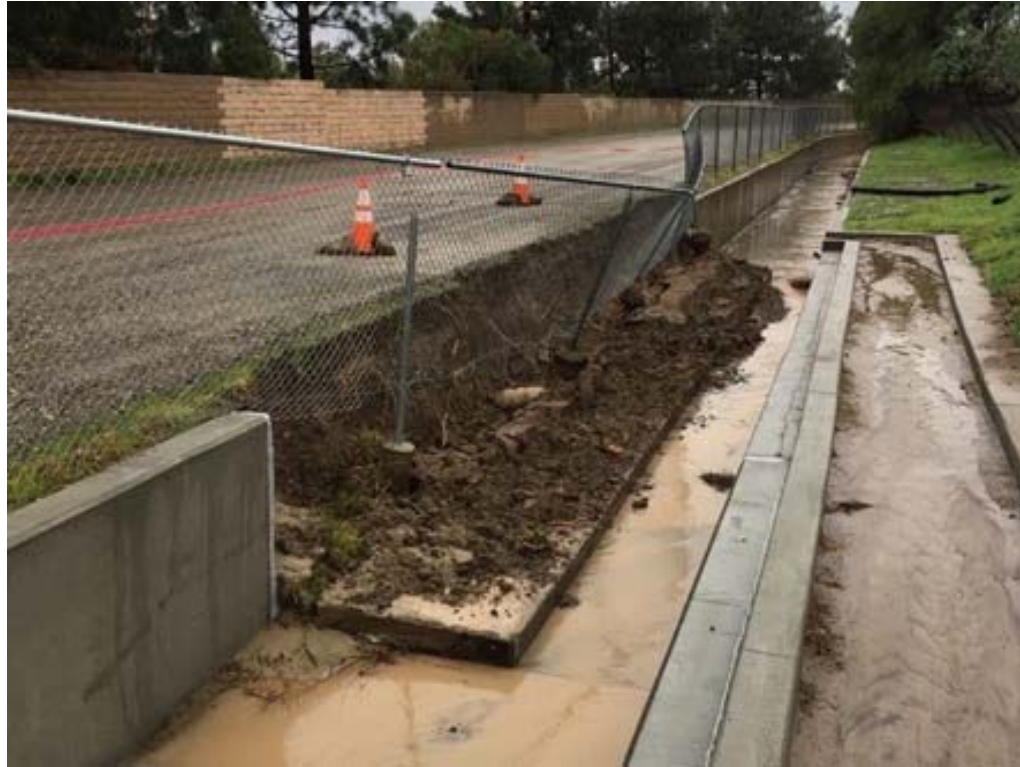
8' wide channel, 4' tall wall

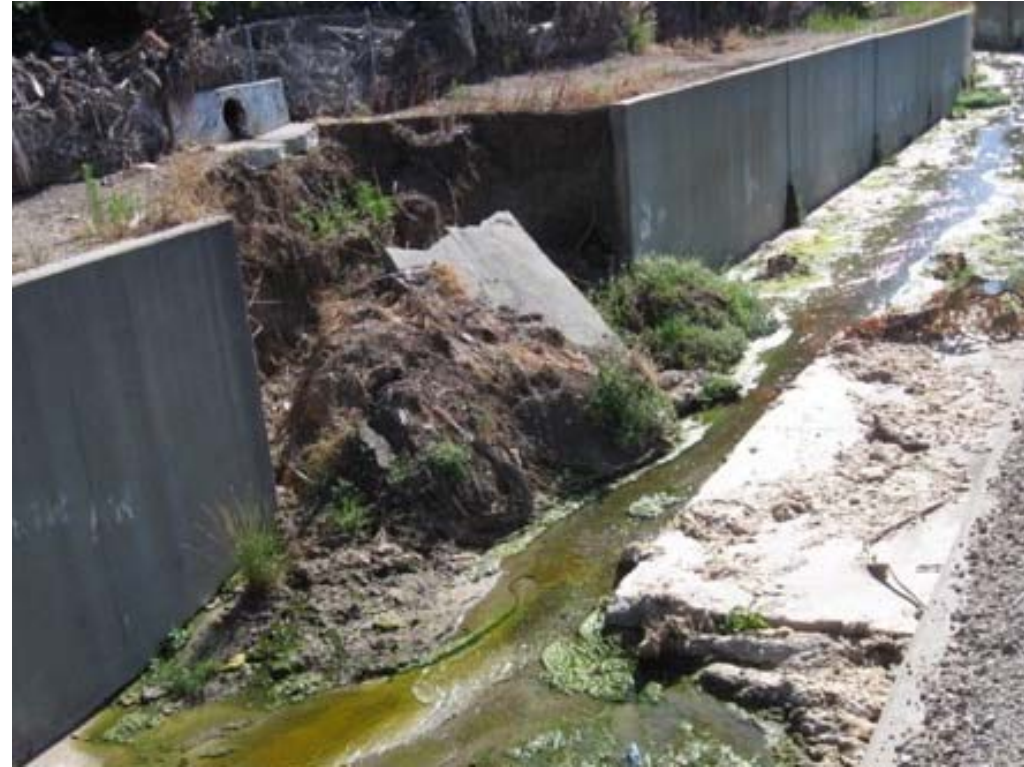
30' wide channel, 16' tall wall

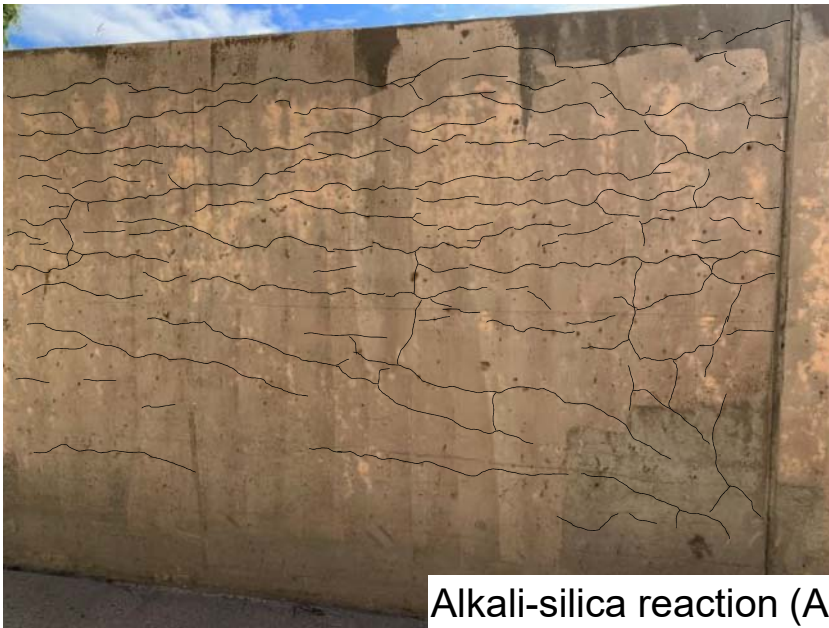
Alkali-silica reaction (ASR)

ASR: Repairs

- Primary repair goal – prevent water ingress into cracks on top face of wall to mitigate expansion
 - Route and seal cracks on top face of walls
 - For wide cracks on top face of walls, inject or gravity feed grout or epoxy to fill internal (subparallel) cracks
- Future repair considerations – if indications of structural impacts develop, provide alternate means of force transfer across subparallel cracks
 - Install epoxied tie rods through wall thickness

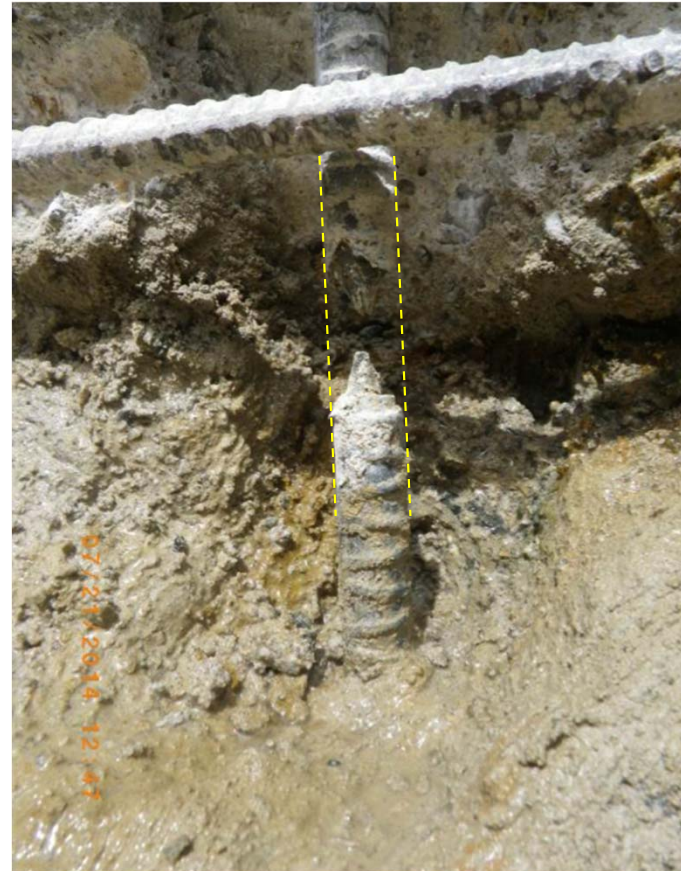
Reinforcement Corrosion: Localized

- Corrosion occurs only at isolated locations subjected to corrosion-inducing conditions
 - For example, at a poor-quality construction joint

Photograph from Whitlock, Dalrymple, Poston and Associates' previous investigation of these flood channel walls

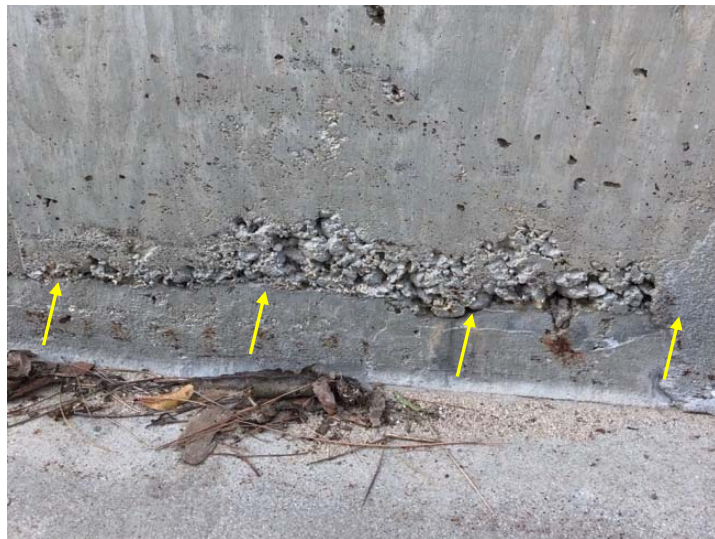
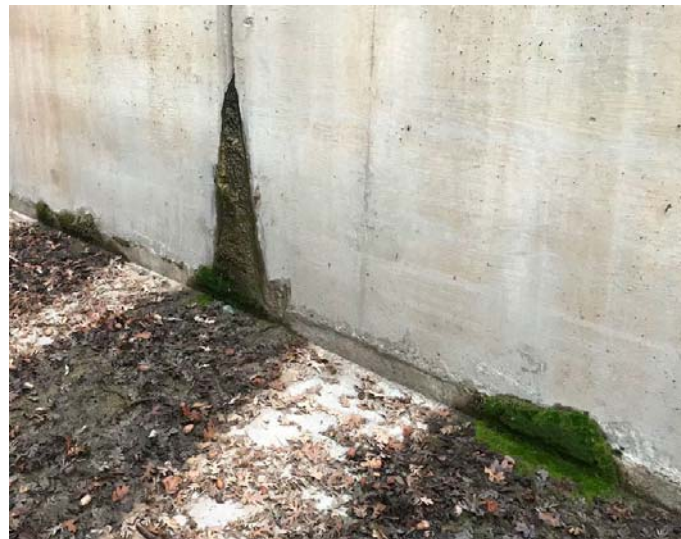
Localized Corrosion: Investigation

- Investigation methods:
 - Visual observations
 - Nondestructive testing
 - Destructive verification

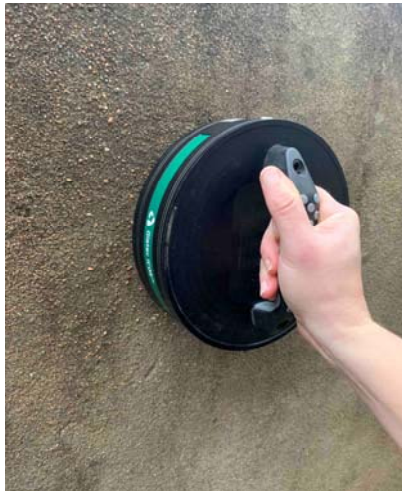
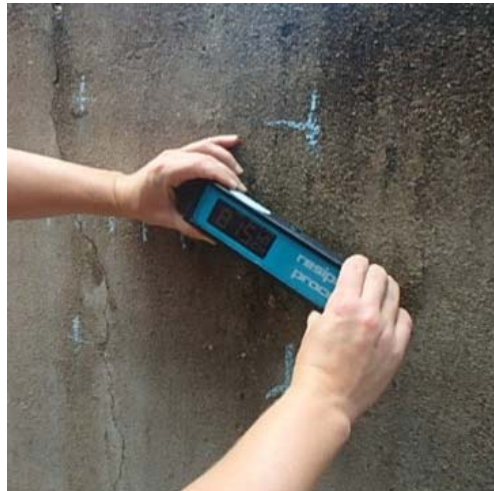
Localized Corrosion: Investigation

- Investigation methods:
 - Visual observations
 - **Nondestructive testing**
 - Destructive verification

- Limitations of NDT methods for (localized) corrosion:
 - Results reflect instantaneous conditions only
 - Ineffective for bars farther from surface (~3" depth max)
 - Concrete resistivity has minimal impact on localized corrosion
 - Corrosion rate measurements have not been developed for localized corrosion conditions

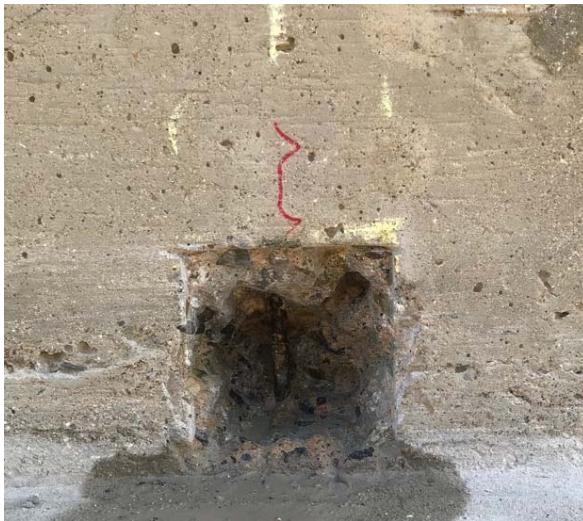
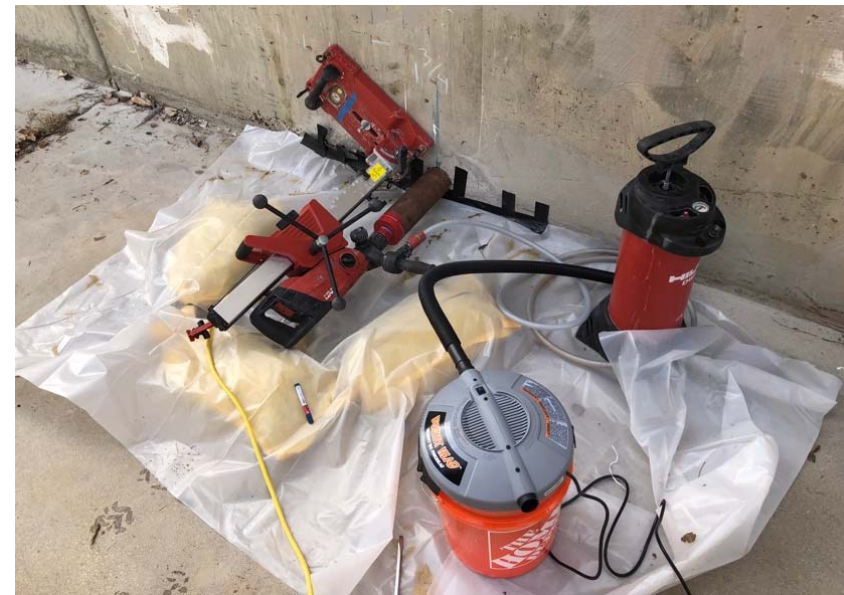
Localized Corrosion: Investigation

- Investigation methods:
 - Visual observations
 - Nondestructive testing
 - **Destructive verification**

- Localized corrosion is most likely cause of wall failures to date
- Moisture availability is most important risk factor
- Destructive verification is most reliable identification method

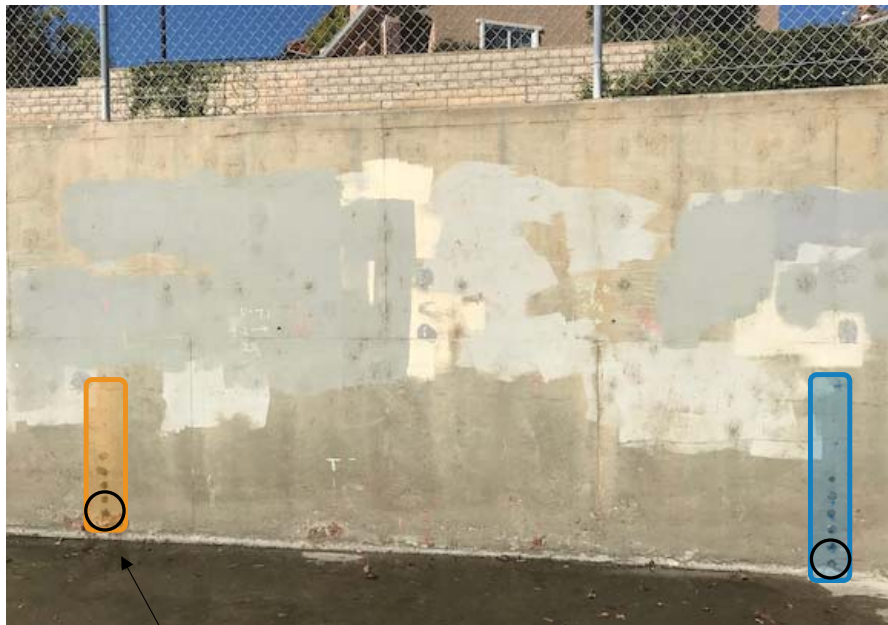
Localized Corrosion: Findings

Corrosion staining

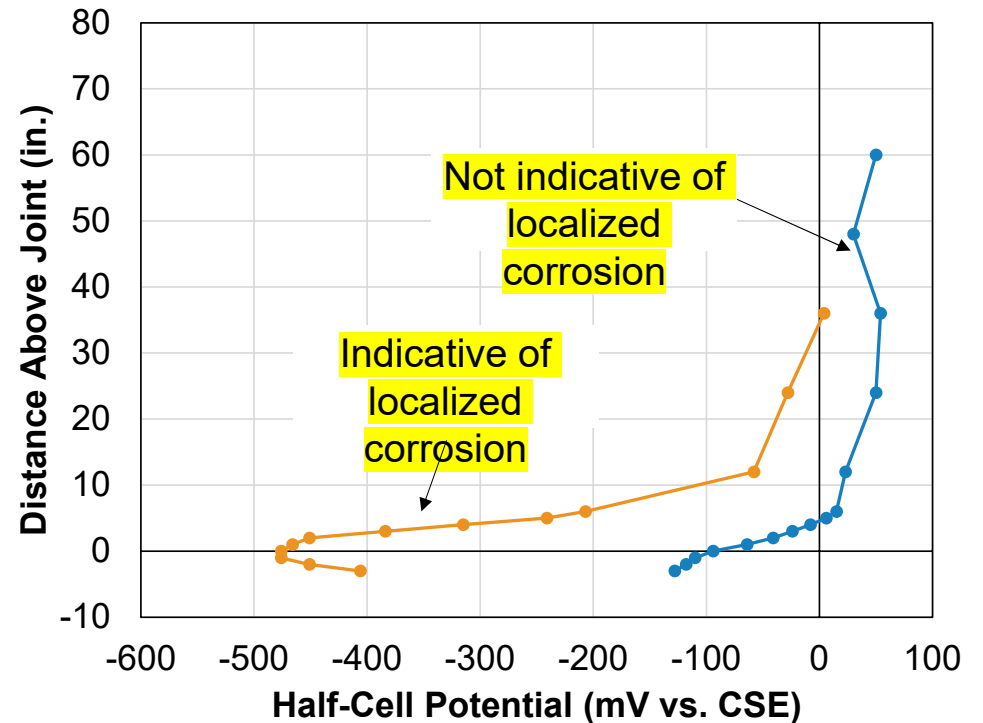
Risk of Localized Corrosion	High	Corrosion staining at joint Wet conditions at joint
	Moderate	Poor-quality joint No starter wall
	Low	Good-quality joint Dry conditions at joint Waterstop

Localized Corrosion: Repairs

- Mitigate ongoing corrosion activity with anodes
- Inject areas of poor consolidation with grout
- Strength repairs to address significant section loss of primary reinforcement due to corrosion

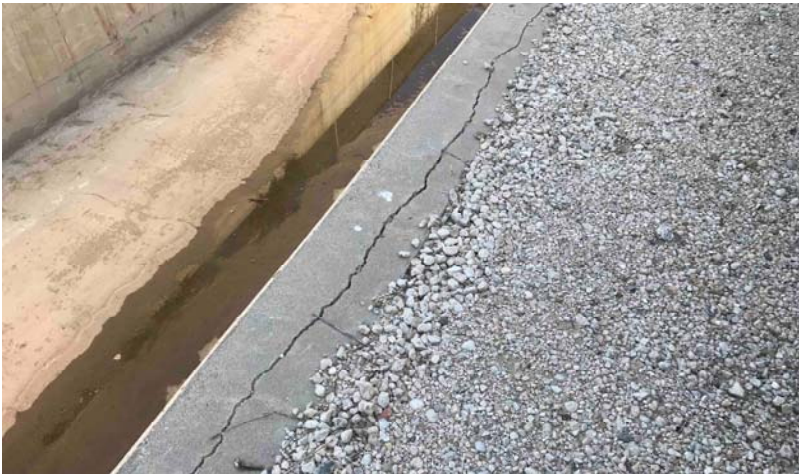
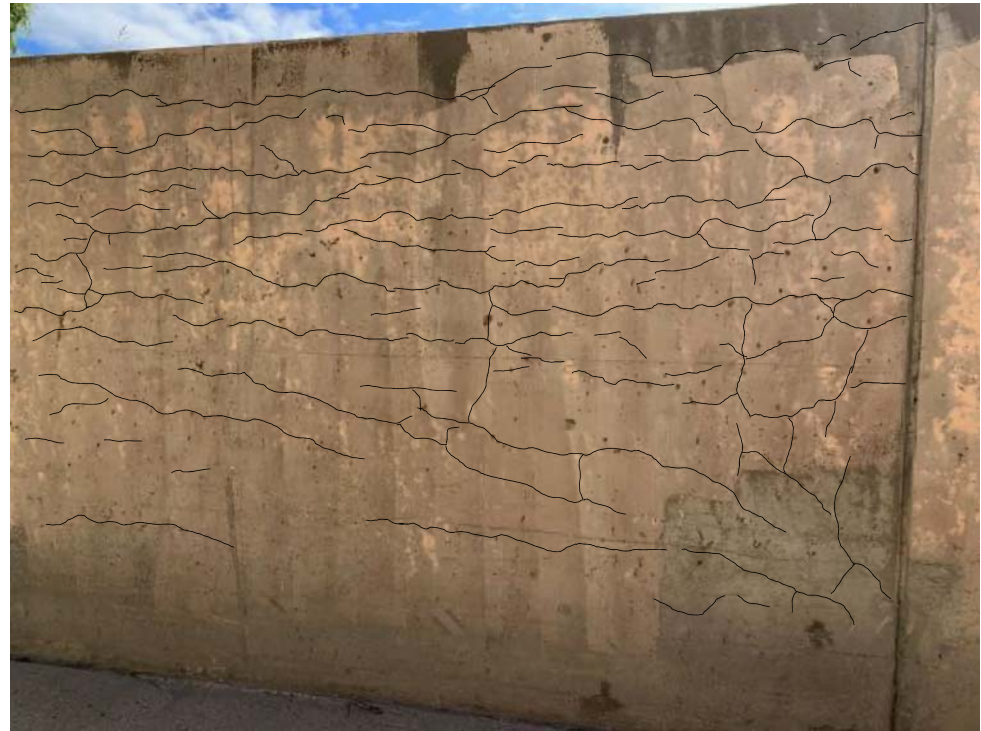
ASR: Investigation

- Investigation methods:
 - Visual observations
 - Nondestructive testing
 - Destructive verification
 - Laboratory testing (petrography)

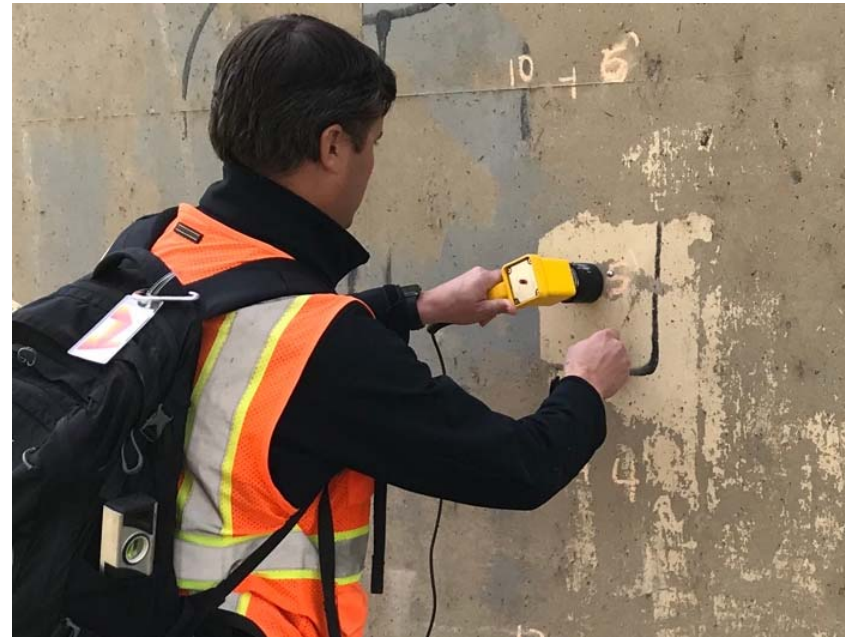
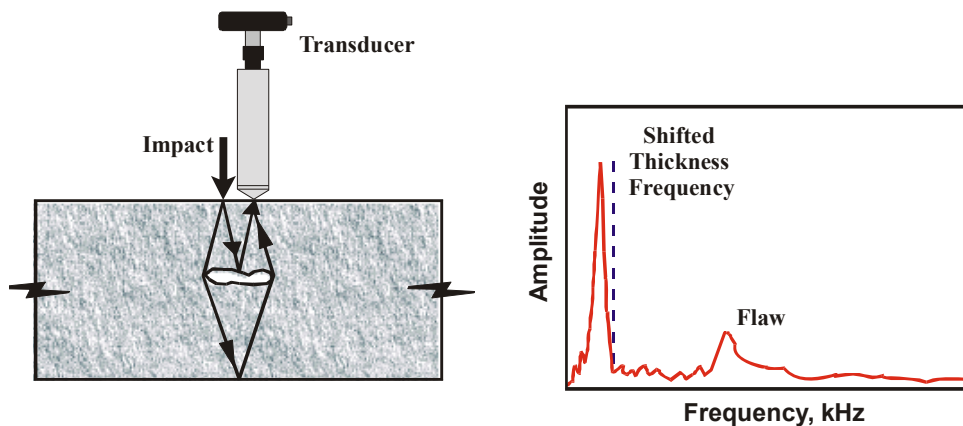
ASR: Investigation

- Investigation methods:
 - Visual observations
 - **Nondestructive testing**
 - Destructive verification
 - Laboratory testing (petrography)

Figure adapted from "Impact-Echo: Nondestructive Evaluation of Concrete and Masonry," MJ Sansalone and WB Streett

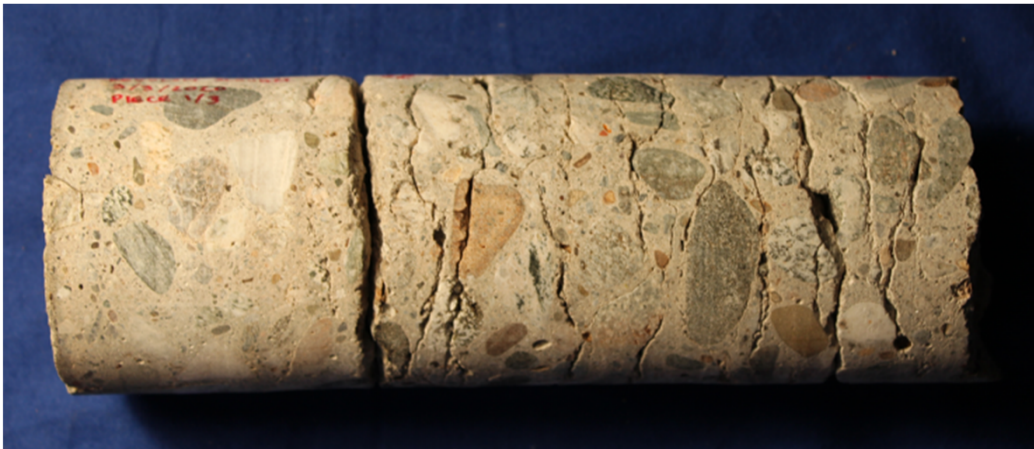
ASR: Investigation

- Investigation methods:
 - Visual observations
 - Nondestructive testing
 - **Destructive verification**
 - Laboratory testing (petrography)

- Concrete typically includes reactive components susceptible to ASR
- Significant ASR distress only observed where moisture is available to fuel the reaction and expansion
- Lack of transverse reinforcement allows for extensive subparallel cracking which could result in a future loss in strength
 - No evidence that ASR is contributing to strength concerns yet

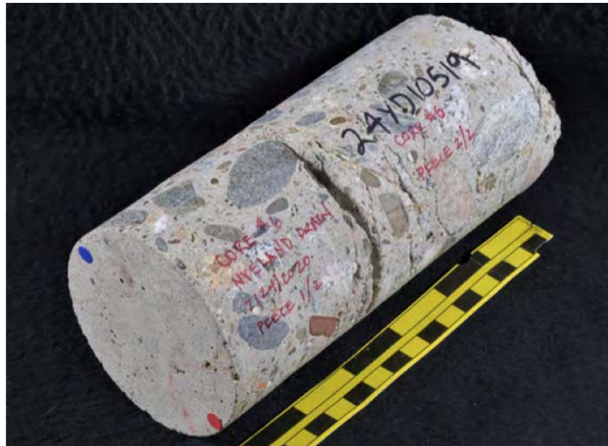
ASR: Investigation

- Investigation methods:
 - Visual observations
 - Nondestructive testing
 - Destructive verification
 - Laboratory testing (petrography)
