# Assessment and Rehabilitation of Waste Water Treatment Structures Affected by Microbially-Induced Corrosion of Concrete

Meghdad Hoseini, Ph.D., P.Eng.

WSP Canada- Vancouver

## Highbury Interceptor Condition Assessment Using Non-Destructive Test Methods

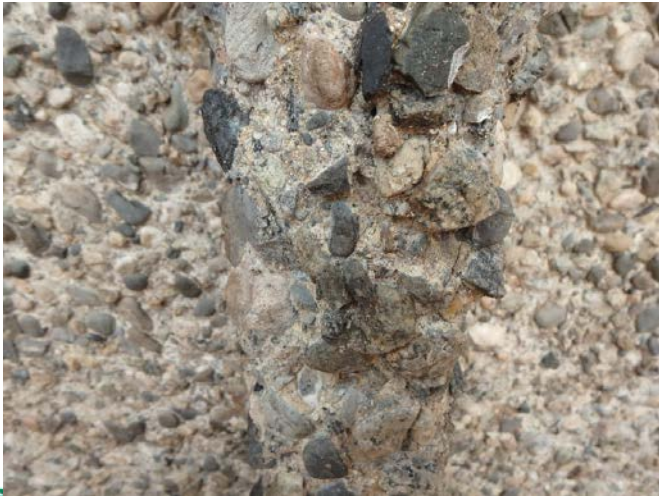
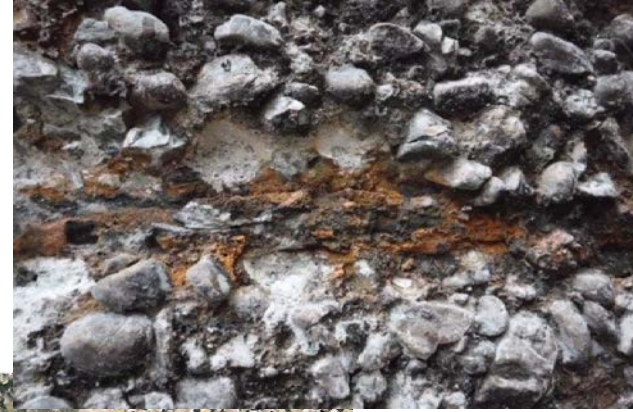
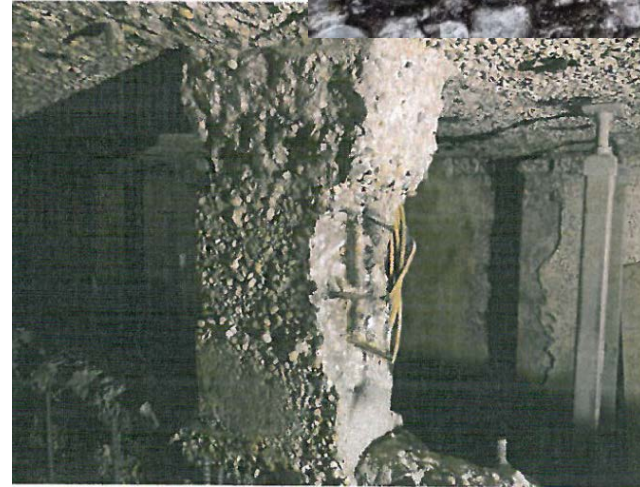
# Signs of Deterioration

- Softening and removal of cement paste
- Dislodging of coarse aggregate
- Erosion of surface paste (due to combination of MIC and flow)
- Reduced cover
- Corrosion of reinforcement: cracking, delamination, and spalling

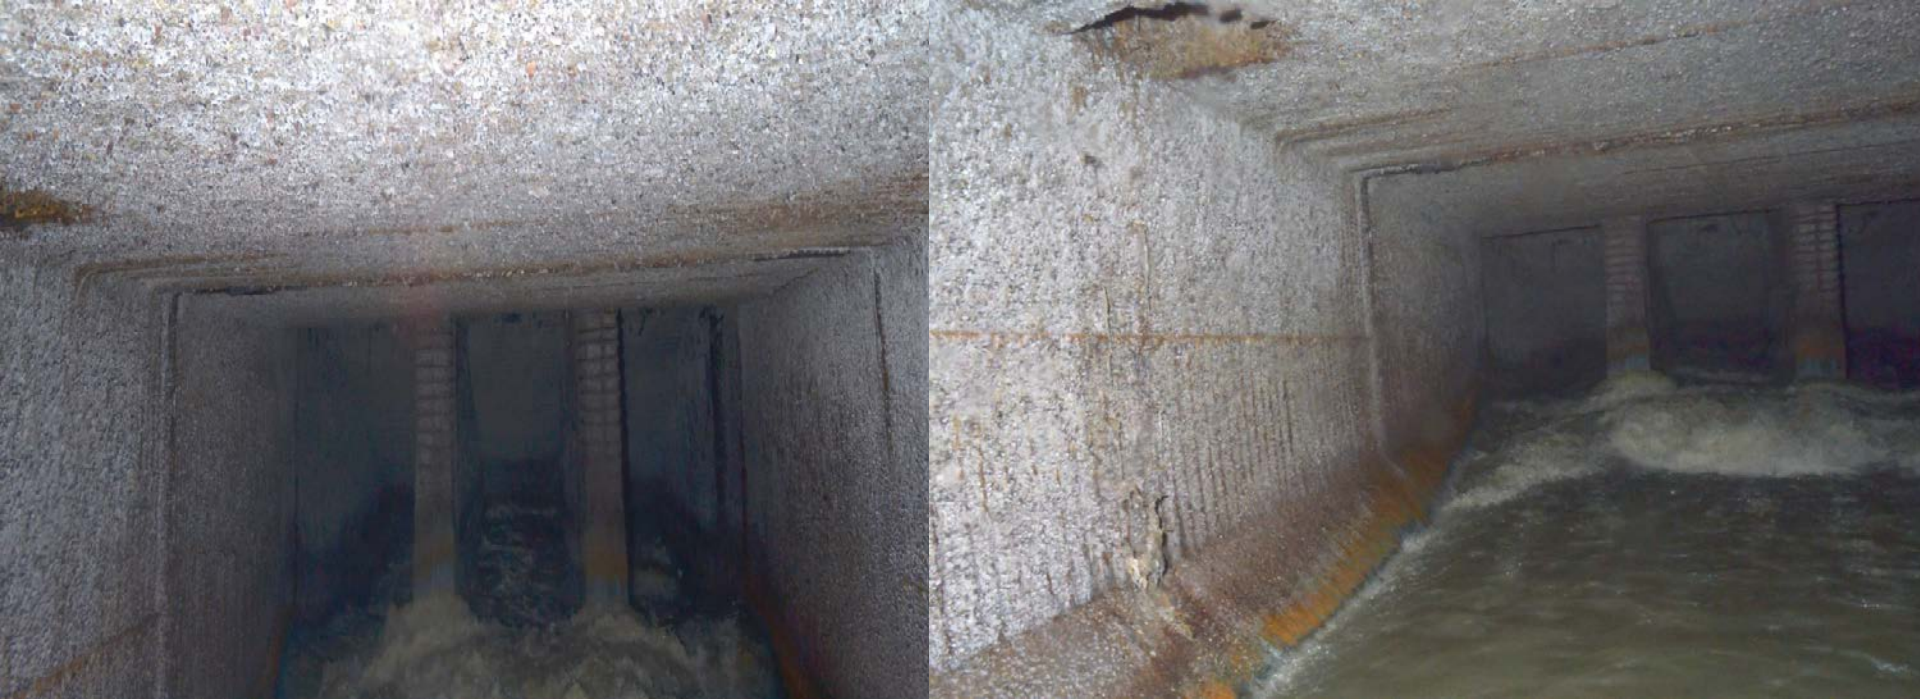
# Still Photography

- A SLR camera was lowered into the head space within the chamber using the same manhole used for the CCTV video footage.
- A high powered flash was used to illuminate the chamber

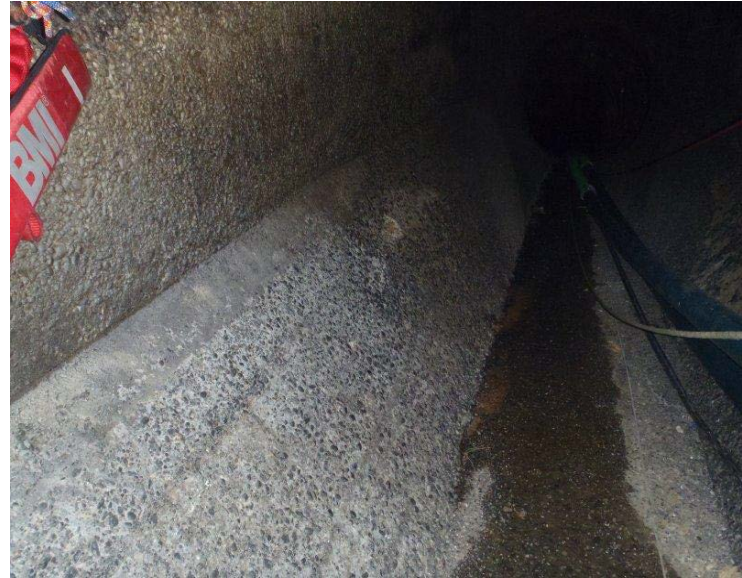
# Still Photography

- Concrete beneath the average effluent level appears to remain in sound and serviceable condition.

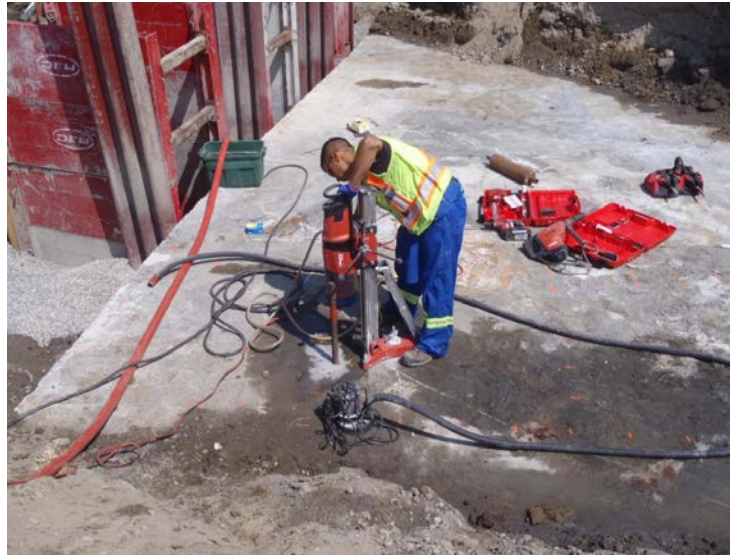
# Coring

- Four locations in the roof slab and at one location of the west sidewall

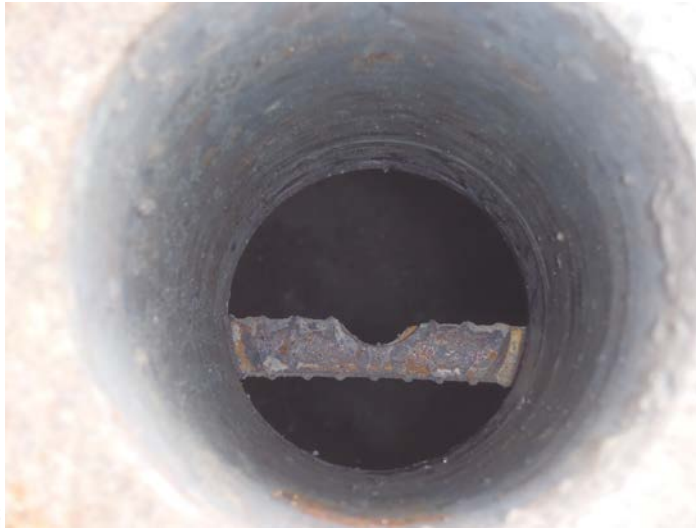
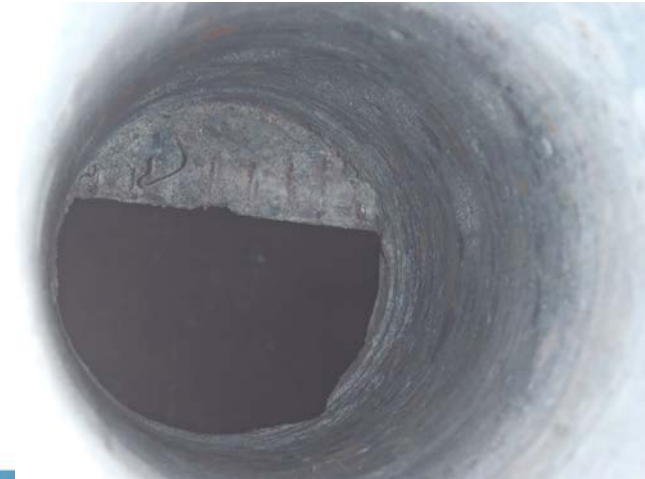
# Coring

- Rebar was found to be unbonded to the concrete at core locations

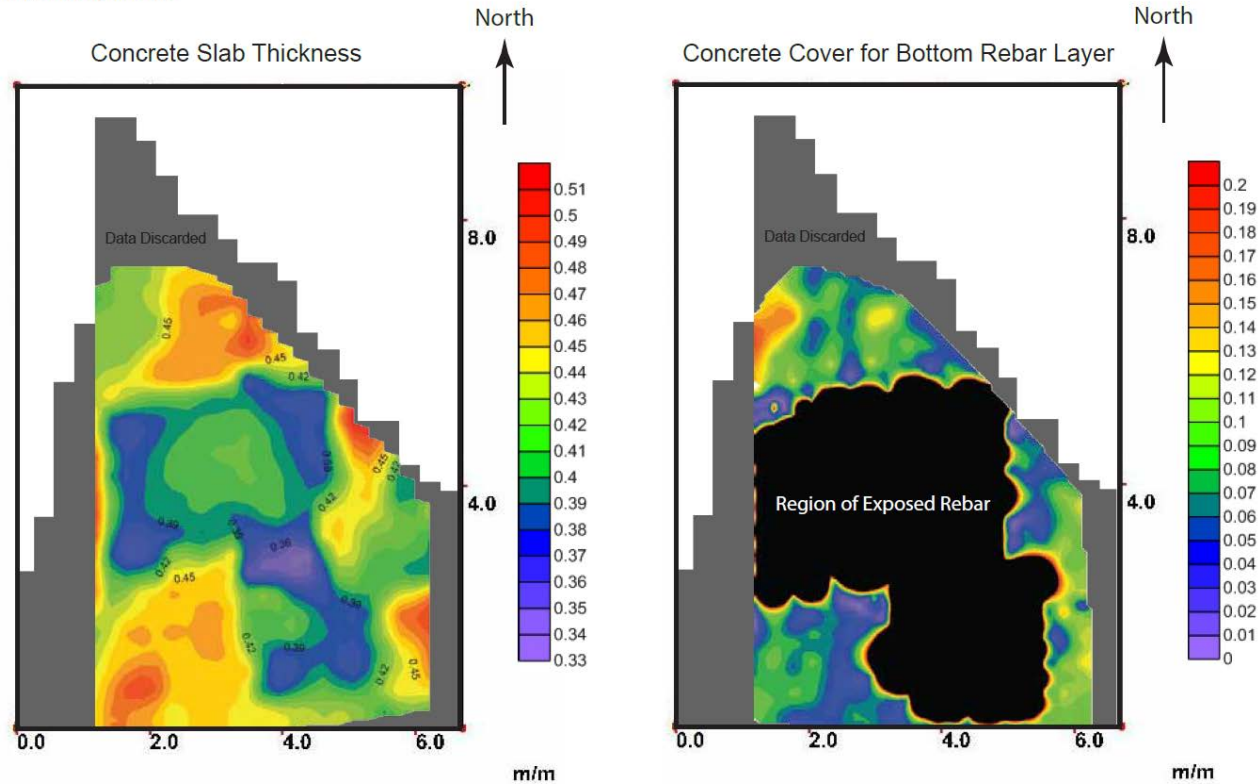
# GPR Survey Results

- Used to locate embedments within concrete and determine approximate thickness of concrete elements
- Analogous to the stress-wave propagation methodology (IE method), except that electromagnetic waves are used instead of stress waves

GPR survey results
