# North Bay Courthouse Seismic Structural Retrofit with Precast Concrete Shear Walls

Tim Van Zwol, M.Sc., P.Eng.  
Regional Manager / Associate  
RJC Engineers

2018 Spring Convention | **seismic**solutions | April 11-13 | San Francisco

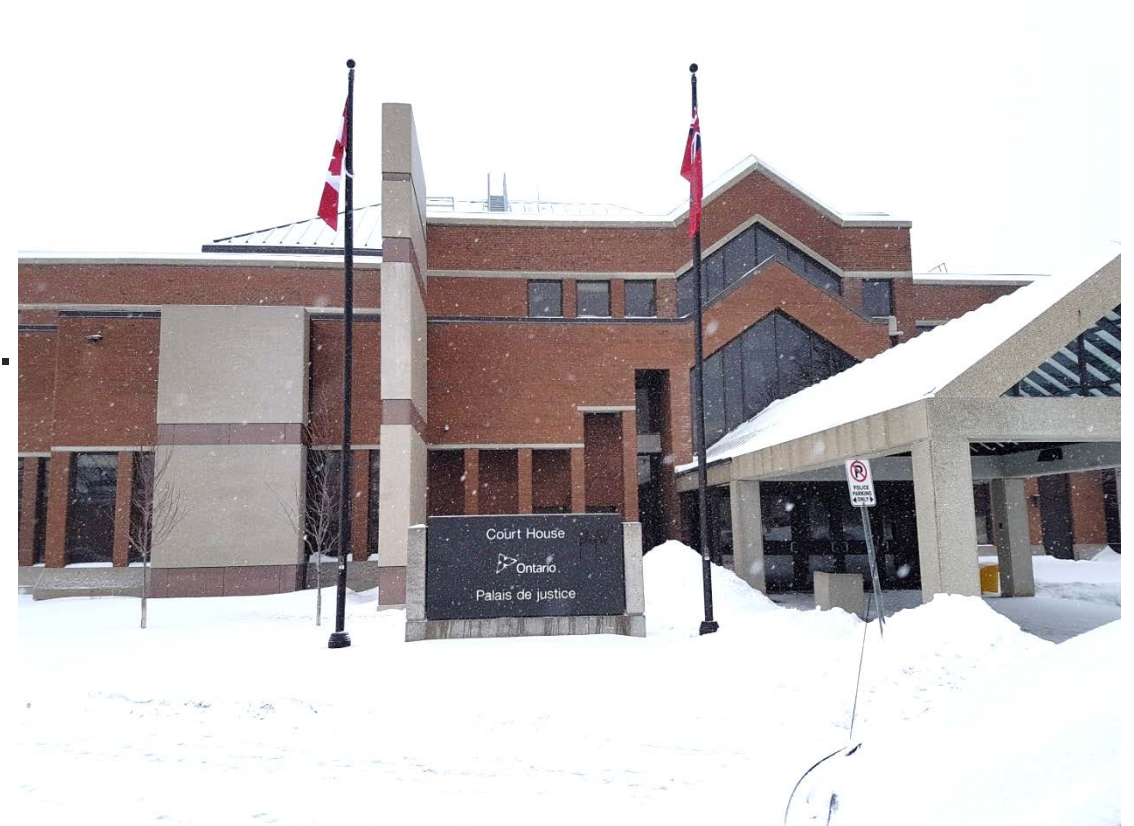
- Four-storey provincial courthouse building (53 ft. height)
- Constructed 1989
- Total floor area – approx. 100,000 sq.ft.
- Cast-in-place concrete foundations
- 6” thick concrete floor slabs on steel deck with structural steel framing
- Brick veneer cladding system

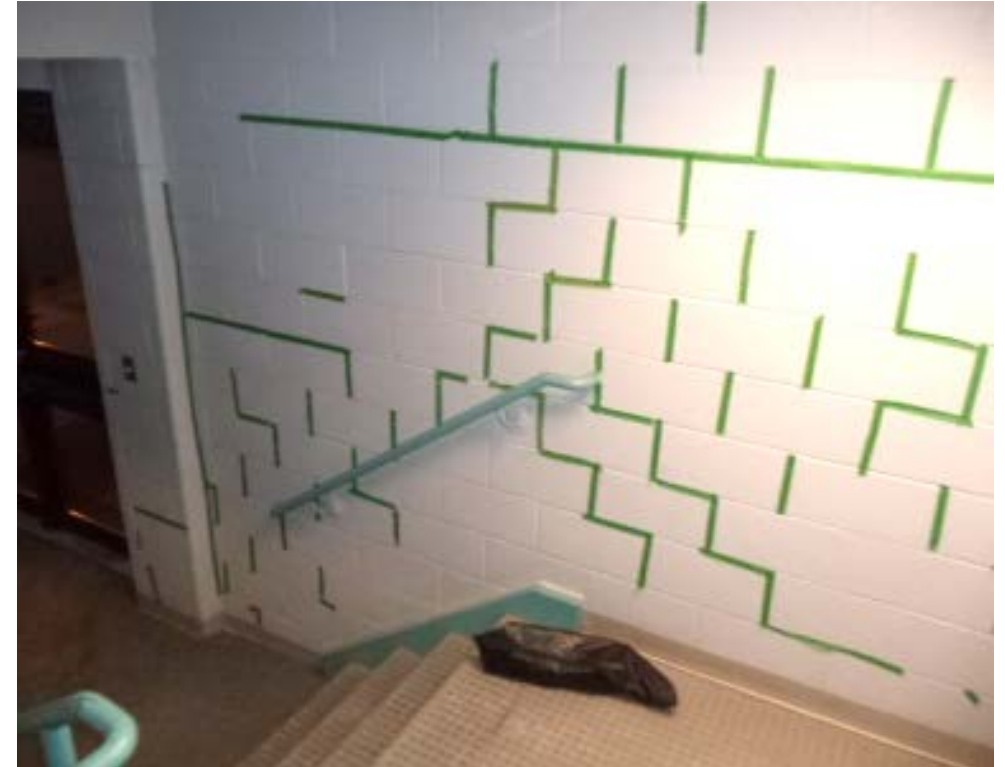
- Cracking at interior concrete masonry unit (CMU) walls at stair shafts
- Building Structure Condition Assessment undertaken in 2014
- Scope of Work:
  - Visual site review of as-built conditions
  - Review available construction drawings
  - Review existing geotechnical reports
  - Perform lateral analysis of the structure
  - Development of potential remedial concepts

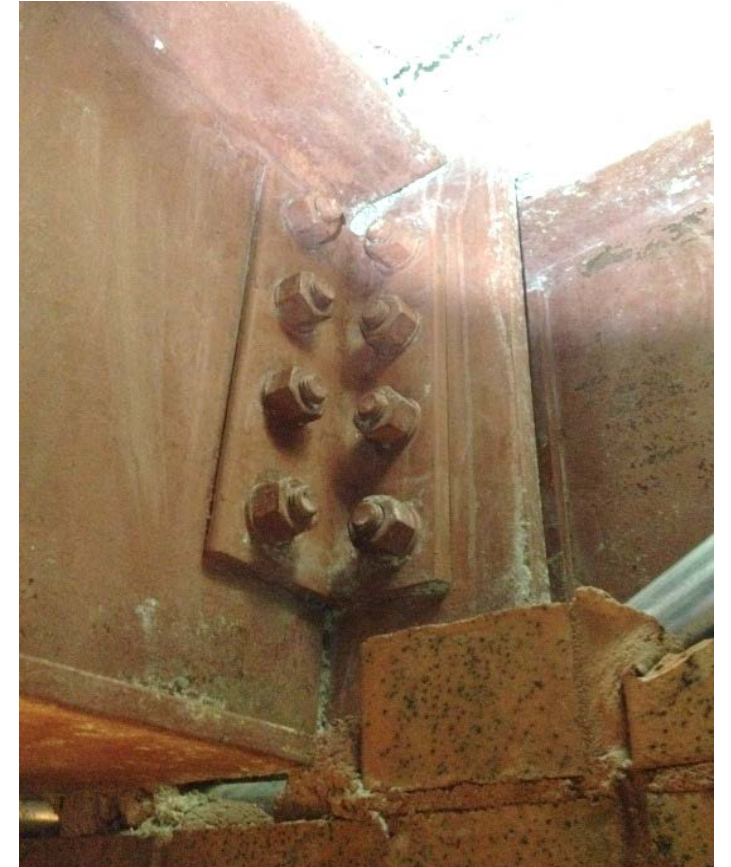
- Assessment Conclusions:
  - No clearly defined lateral force resisting system
  - Existing steel beam-column connections did not have sufficient lateral capacity to meet requirements of Ontario Building Code (OBC)
  - Incidental lateral utilization of CMU walls
  - Cracking of CMU walls result of lateral deflection
  - Building structure at risk of severe damage or partial collapse if subjected to a design seismic event

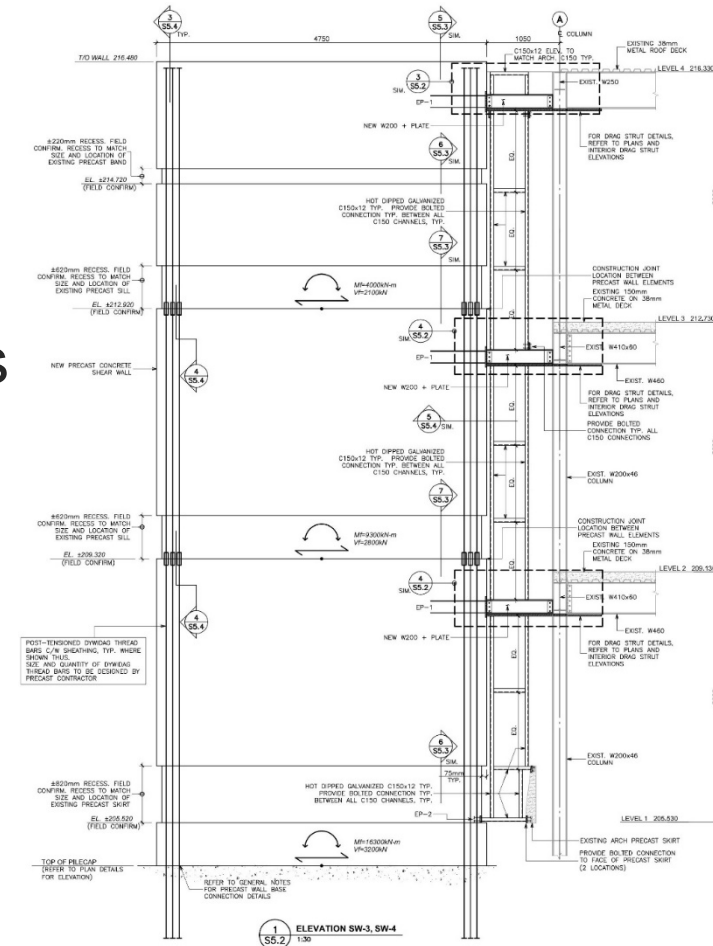
# Option 4 – External Precast Concrete Shear Walls

- Shear walls at exterior of building – simplify construction
- Complement existing building aesthetics
- Interior work could be phased to maintain building operations
- Interior work completed during evenings and weekends only

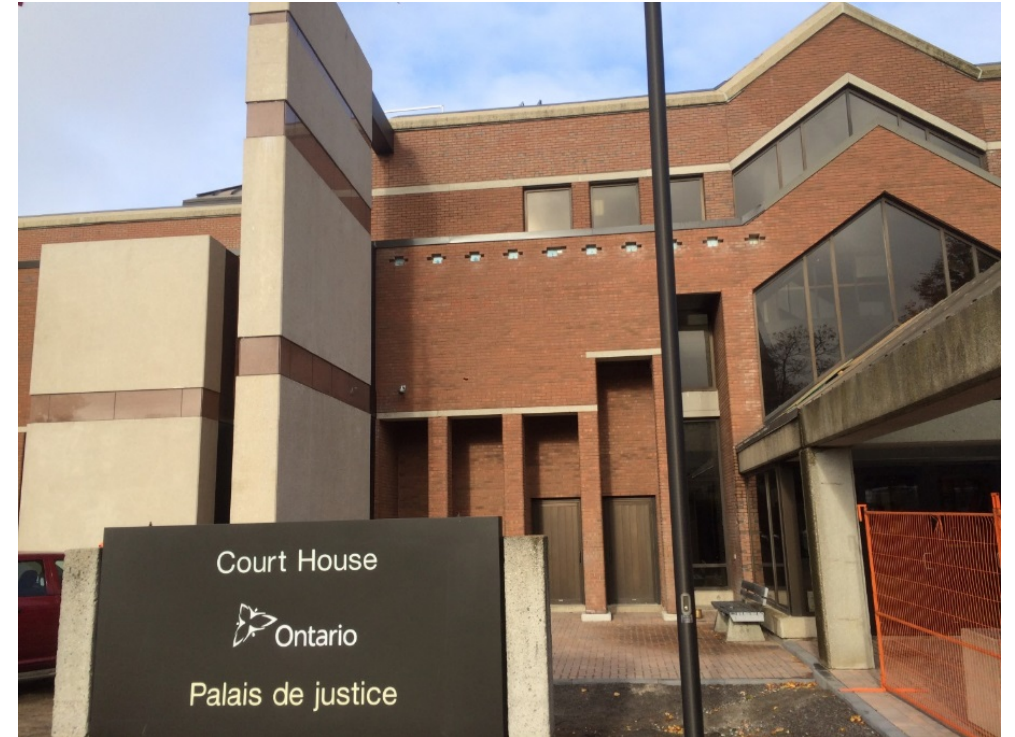
- Start January 2016
- Substantially Complete by November 2017
- 23 Month Construction Schedule
- Approx. \$14 million Construction Cost

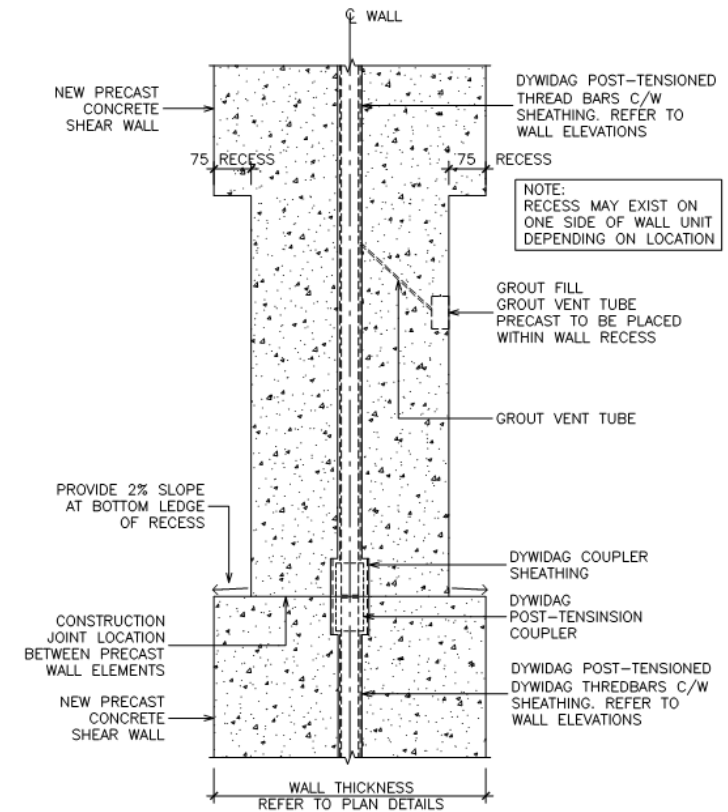
4  
S5.4 N.T.S.

- 13 exterior precast concrete shear walls
- 35 Mpa (5,000 psi), Exposure Class C-1
- Shear wall thickness varies 19" - 22"
- 3" recesses for architectural granite panels; hide construction joints, grout ports
- Regular reinforcement + Dywidag post-tensioned threadbars
- Walls fabricated in sections to suit shipping

TYPICAL DYWIDAG COUPLER DETAIL AT WALL CONSTRUCTION JOINT

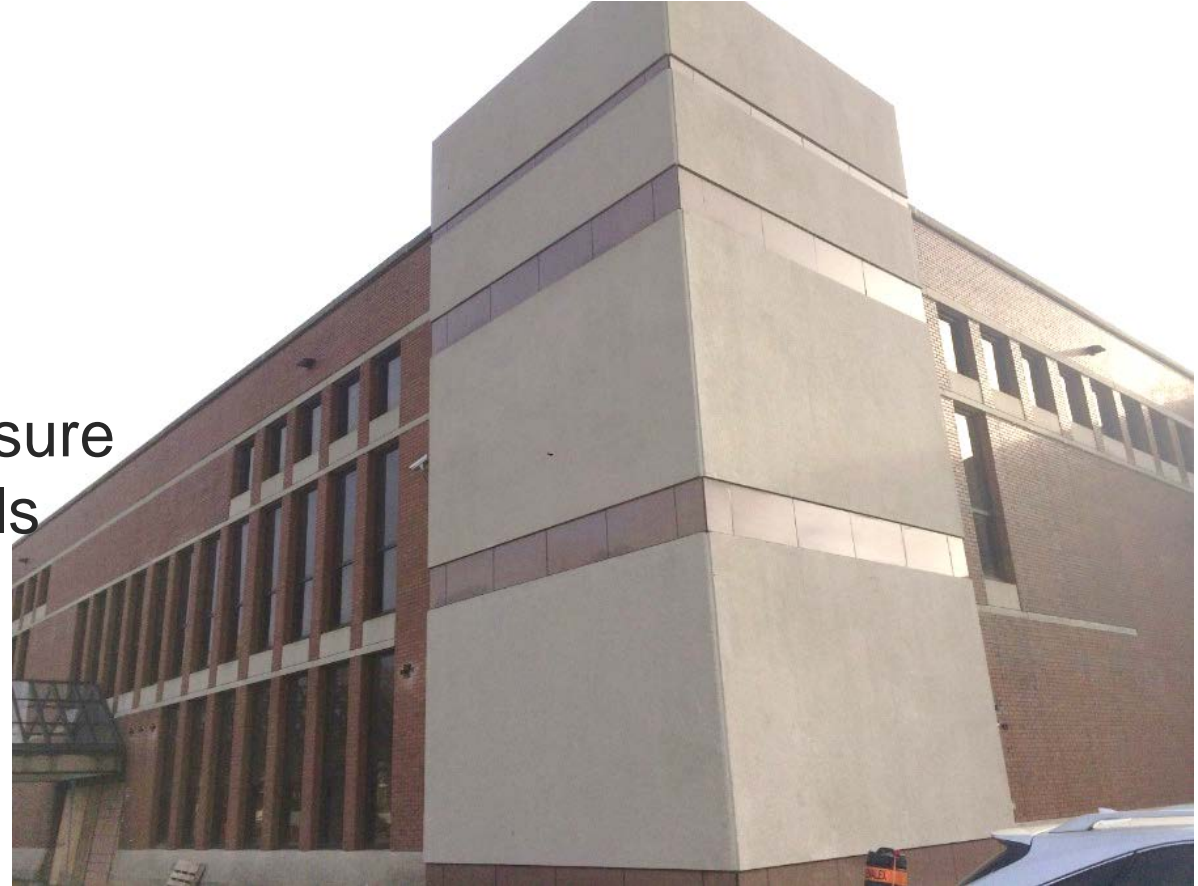
# External Precast Concrete Shear Walls

- Formed side of wall is exposed
- Consistent medium sandblast finish surface with penetrating sealer
- Colour pigment and aggregate exposure to match existing building precast sills
- 3" recesses for architectural granite bands

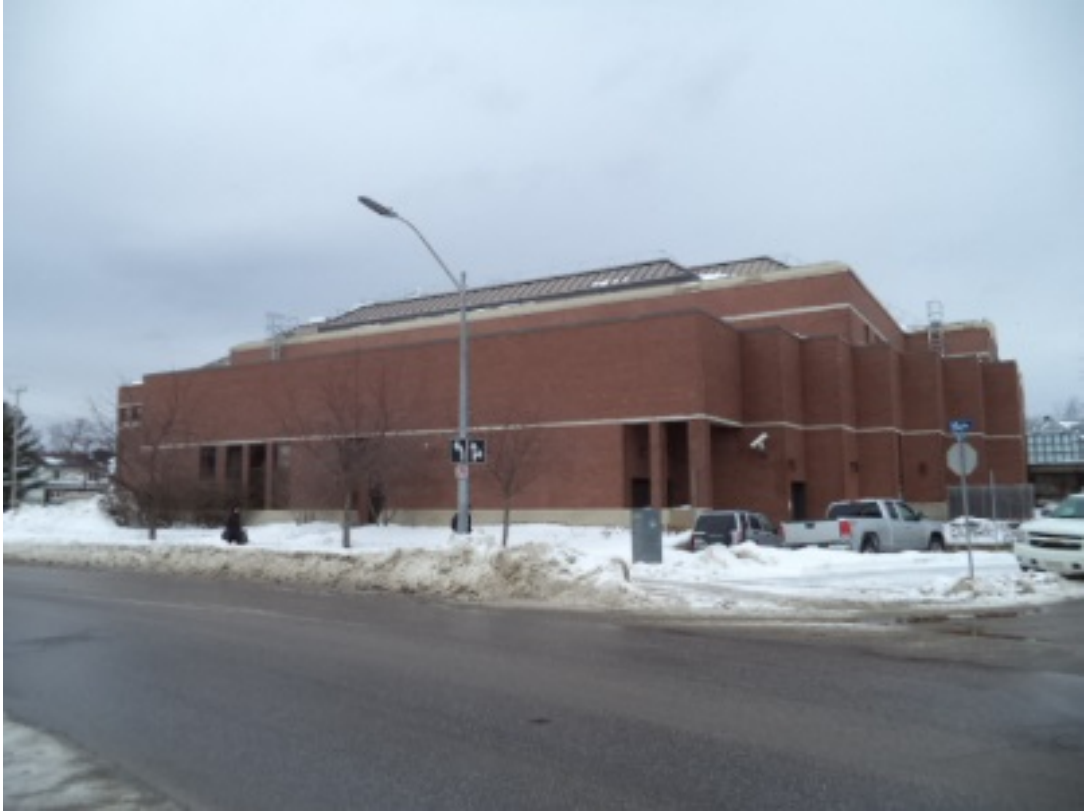
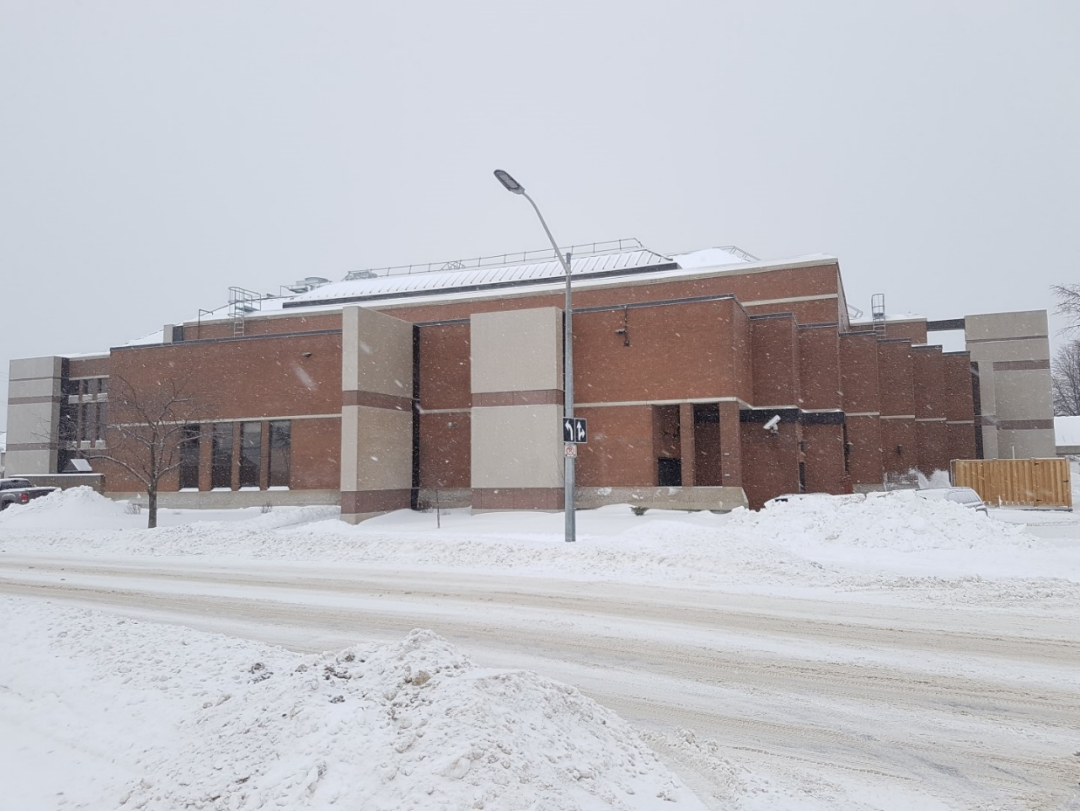
# Before / After

- External Precast Shear Walls – proved to be most viable option
- Seismic retrofit complimented existing building exterior aesthetics
- Construction schedule requirements were met
- Project completed on budget
