Brooklyn Basin Wharf Repair and Seismic Retrofit

Sara Barrett, P.E.

Ali Naeem, P.E.

April 12, 2018

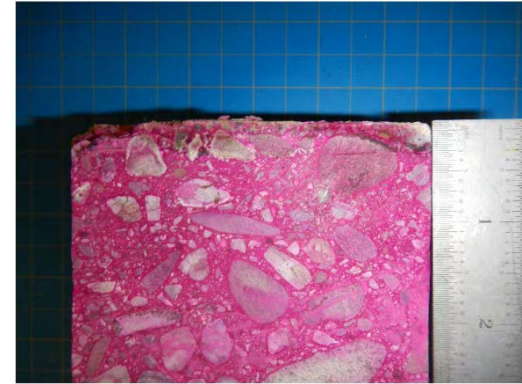
Photo #1– Depth of carbonation on sample P109G-B

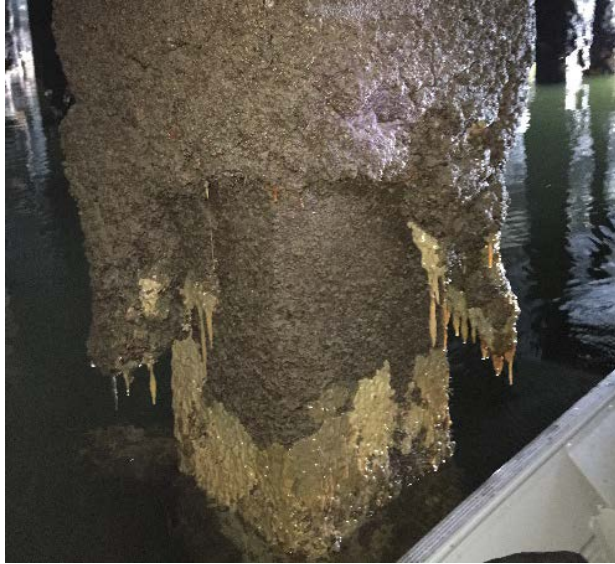
Pile Jacket Deterioration

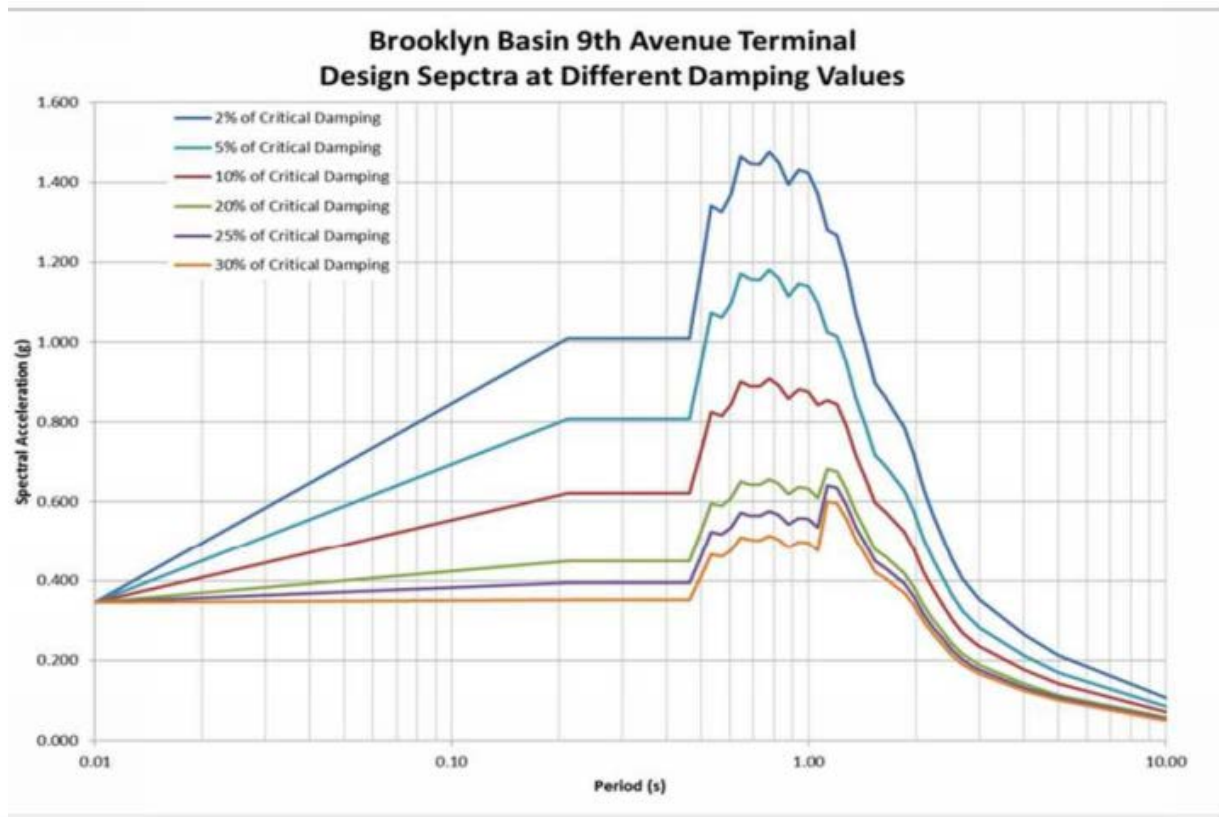
Site Specific Spectra

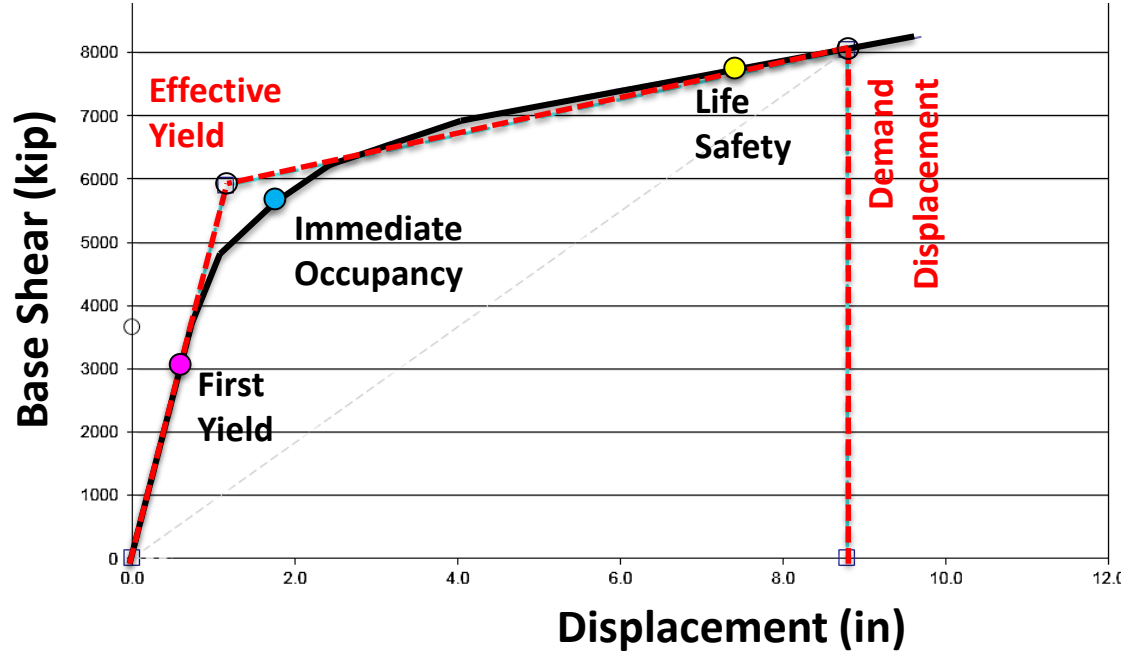
Wharf Evaluation – Pushover Analysis
